RESERVE STUDY
for
SAINT PETRONILLE PARISH
at
420 GLENWOOD LANE
GLENN ELLYN, ILLINOIS 60137

KGH NO. 19-11-454

November 11, 2019

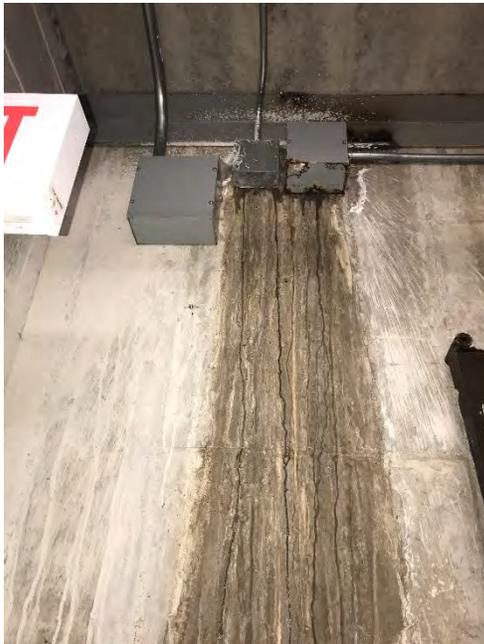
Fig. 1 - View of leak location in the basement located below the pipe to the south of the northeast stair exit door.

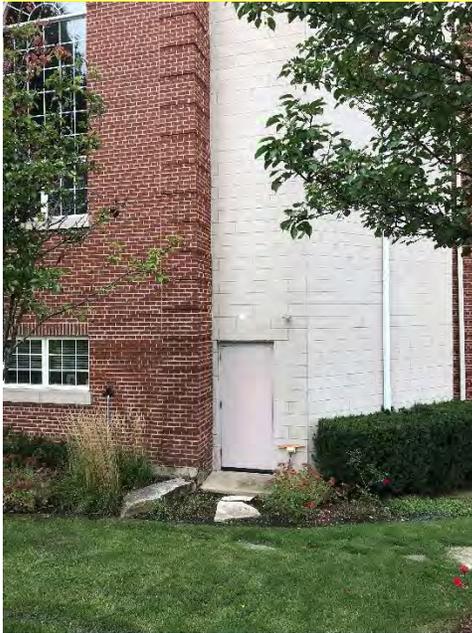
Fig. 2 - View of leak location to the basement located below the pipe to the south of the stair door.

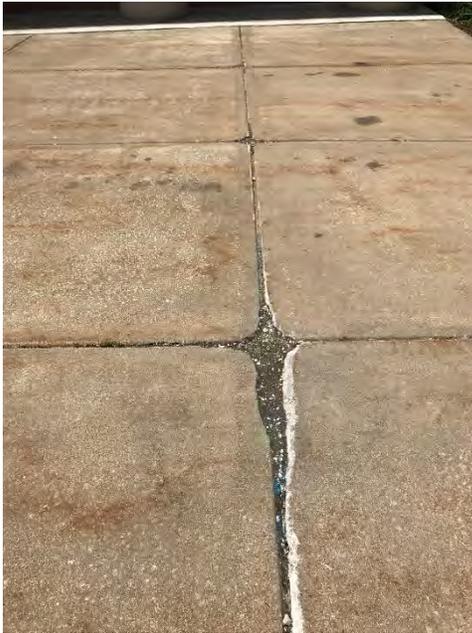
Fig. 6 - View of deteriorated concrete at church entrance.

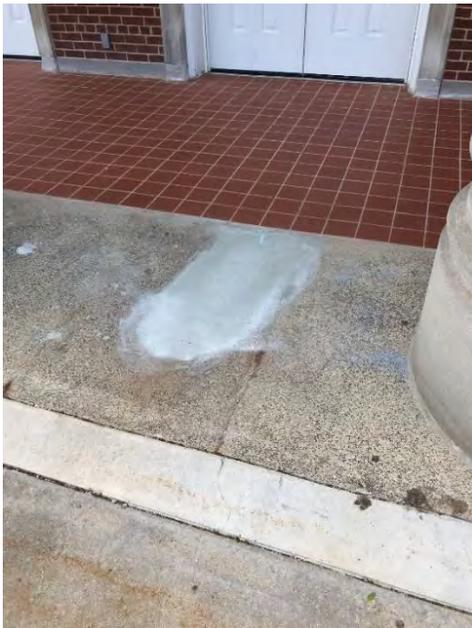
Fig. 7 - View of poorly patched concrete repair at church entrance.

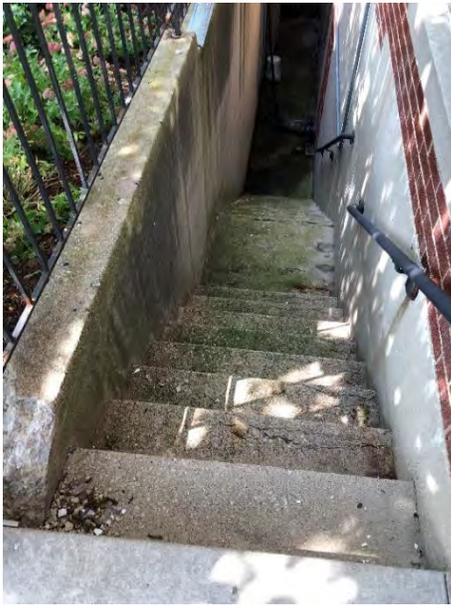
Fig. 8 - View of exterior stairs to church Basement.

| i) Concrete stairs to basement in poor condition require significant repair / replacement. | |

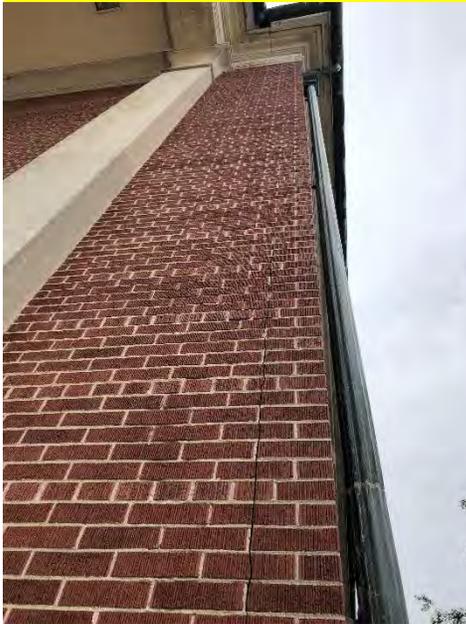
Fig. 1 – View of crack in brick that extends full height at north side of church east elevation.

| <u>Church</u> | <u>Estimated Cost</u> |
|---|---|
| 1) Brick masonry cracking at the east corner of the church (north of portico). <ol style="list-style-type: none"> a) Recommend rebuilding the masonry around the structural column and installing a permanent expansion joint to accommodate minor movement. Recommendation year 2021 | \$35,000 |

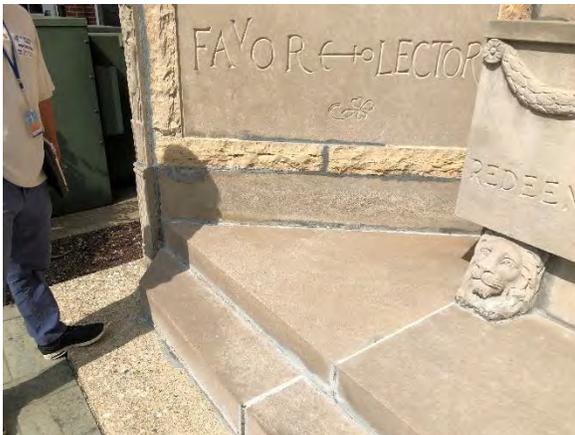
Fig. 2 – View of poor mortar repair at St. Petronille Shrine.

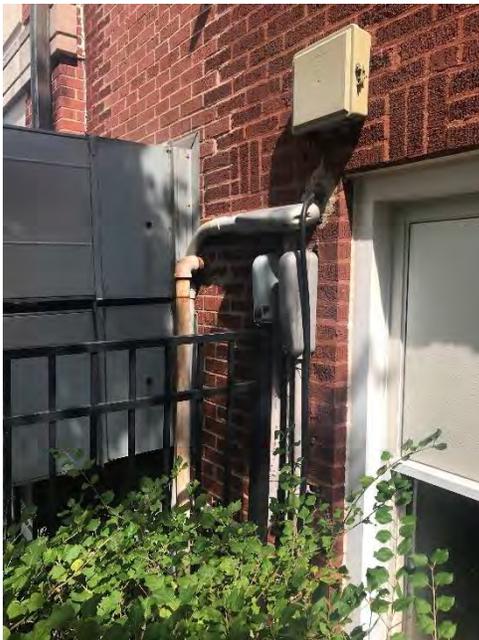
Fig. 4 – View of school west elevation with unsealed openings and failed sealant at duct.

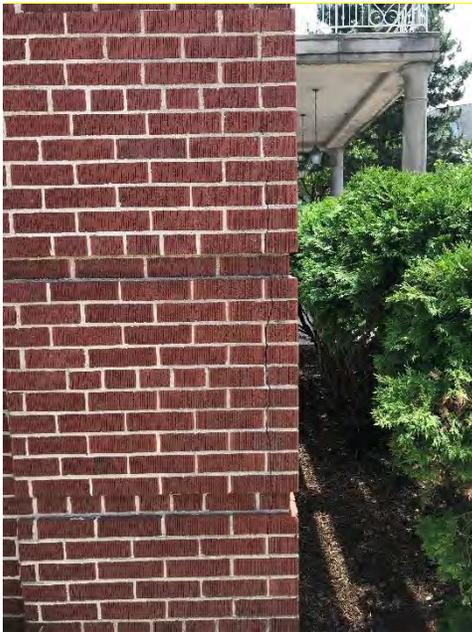
Fig. 5 – View of crack in brick that extends full height at west side of north elevation.

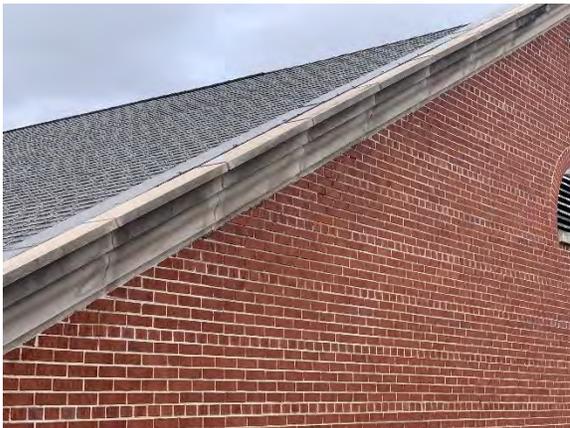
Fig. 6 – View of weathered and open mortar joints below limestone along the school east elevation.

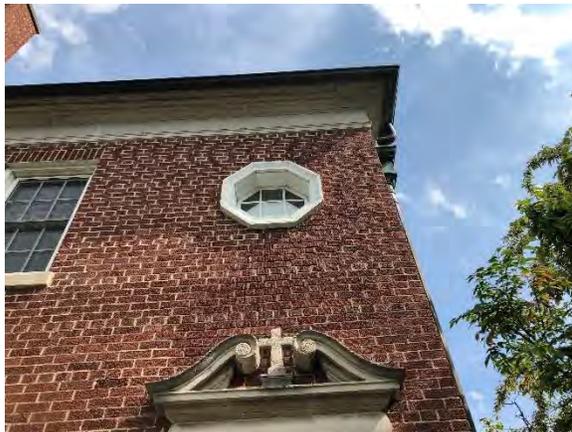
Fig. 11 – View of deteriorated mortar joints at south side of kindergarten west elevation.

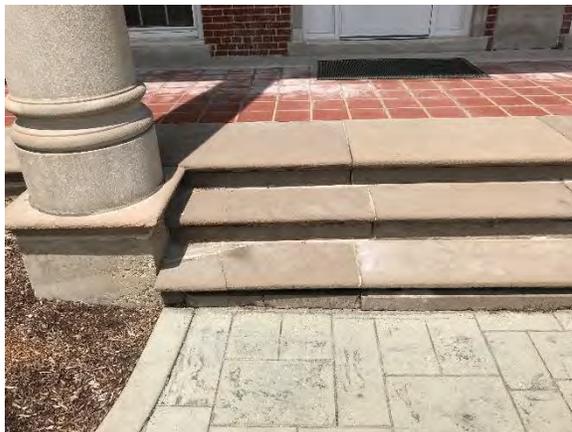
Fig. 12 – View of deteriorated limestone joints and tile efflorescence at kindergarten south elevation entrance.

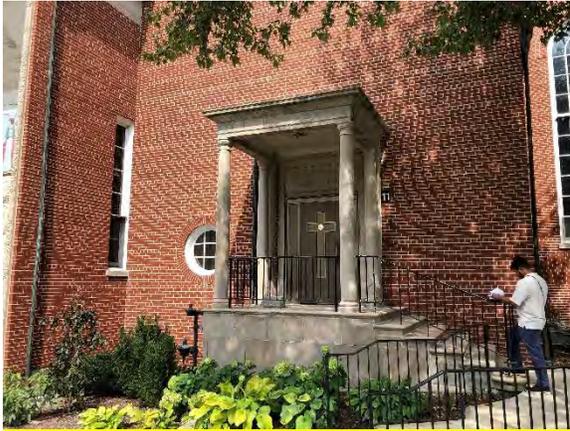
Fig. 13 – View of severe mortar joint deterioration at Mary Chapel entrance.

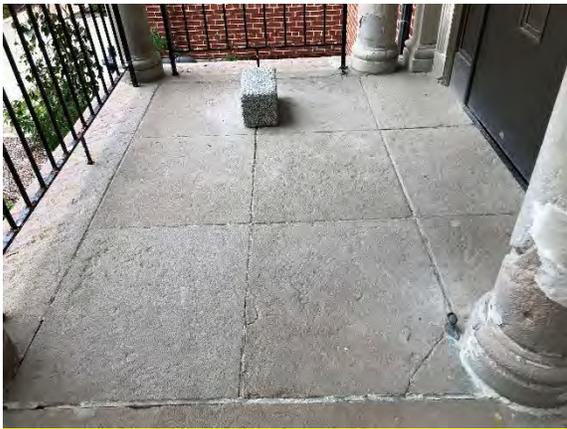
Fig. 14 – View of severe mortar joint deterioration and limestone patch repairs at columns at Mary Chapel entrance.

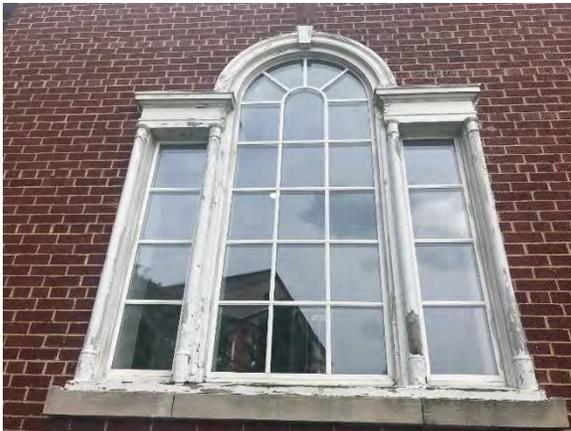
Fig. 1 – View of deteriorated kindergarten window at north elevation.

| 5) Kindergarten - Wood window at the north elevation displayed peeling paint. Recommendation – year 2025 | \$5,000 |

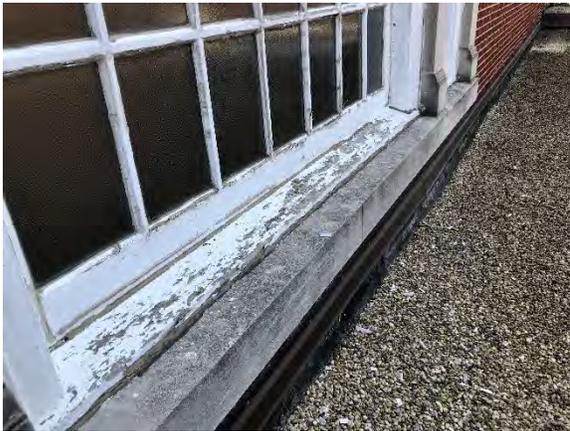
Fig. 2 – View of deteriorated church window behind alter.

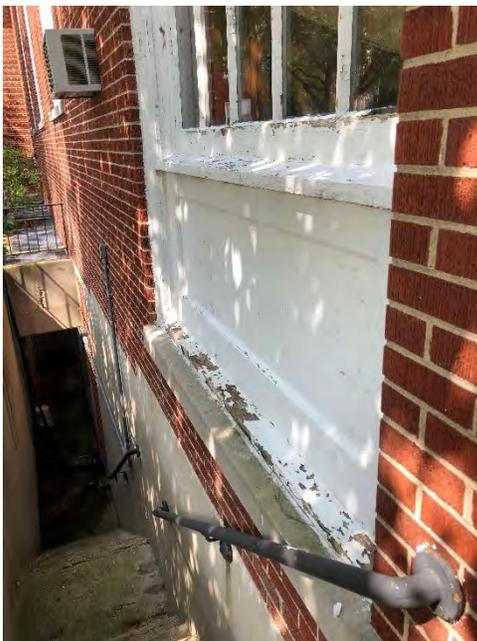
Fig. 3 – View of deteriorated church window.

| 1) Church - Existing wood windows at the elevations of the church displayed peeling paint, failed putty, failed sealant, and limited areas of deteriorated wood. Recommendation – year 2020 | \$200,000 |

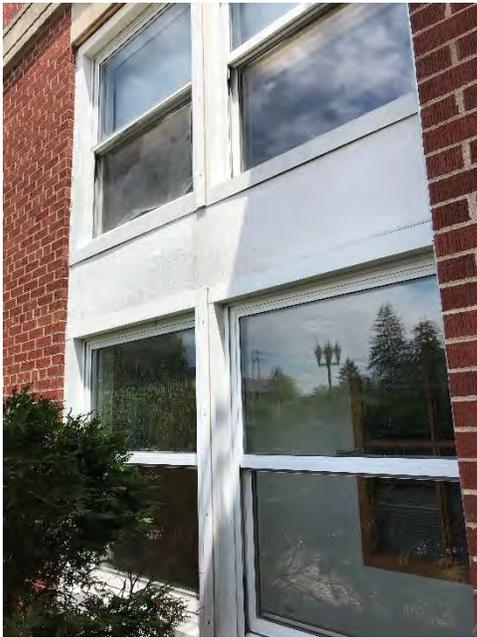
Fig. 4 – View of deteriorated school spandrel between windows.

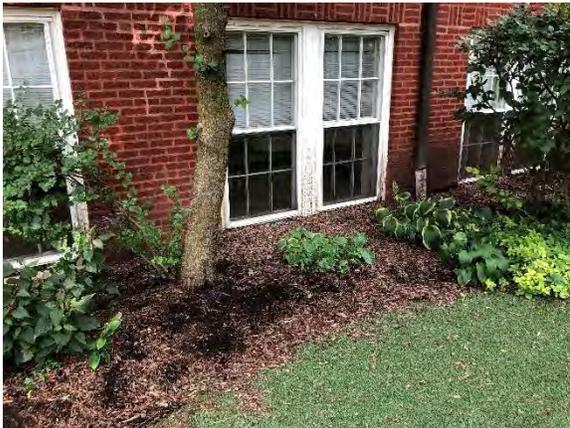
Fig. 5 – View of school window at west elevation requiring painting.

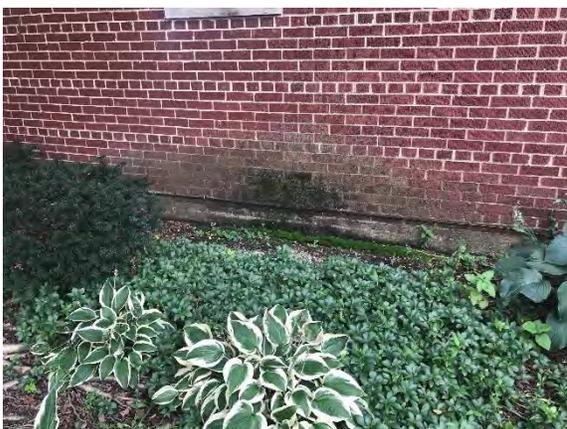
Fig. 2 – View of staining and algal growth on brick masonry due to overflowing roof gutters.

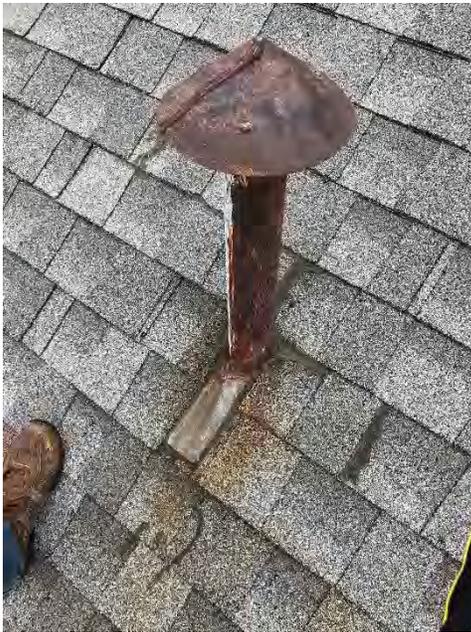
Fig. 5 – View of school corroded roof vent.

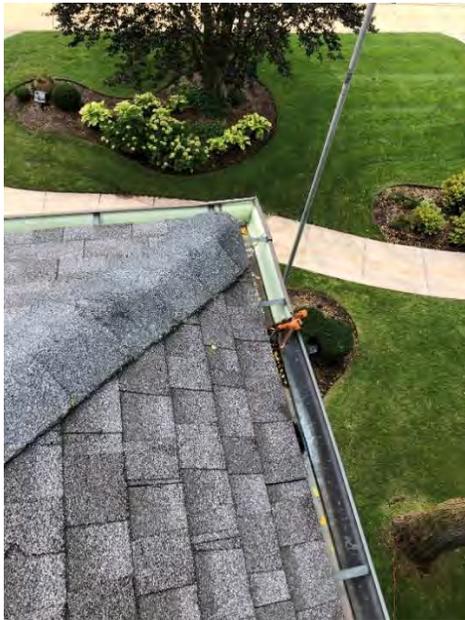
Fig. 6 – View of school roof gutter repair with clamp.

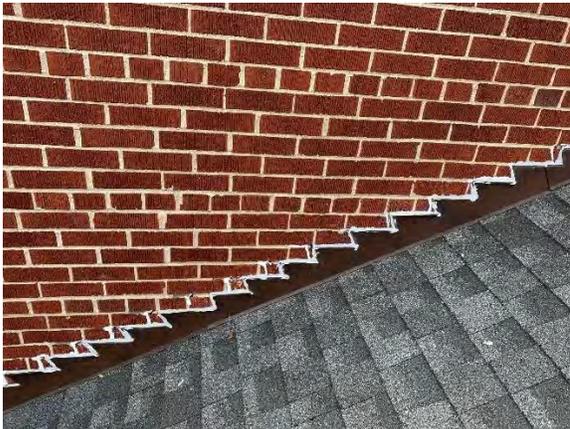
Fig. 9 – View of failed sealant at school step flashing.

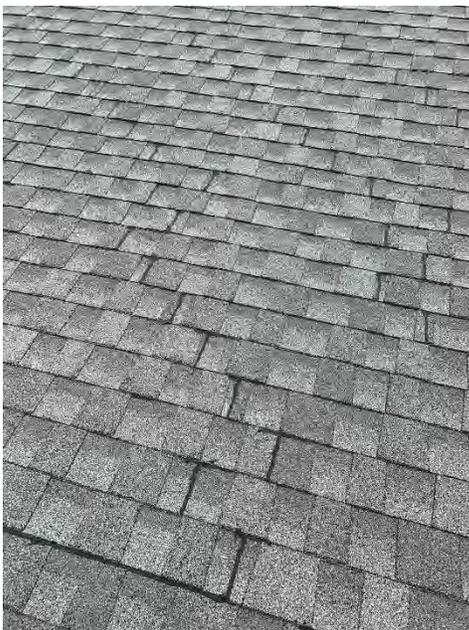
Fig. 10 – View of previous repairs to school asphalt shingles.

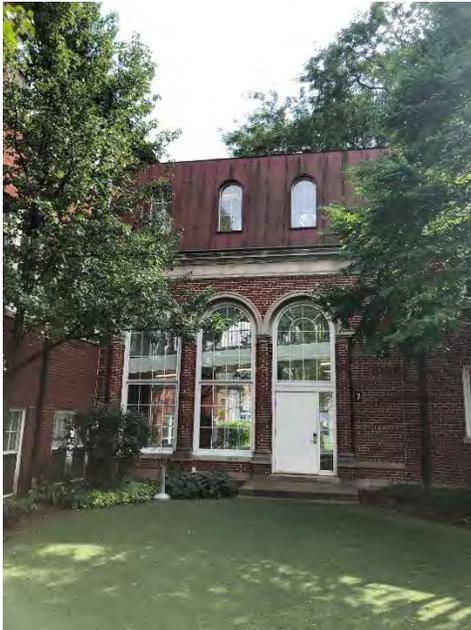
Fig. 11 – View of worn metal mansard roof at kindergarten walkway.

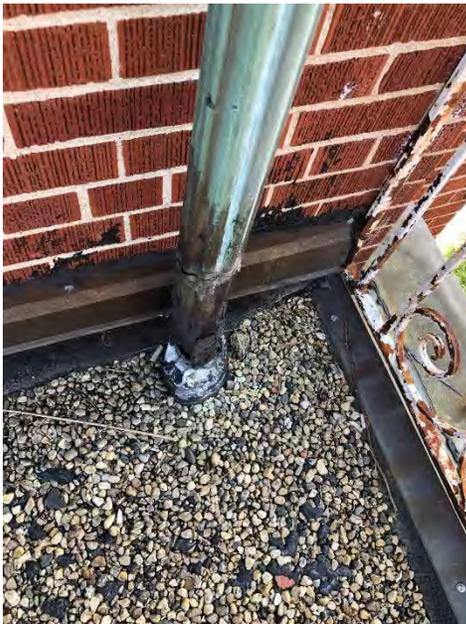
Fig. 12 – View of deteriorated southwest church downspout connection at gravel ballasted roof.

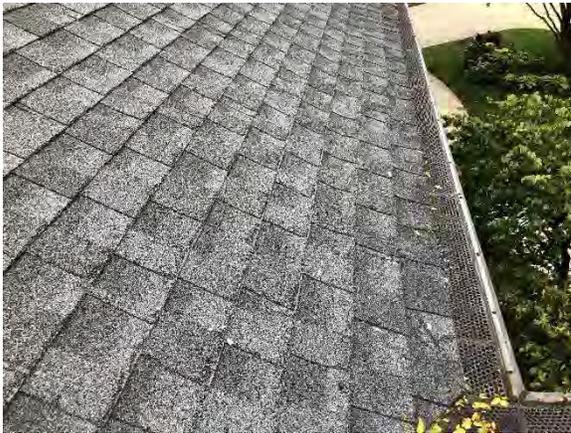
Fig. 13 – View of worn kindergarten asphalt shingles.

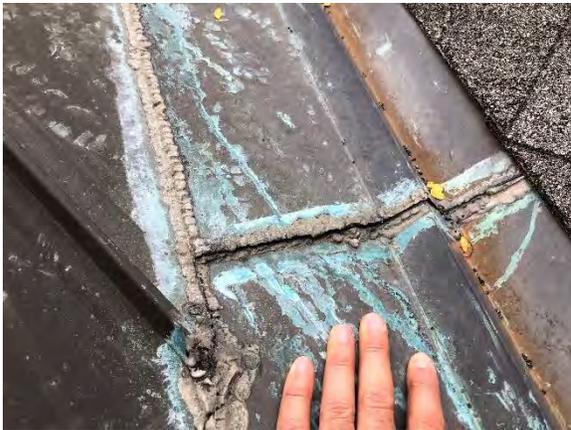
Fig. 14- View of failed soldered seam at kindergarten metal roof.

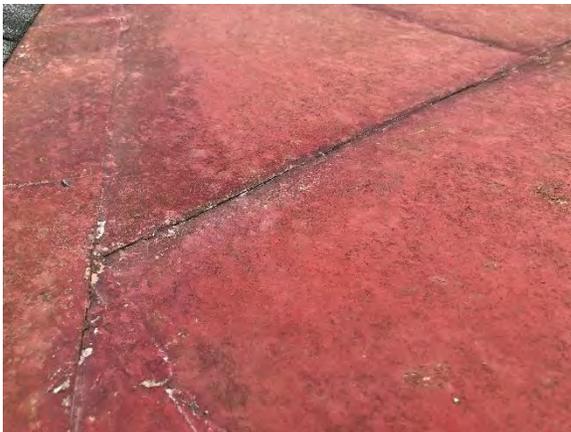
Fig. 15 – View of worn paint and failed seam at kindergarten walkway roof.

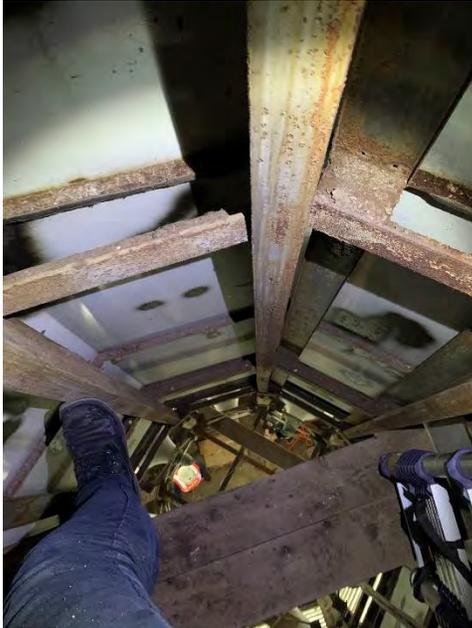
Fig. 1 – View of worn corroding steel elements in the church spire.

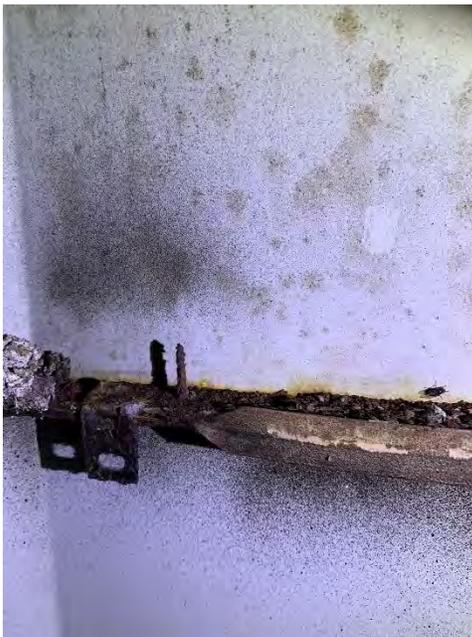
Fig. 2 – Closeup view of corroding fasteners in church spire.

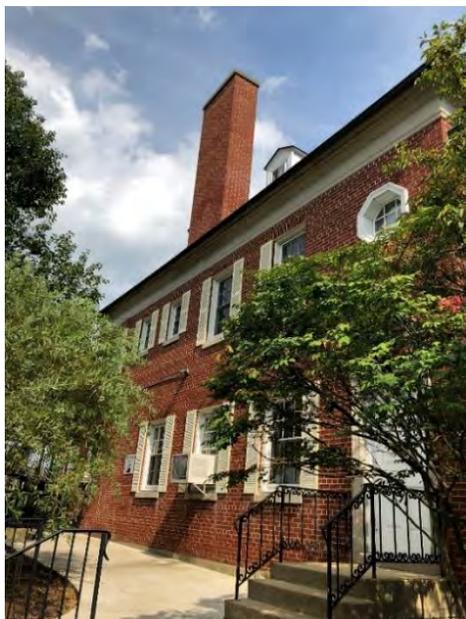
Fig. 5 – View of corroding railings at west kindergarten stoop.

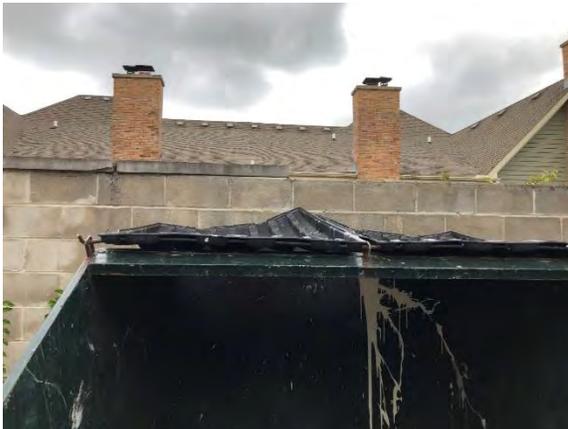
Fig. 3 – View of shifted limestone coping and missing copings atop the dumpster enclosure.

| i) Remove all loose coping immediately. | |
| ii) Reinstall / replace remaining copings. | |

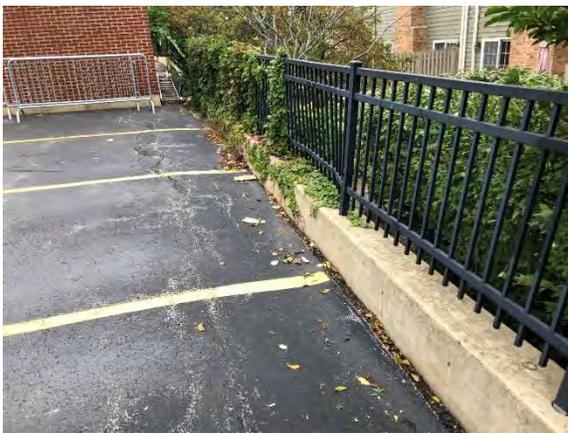
Fig. 4 – View of deteriorated retaining wall and deteriorated asphalt at northeast side of parking areas.

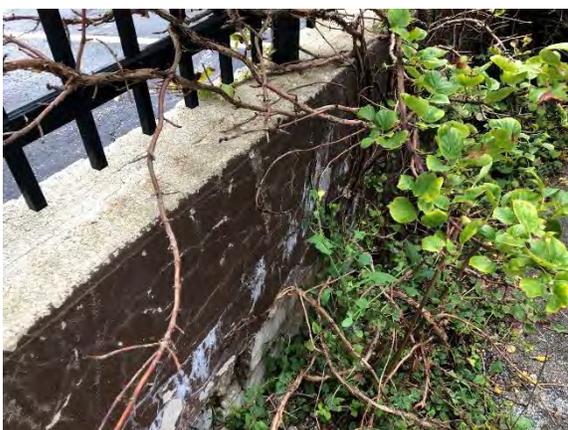
Fig. 5 – View of severely deteriorated retaining wall.

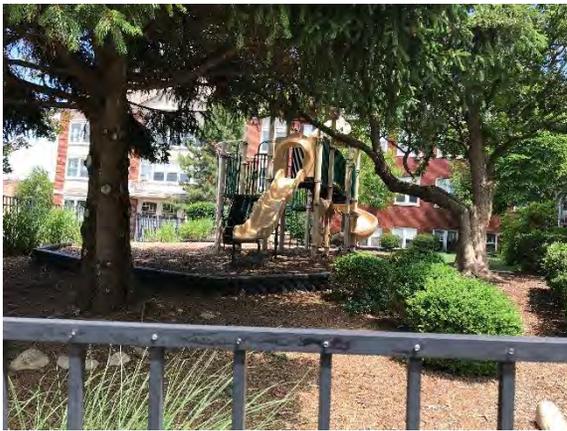
Fig. 7 – View of tree with branch over the play area that has split and requires pruning.

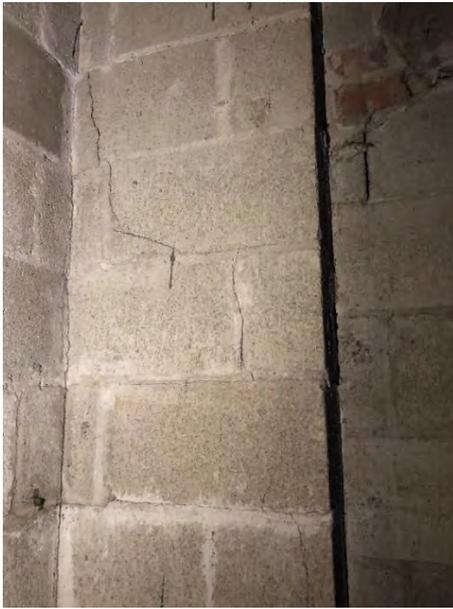
Fig. 1 - View of crack in CMU in bell tower.

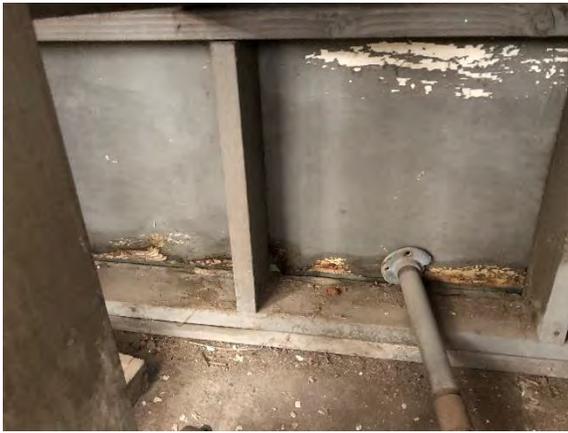
Fig. 3 - View of deteriorated wood base plate on bell tower clock room.

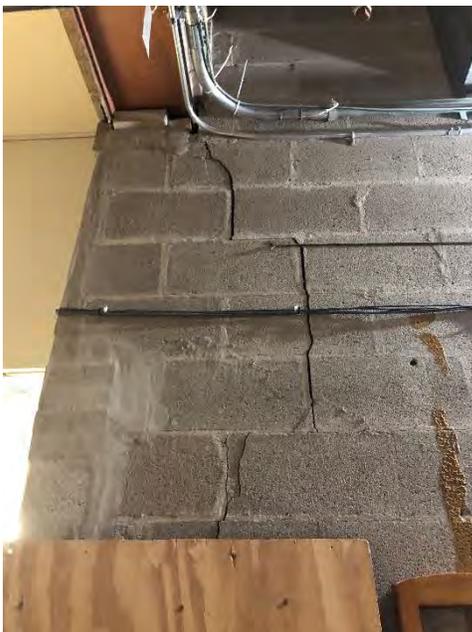
Fig. 4 - View of crack of CMU wall below beam and adjacent to door to flat roofs.

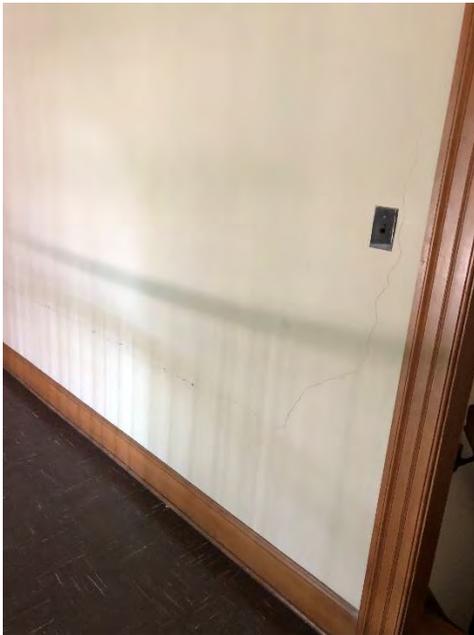
Fig. 5 - View of crack in wall at upper level of chapel.

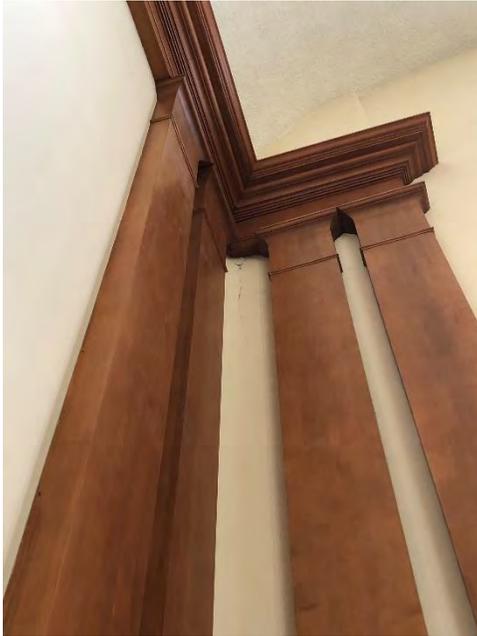
Fig. 7 - View of plaster corner crack below wood cornice.

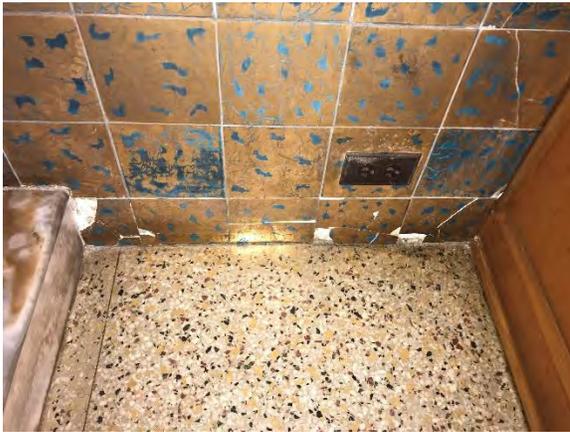
Fig. 1 – View of deteriorated ceramic tile west of Alter.

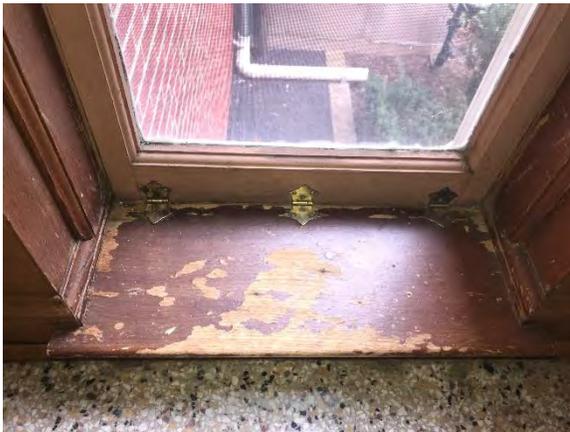
Fig. 2 – View of deteriorated finish on wood sill.

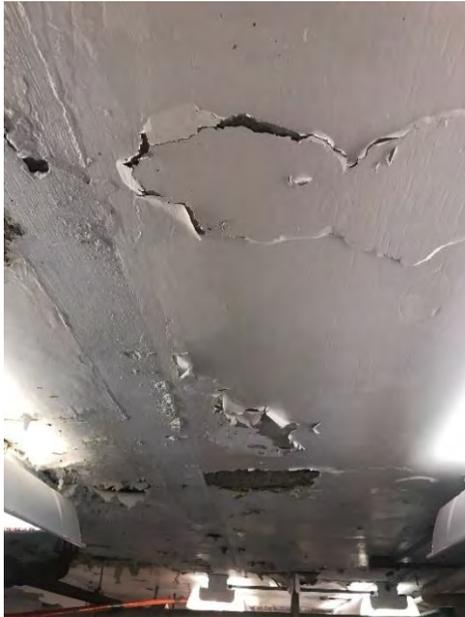
Fig. 1 - View of deteriorated concrete ceiling in gymnasium storage ceiling.

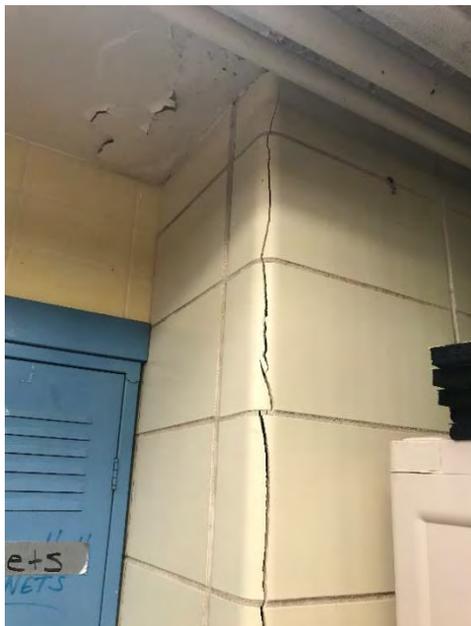
Fig. 2 - View of cracked tile column enclosure with concrete spall above.

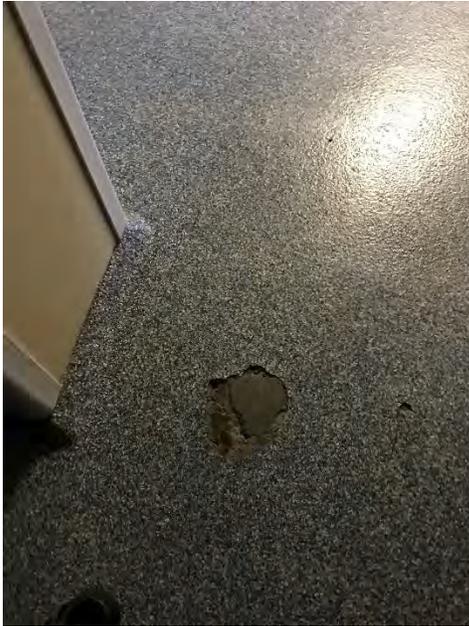
Fig. 1 - View of deteriorated lunchroom floor.

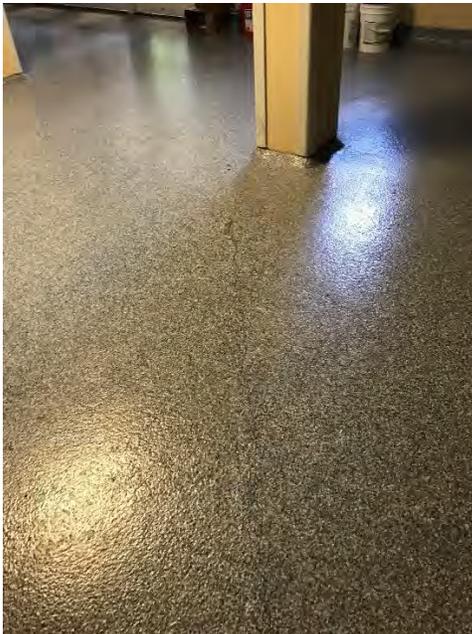
Fig. 2 - View of crack at lunchroom floor

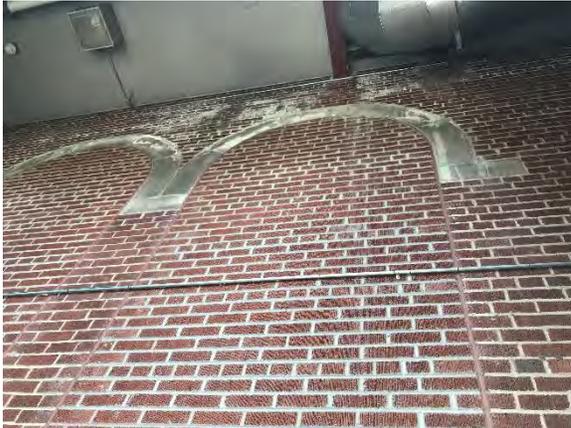
Fig. 3 - View of efflorescence at north wall of passageway 101 located at the south side of the lunchroom exit stair.

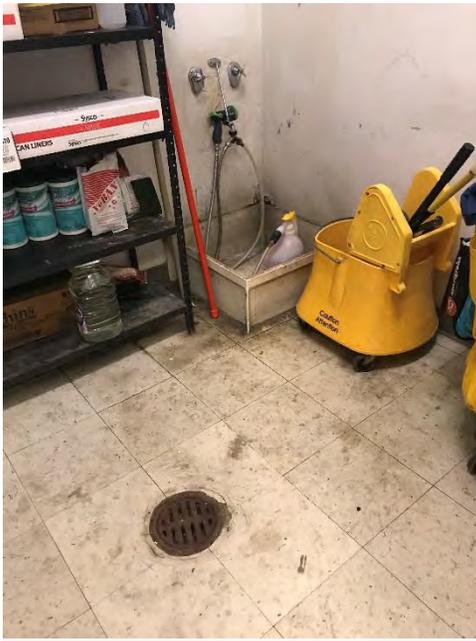
Fig. 1 – View of 2nd floor custodial closet and damaged gypsum board and worn tile.

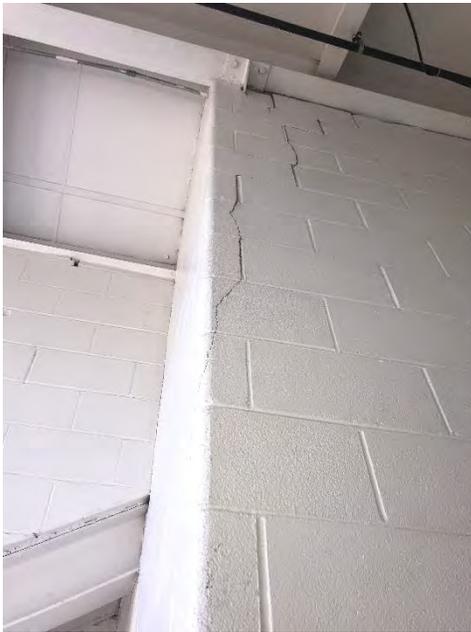
Fig. 3 – View of west stairwell cracked CMU.

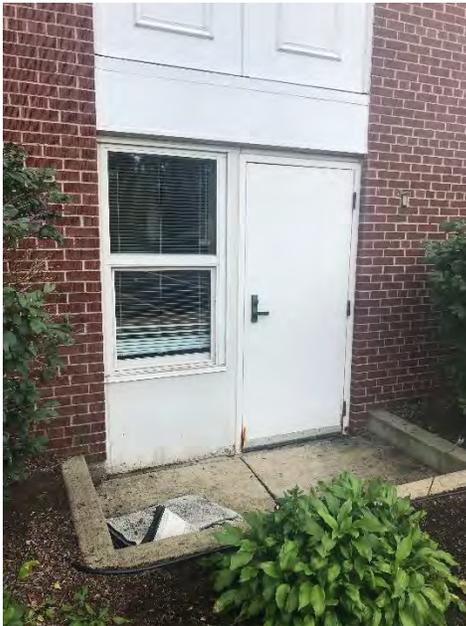
Fig. 4 – View of north door and frame corrosion.

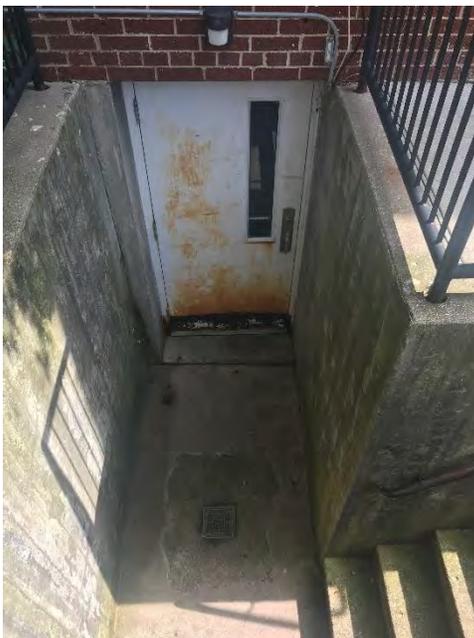
Fig. 2 – View of deteriorated door/frame/threshold at basement.

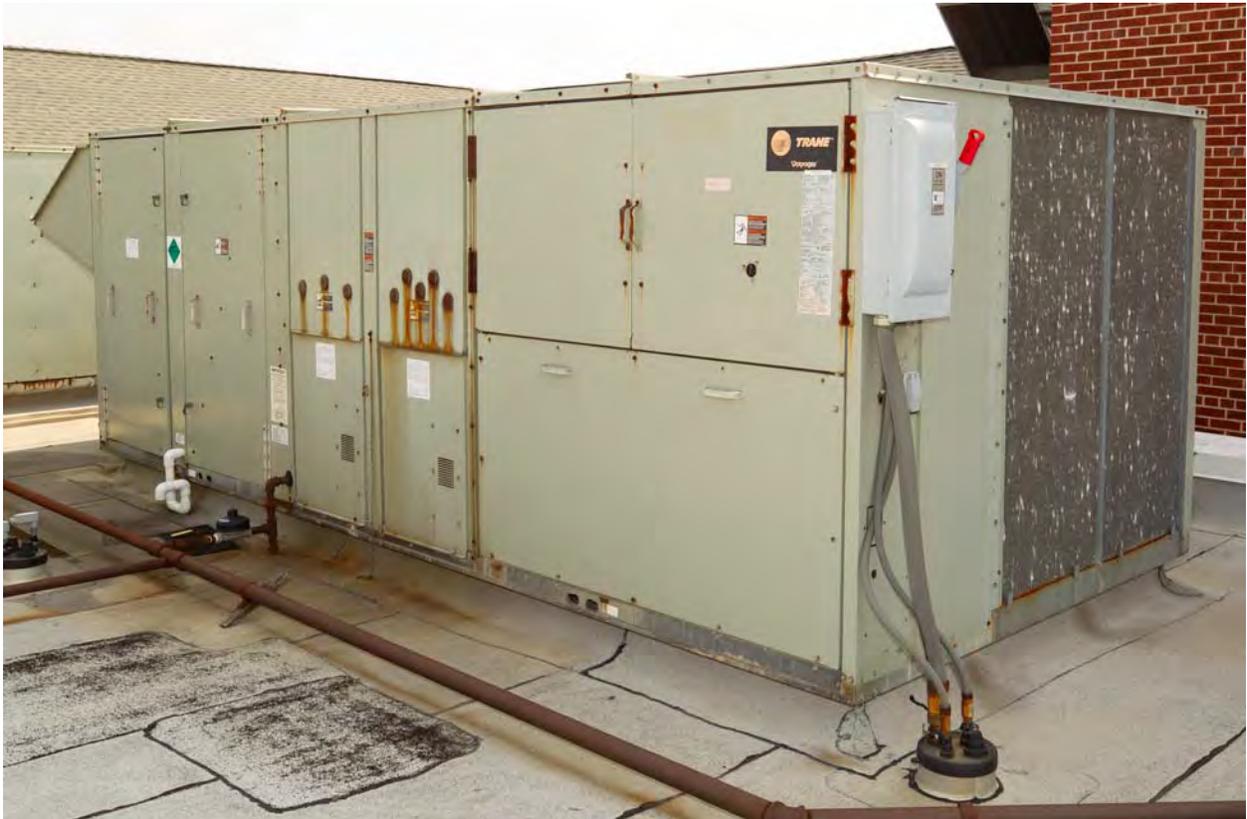
SAINT PETRONILLE PARISH - PHOTO #2-05

ROOF-TOP HVAC UNIT "RT-4" DAMAGED CONDENSER COIL

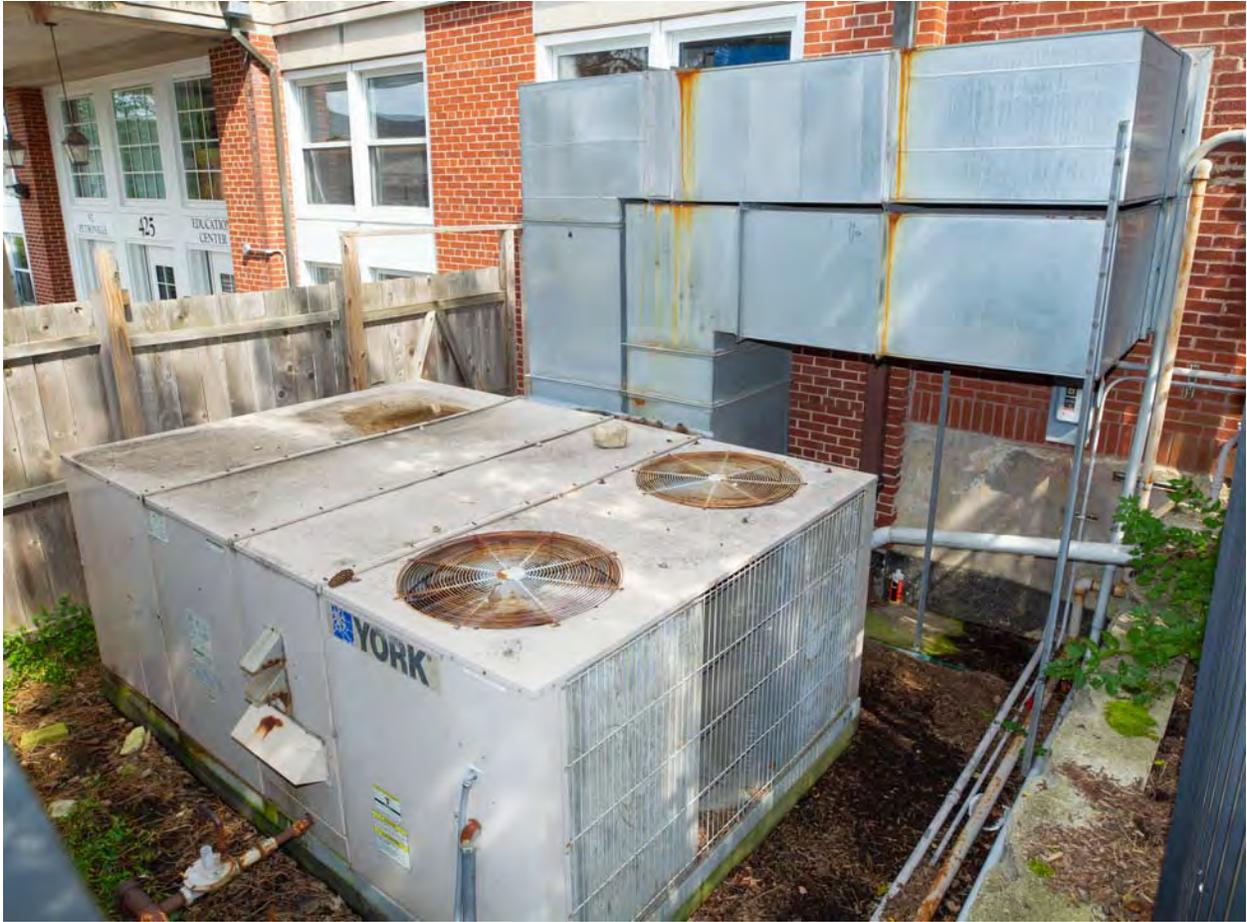
SAINT PETRONILLE PARISH - PHOTO #2-08

ROOF-TOP HVAC UNIT "RT-6" DAMAGED CONDENSER COIL

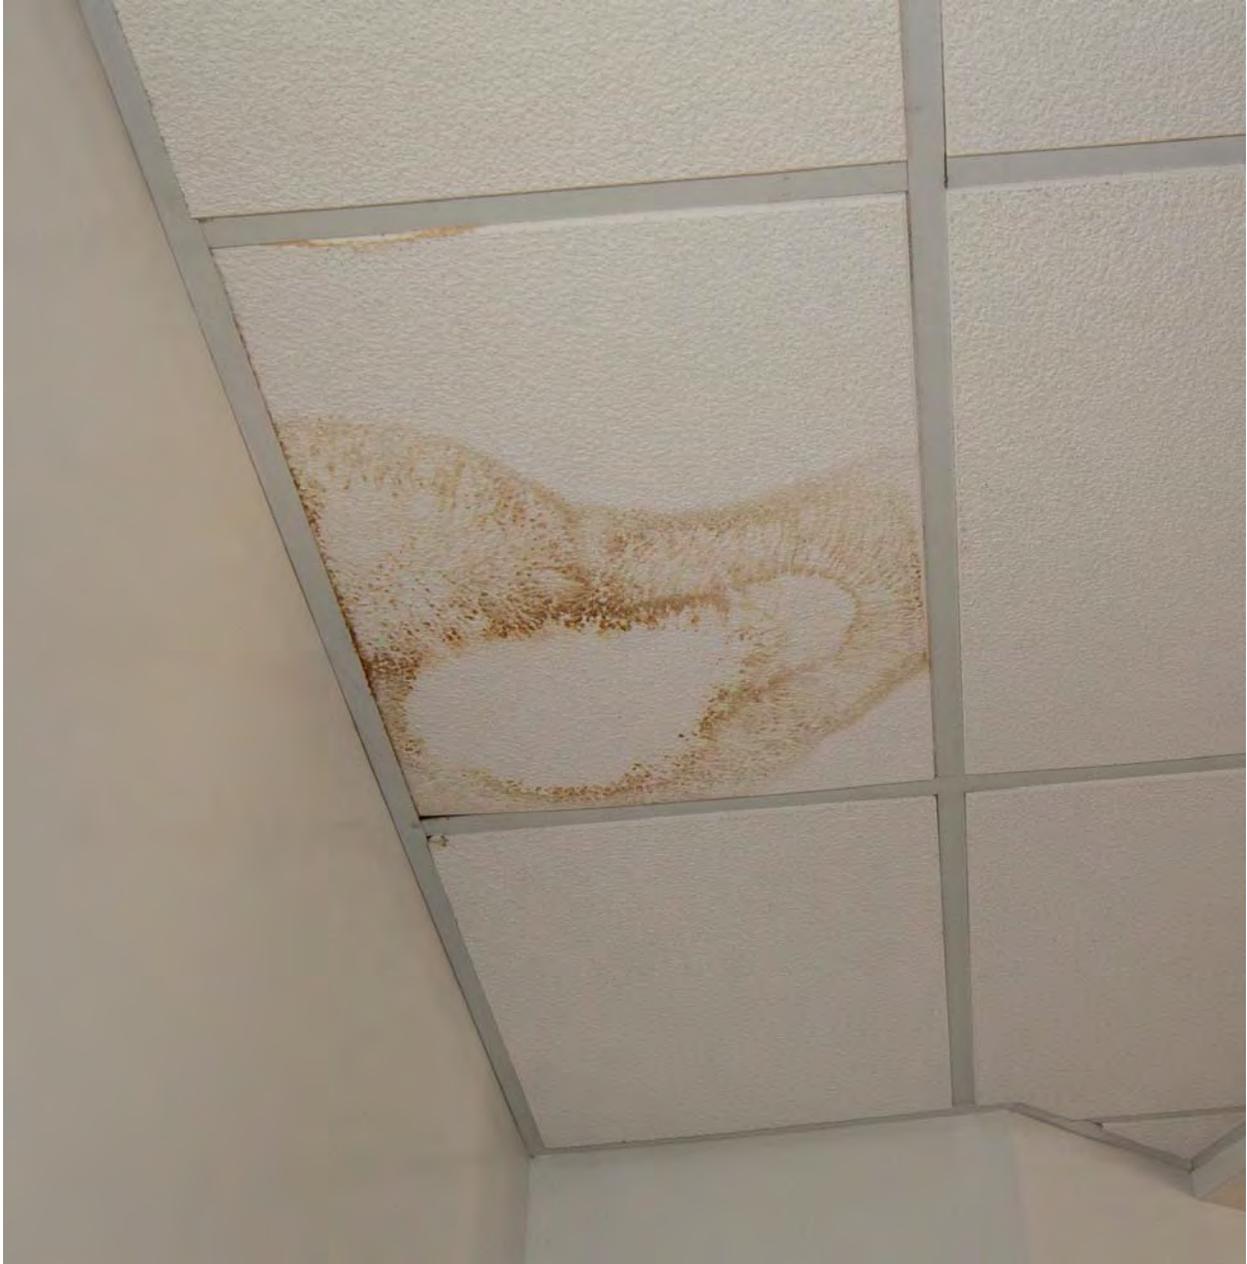
SAINT PETRONILLE PARISH - PHOTO #13-03

LEAKAGE AT WATER SERVICE PENETRATIONS

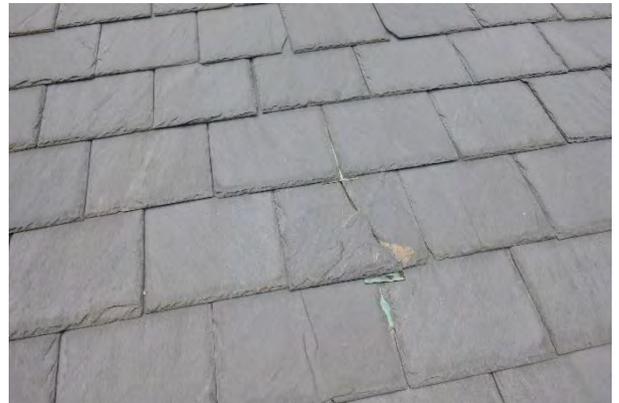
Roof – Cracked Slate Tiles

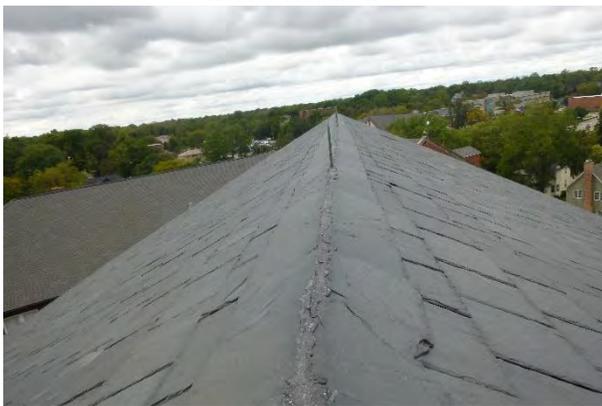
Roof – Ridge Damage

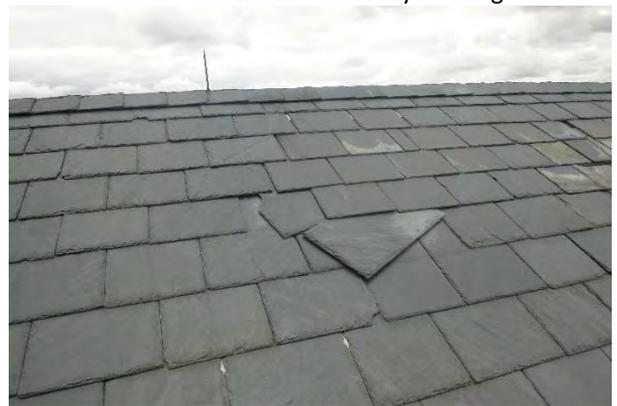
Roof – Displaced Slate Tile
