RESERVE STUDY
for
SAINT PETRONILLE PARISH
at
420 GLENWOOD LANE
GLENN ELLYN, ILLINOIS 60137

KGH NO. 19-11-454

November 11, 2019

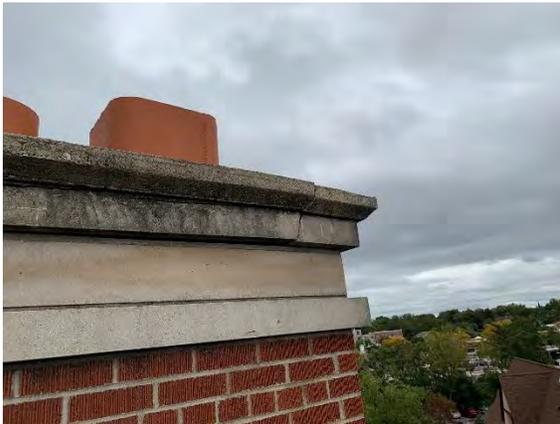
Fig. 3 - View of Parish Life Center chimney cap.

| 4) Parish Life Center - Evaluate crack at chimney cap and repair or replace cap. Recommendation year 2023 | \$5,500 |

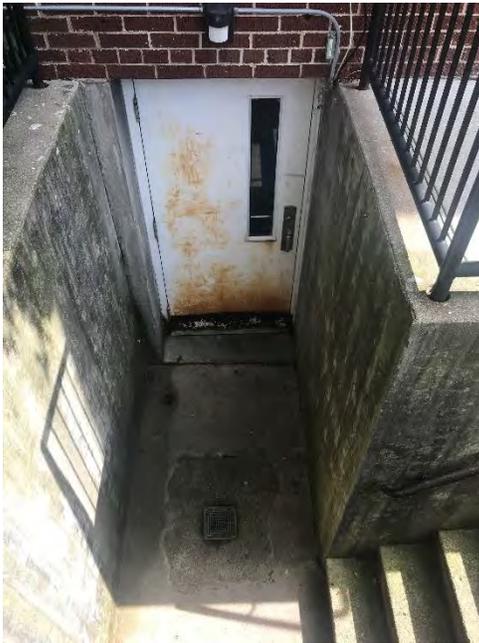
Fig. 4 - View of door and concrete stairwell at kindergarten.

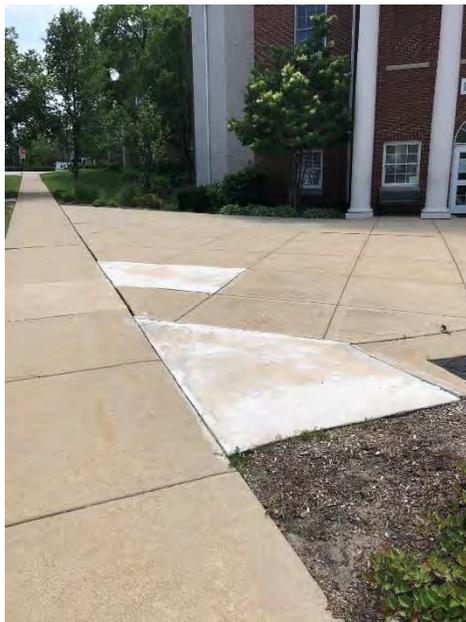
Fig. 5 – View of discolored concrete at Parish Life Center.

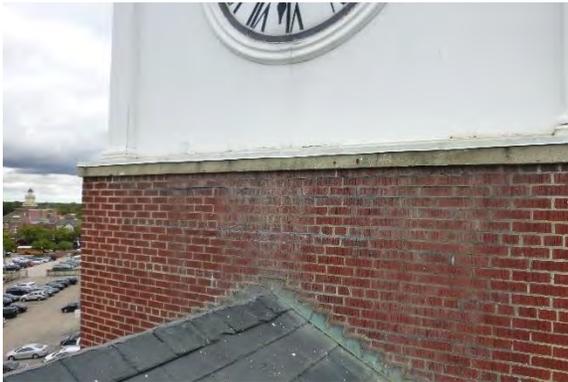
- 3) Church - At the south elevation of the church, the exterior stairwell to the basement is in poor condition.
- 4) Church Steeple - An exposed concrete slab separates the masonry base of the spire from the wood cladding at the clock level. The concrete slab was unpainted and was capped with sheet metal along the topside surface. The concrete appeared to be in fair condition.

Fig. 11 - View of exposed concrete floor slab between wood and brick at church steeple.

| 2) Church Steeple – Exterior slab edge requires routing and sealing of concrete slab cracks and painting/waterproofing of concrete. Recommendation year 2025 a) (Coordinate with masonry repairs at Steeple). | \$15,000 |

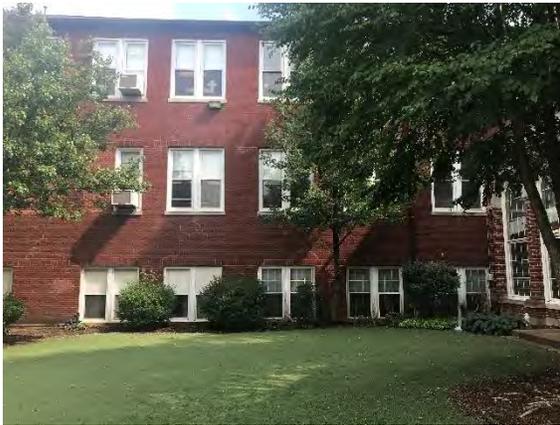
Fig. 3 – View of school west elevation with previous step cracks from corroding steel lintels.

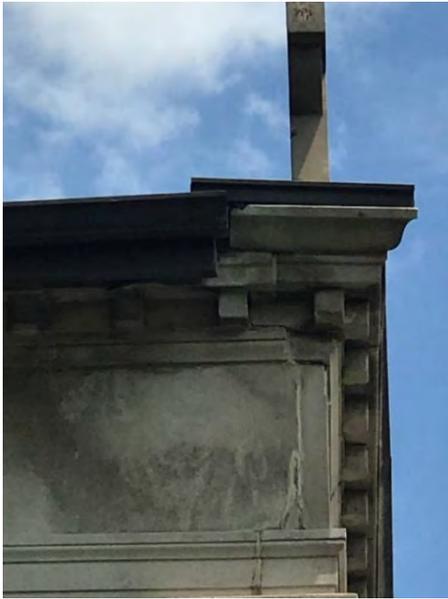
Fig. 7 – View of limestone corner at southwest corner of the school, south portico entry that requires rebuilding.

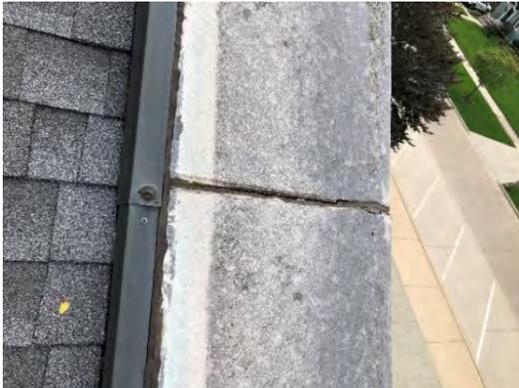
Fig. 8 – View of open limestone mortar joints at Copings.

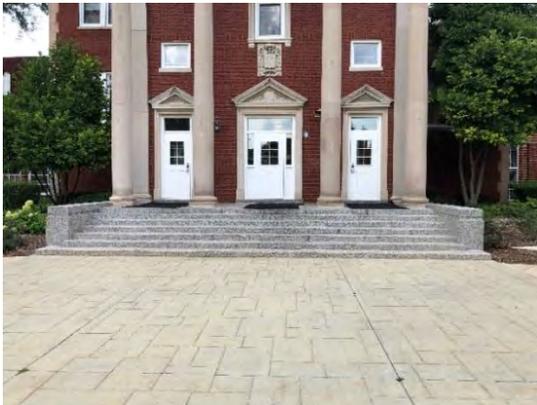
Fig. 9 – View of open granite step paver mortar joints.

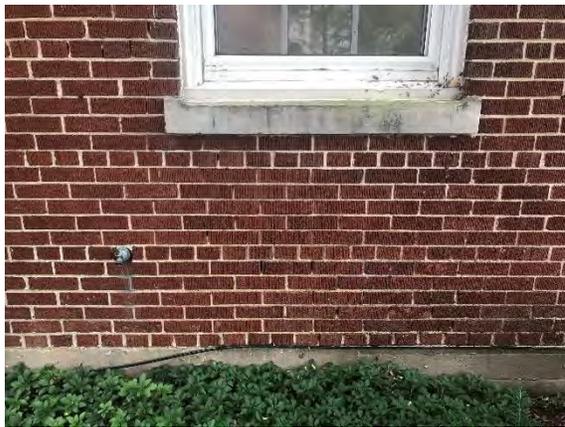
Fig. 10 – View of kindergarten north elevation with open mortar joints.

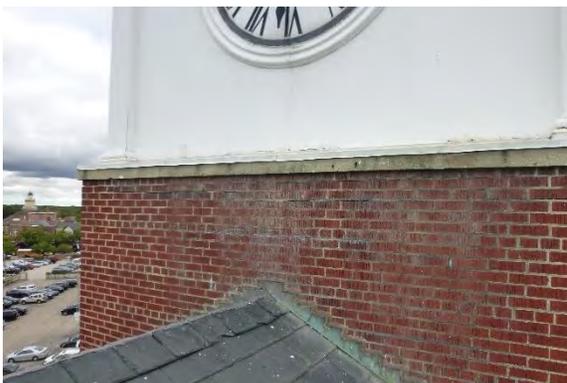
Fig. 15 – View of severe mortar joint deterioration at church steeple.

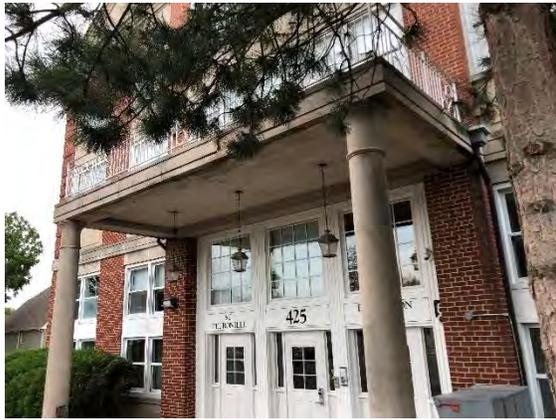
Fig. 15 – View of school west portico entrance and limestone columns and fascia. Fascia has limestone spalls and deteriorated mortar joints.

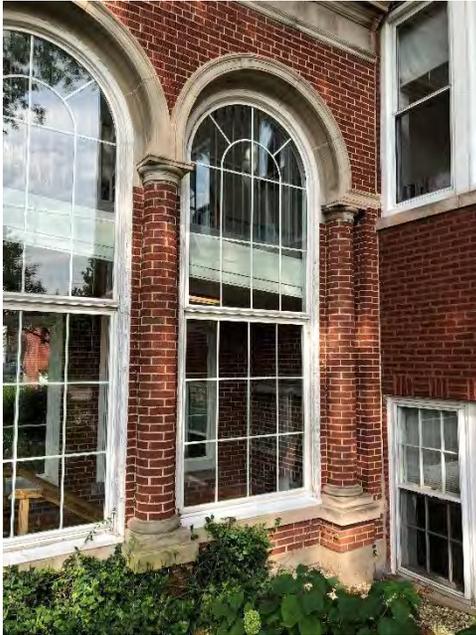
Fig. 6 – View of south elevation kindergarten walkway window frames with peeling paint.

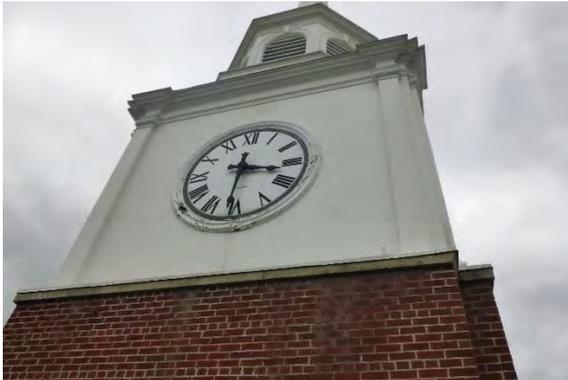
Fig. 1 – View of clock tower deterioration.

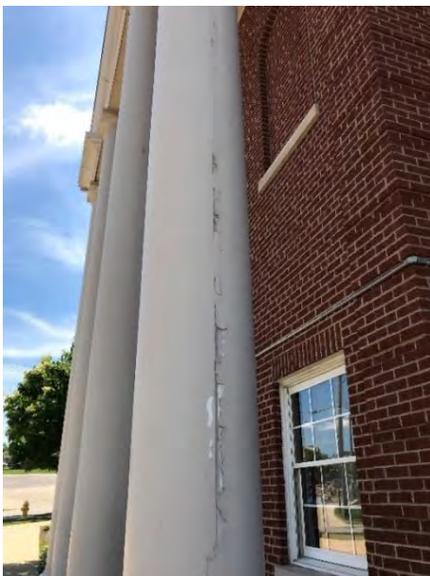
Fig. 3 – view of peeling paint at parish office columns.

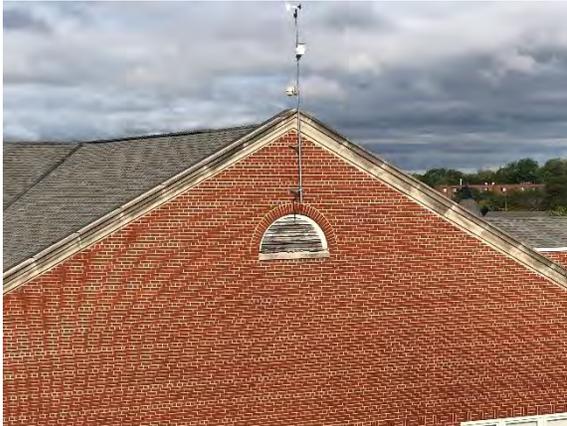
Fig. 3 – View of deteriorated wood louver at school.

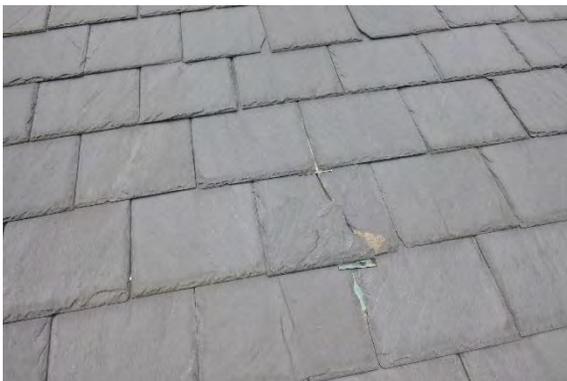
Fig. 1 – View of broken church slate roof tile.

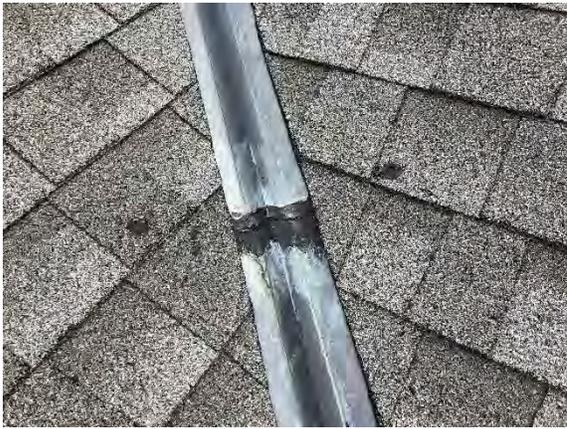
Fig. 3 – View of school metal valley joint failure.

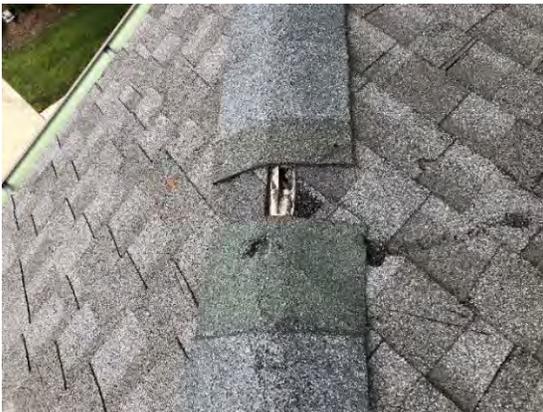
Fig. 7 – View of school missing roof shingle.

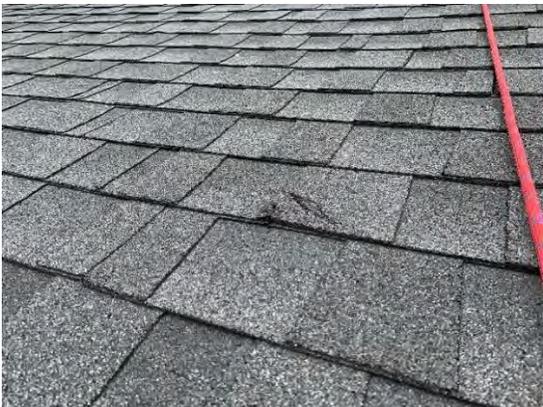
Fig. 8 – View of school nail pop and shingle damage.

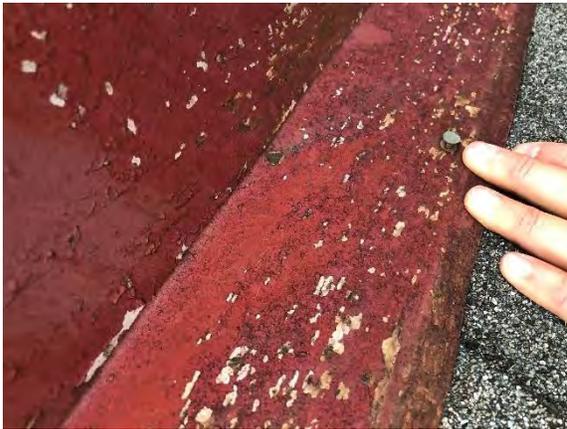
Fig. 16 – View of kindergarten walkway mansard roof peeling paint and nail pop.

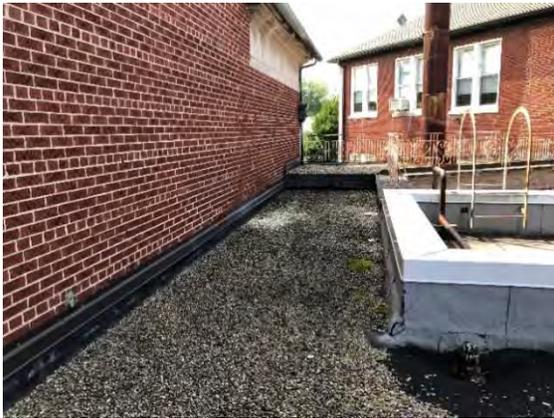
Fig. 3 – View of corroding railings, chimney stack and ladder.

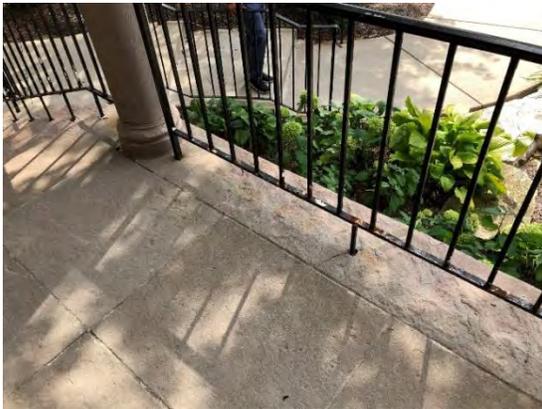
Fig. 4 – View of corroding railings at Mary Chapel.

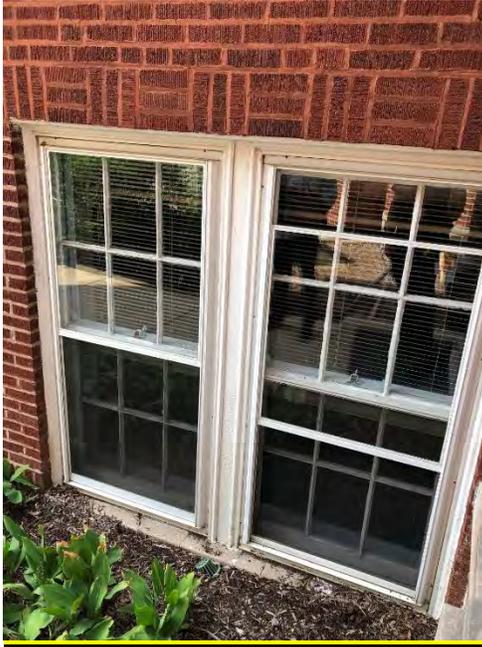
Fig. 1 – View of landscaping draining to window systems.

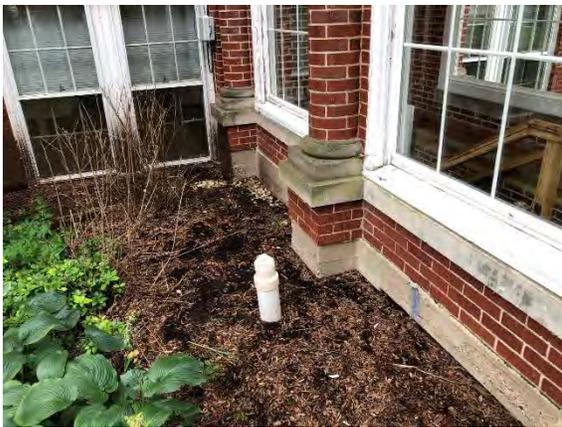
Fig. 2 – View of splash onto windows from drainage and gutter system above.

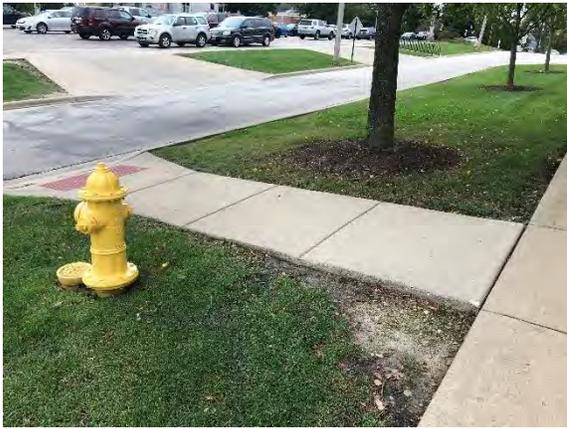
Fig. 6 – View of landscaping soils missing adjacent to sidewalks.

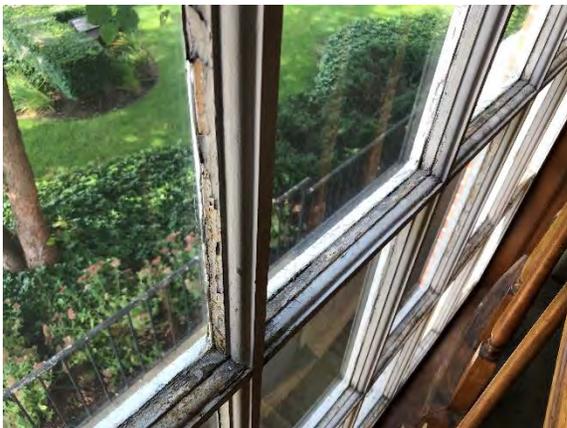
Fig. 6 - View of deteriorated interior window paint.

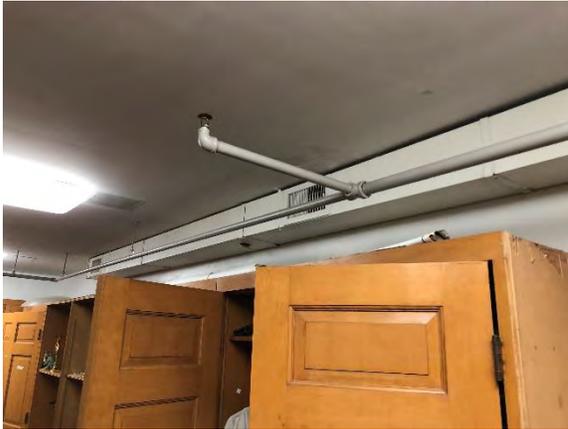
Fig. 9 - View of peeling ceiling paint.

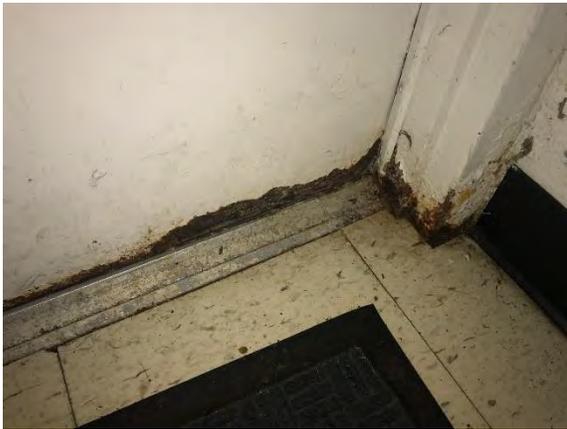
Fig. 1 – View of deteriorated door/frame/threshold at basement.

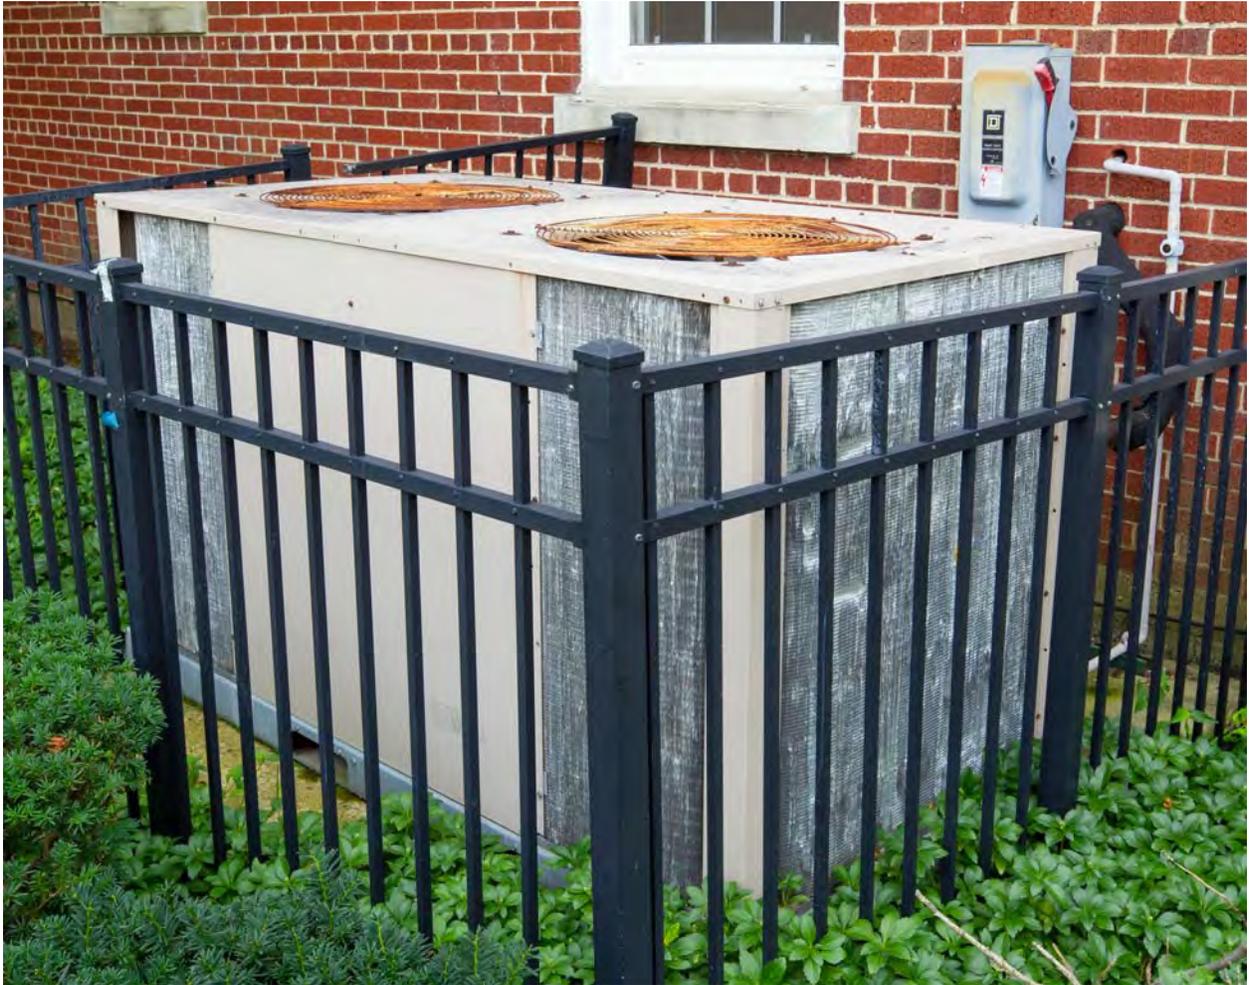
SAINT PETRONILLE PARISH - PHOTO #1-11

1.06.3 - It is believed to be teamed with Air-Cooled Condensing Unit "CU" York Model No. H3CE180A46A, Serial No. NEGM051957, 12 tons cooling (Refrigerant R22) located at Grade along side of the School (see Photo #1-11).

AIR-COOLED CONDENSING UNIT "CU"

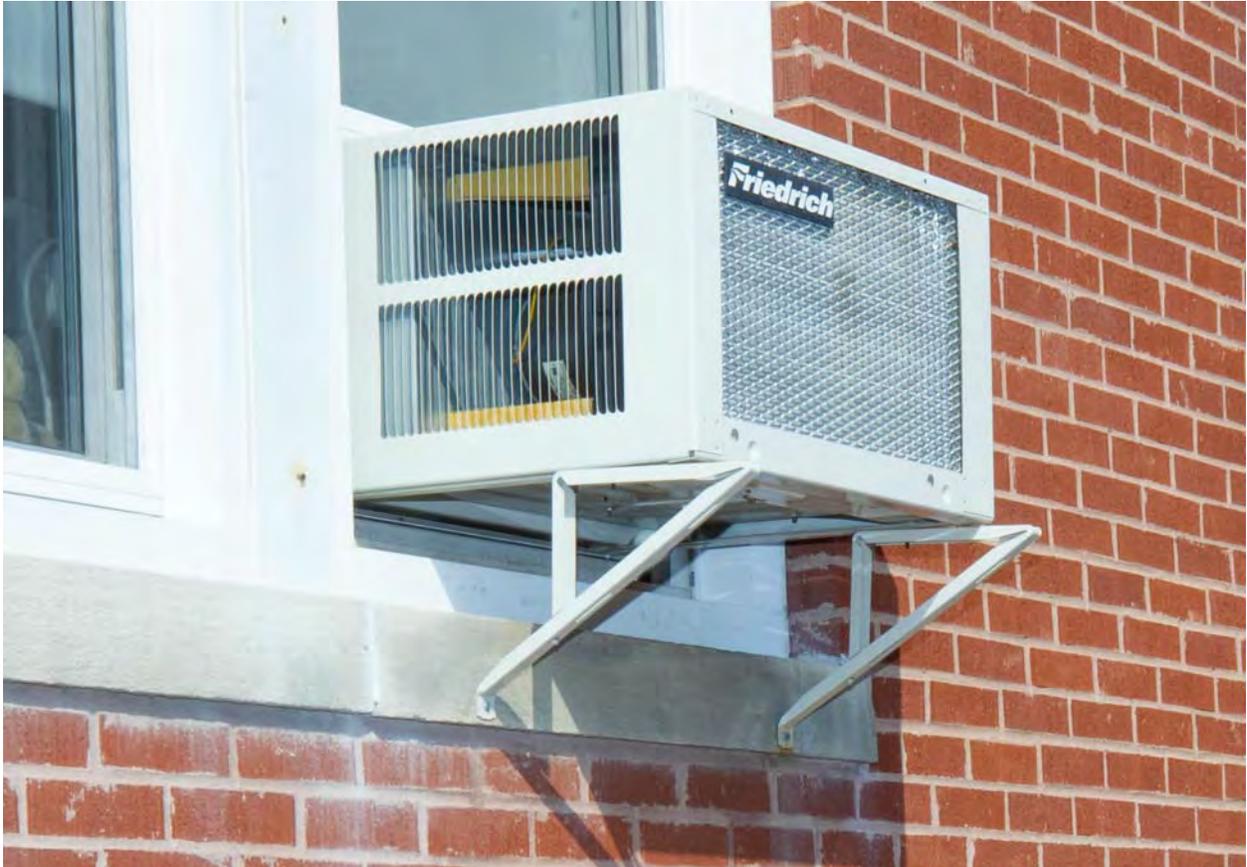
SAINT PETRONILLE PARISH - PHOTO #1-12

1.07 - There are numerous Window Air-Conditioning Units used throughout, especially in the School (see Photos #1-12 & #1-13).

WINDOW AIR-CONDITIONER

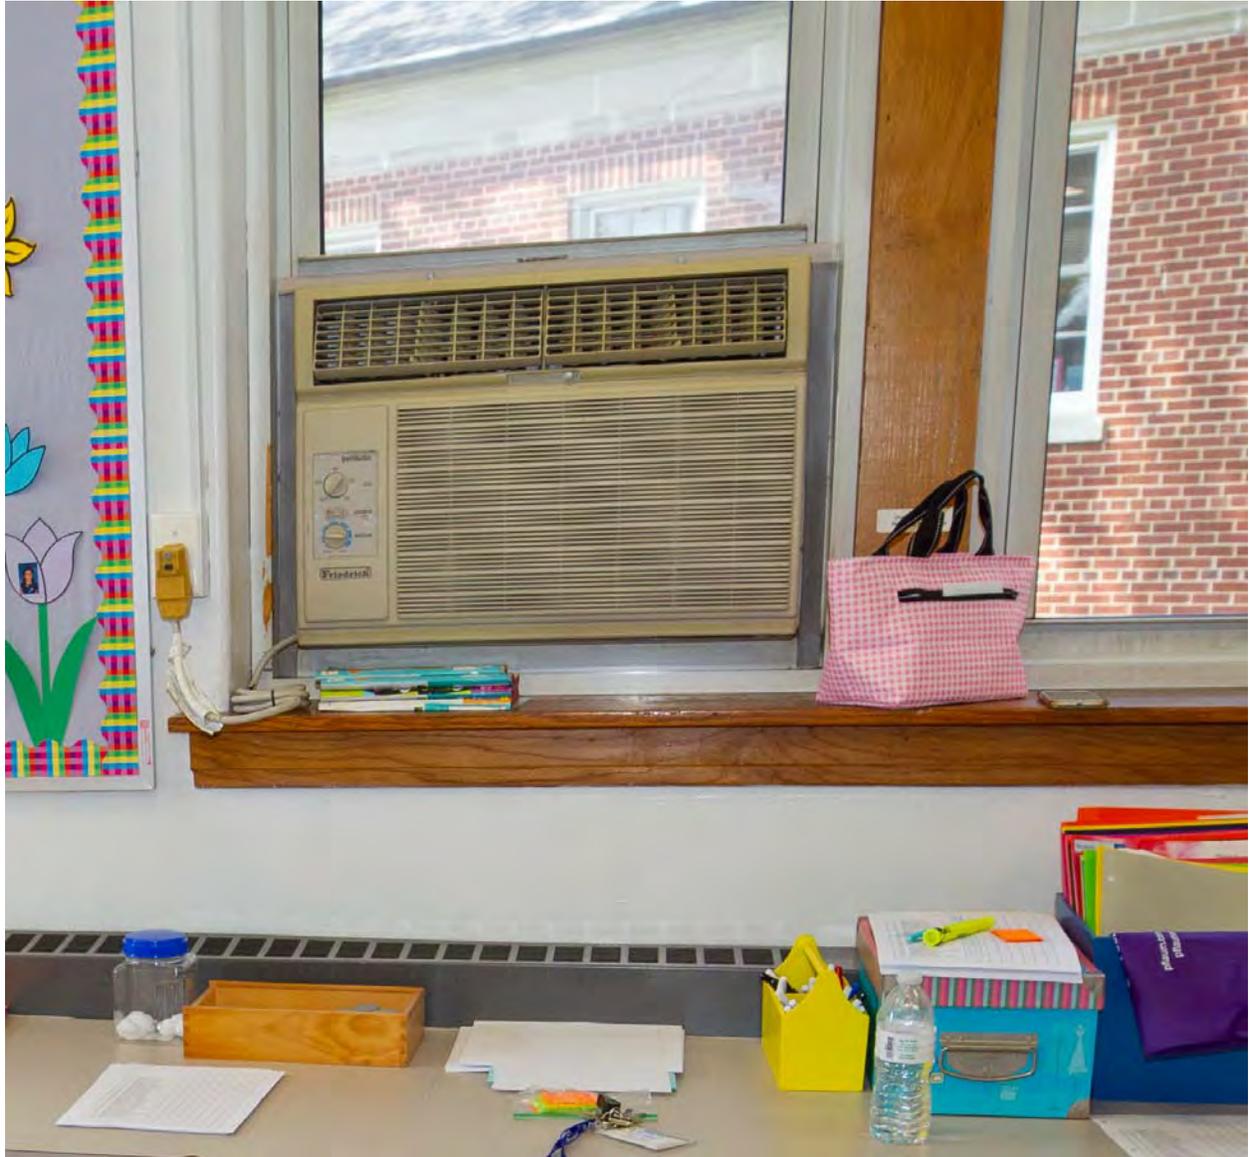
SAINT PETRONILLE PARISH - PHOTO #1-13

TYPICAL CLASSROOM WINDOW AIR-CONDITIONER

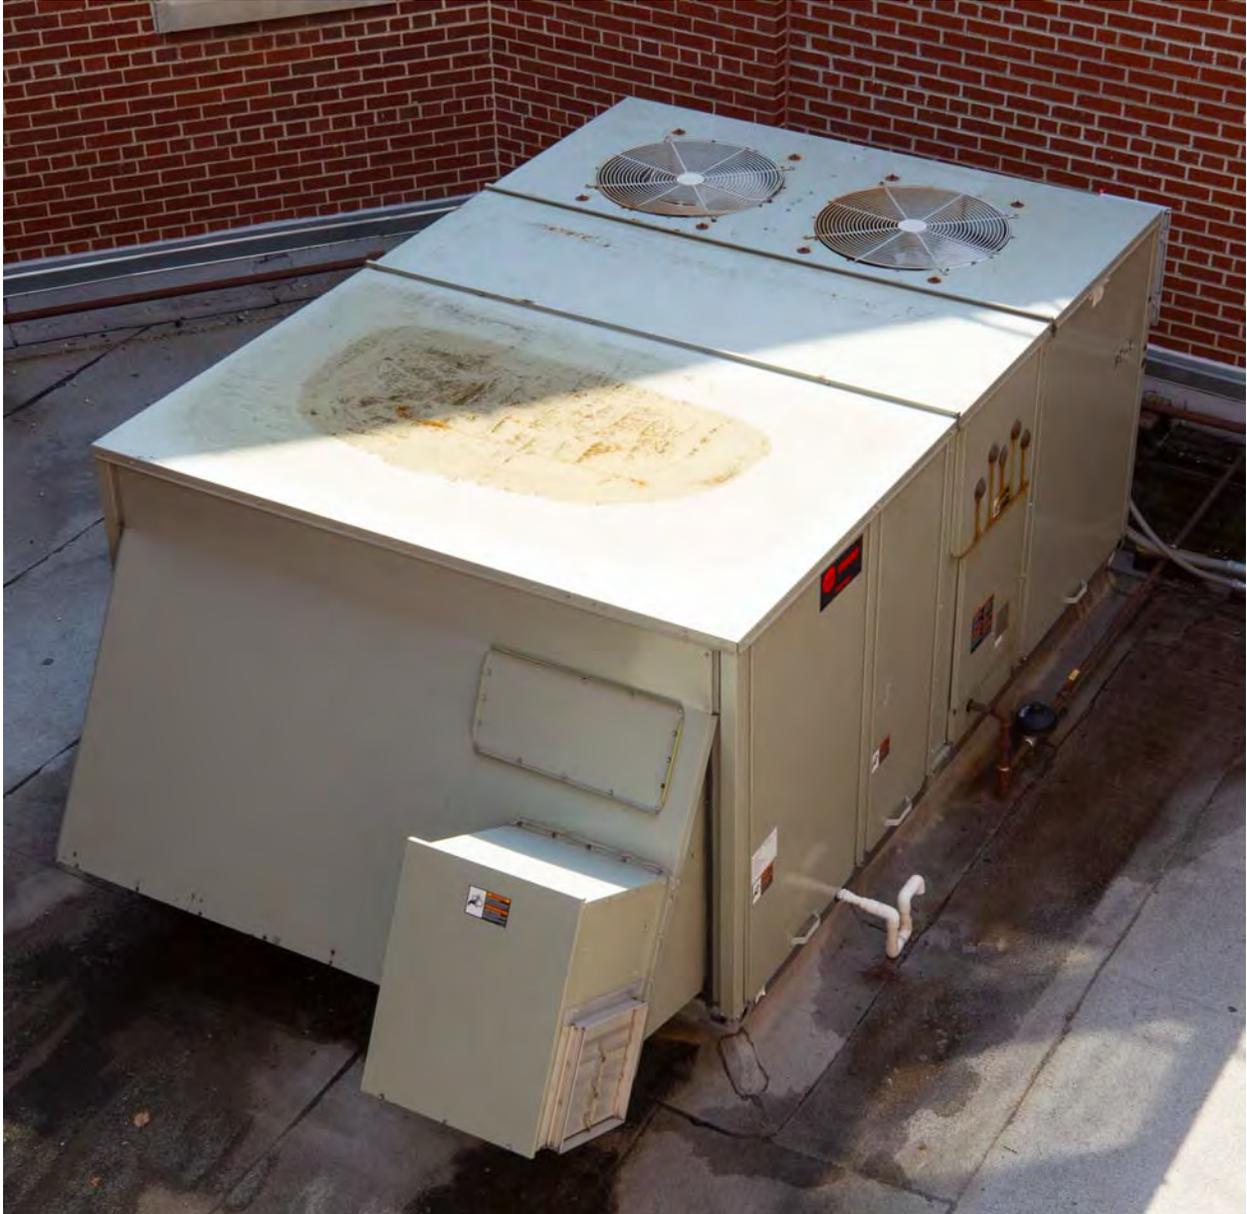
SAINT PETRONILLE PARISH - PHOTO #2-01

2.01.1 - This air-cooled electric cooling, natural gas-fired heating Roof-Top Unit is located outdoors on the roof above Gathering Room 100 (**see Photo #2-01**).

ROOF-TOP HVAC UNIT "RT-1"

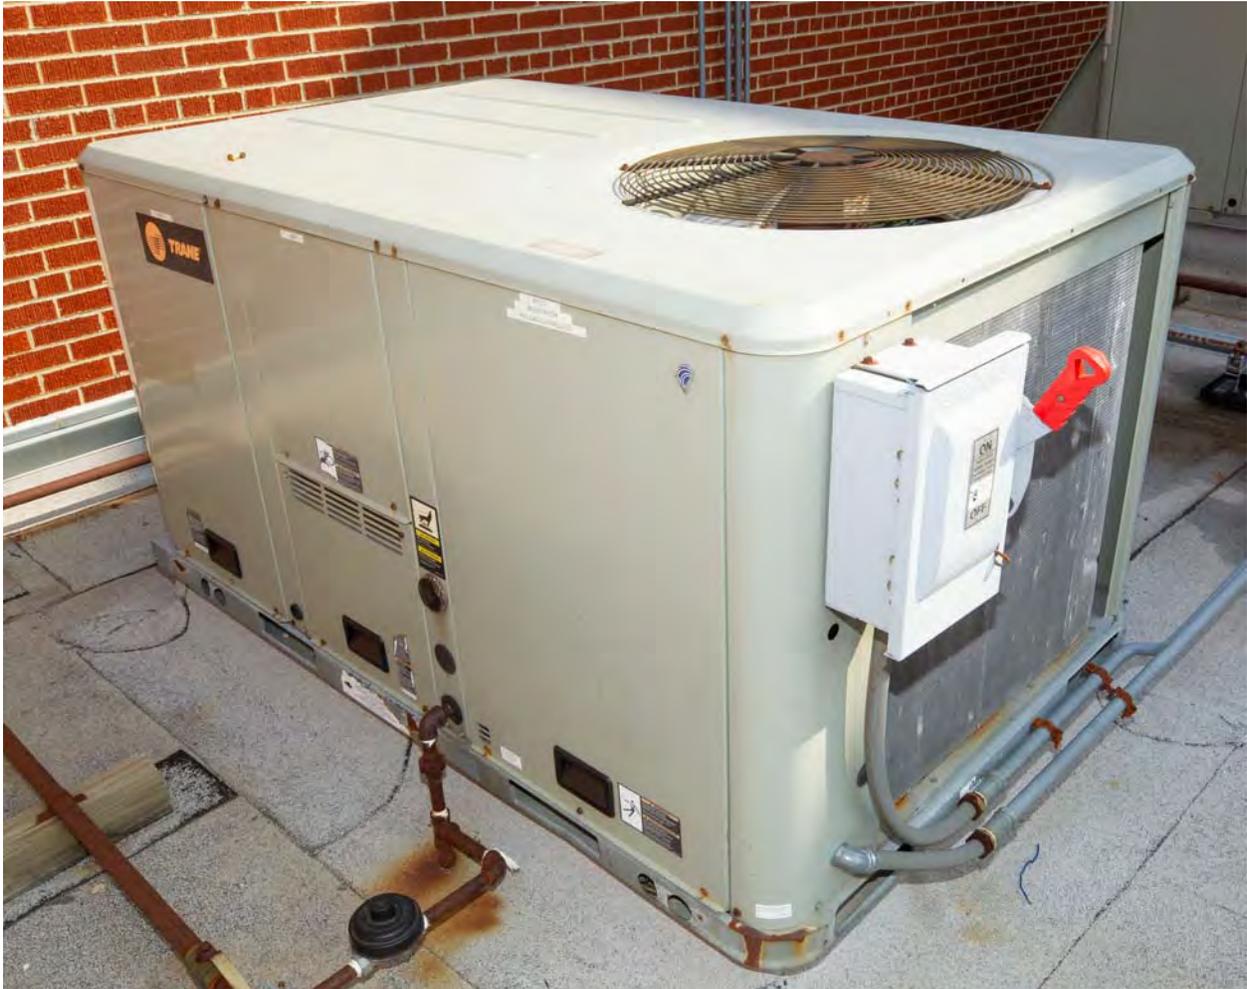
SAINT PETRONILLE PARISH - PHOTO #2-02

2.02.1 - This air-cooled electric cooling, natural gas-fired heating Roof-Top Unit is located outdoors on the roof above Music Room 219 (**see Photo #2-02**).

ROOF-TOP HVAC UNIT "RT-2"

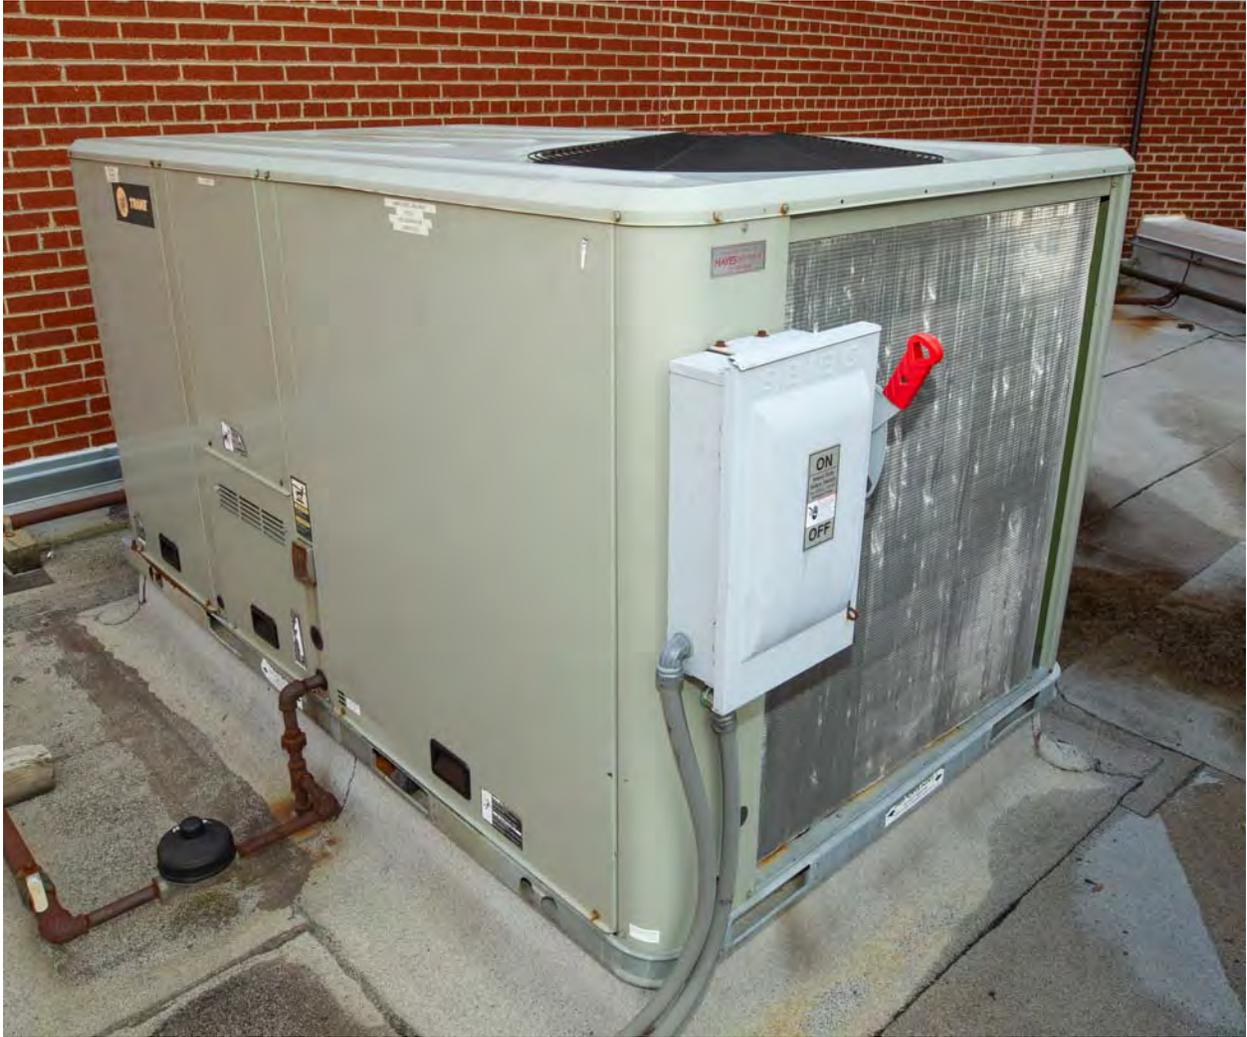
SAINT PETRONILLE PARISH - PHOTO #2-03

2.03.1 - This air-cooled electric cooling, natural gas-fired heating Roof-Top Unit is located outdoors on the roof above Music Rooms 219 (**see Photo #2-03**).

ROOF-TOP HVAC UNIT "RT-3"

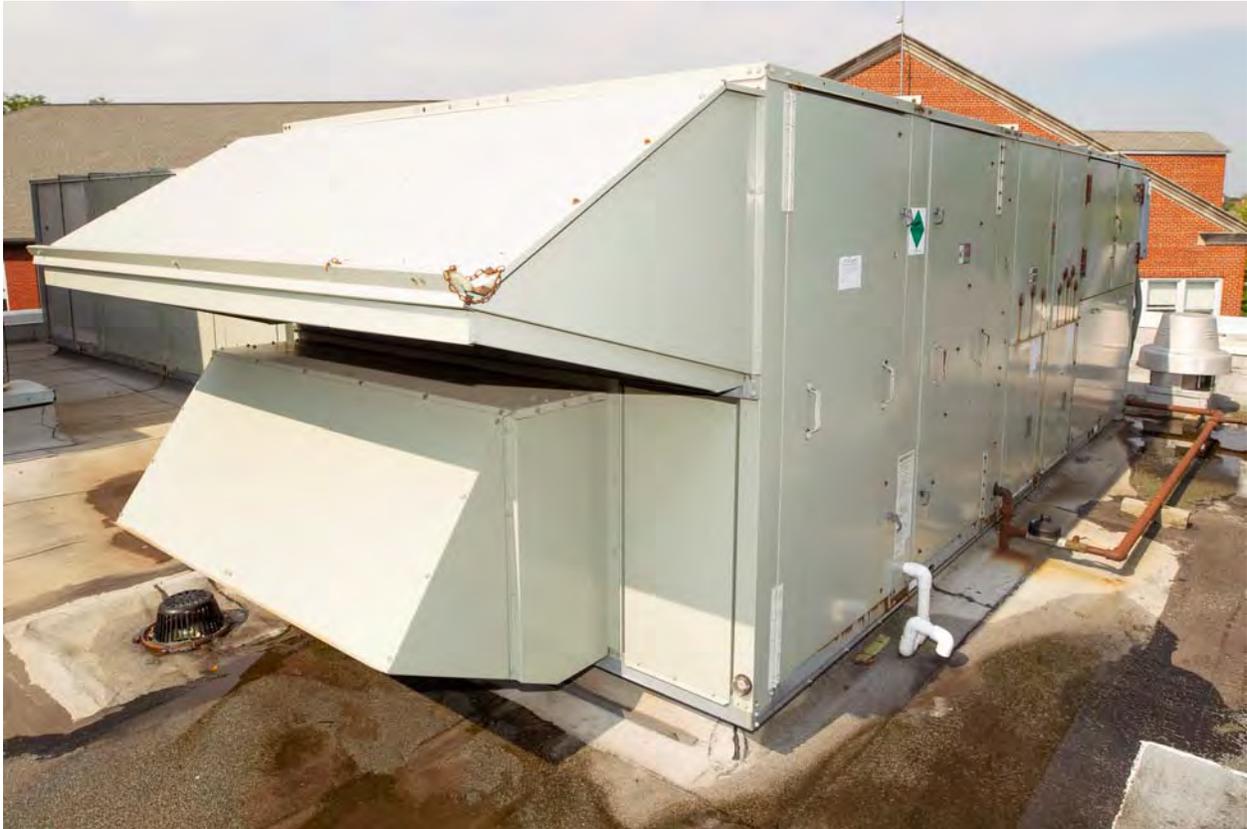
SAINT PETRONILLE PARISH - PHOTO #2-04

2.04.1 - This air-cooled electric cooling, natural gas-fired heating Roof-Top Unit is located outdoors on the roof above Storage 304 (see **Photo #2-04**).

ROOF-TOP HVAC UNIT "RT-4"

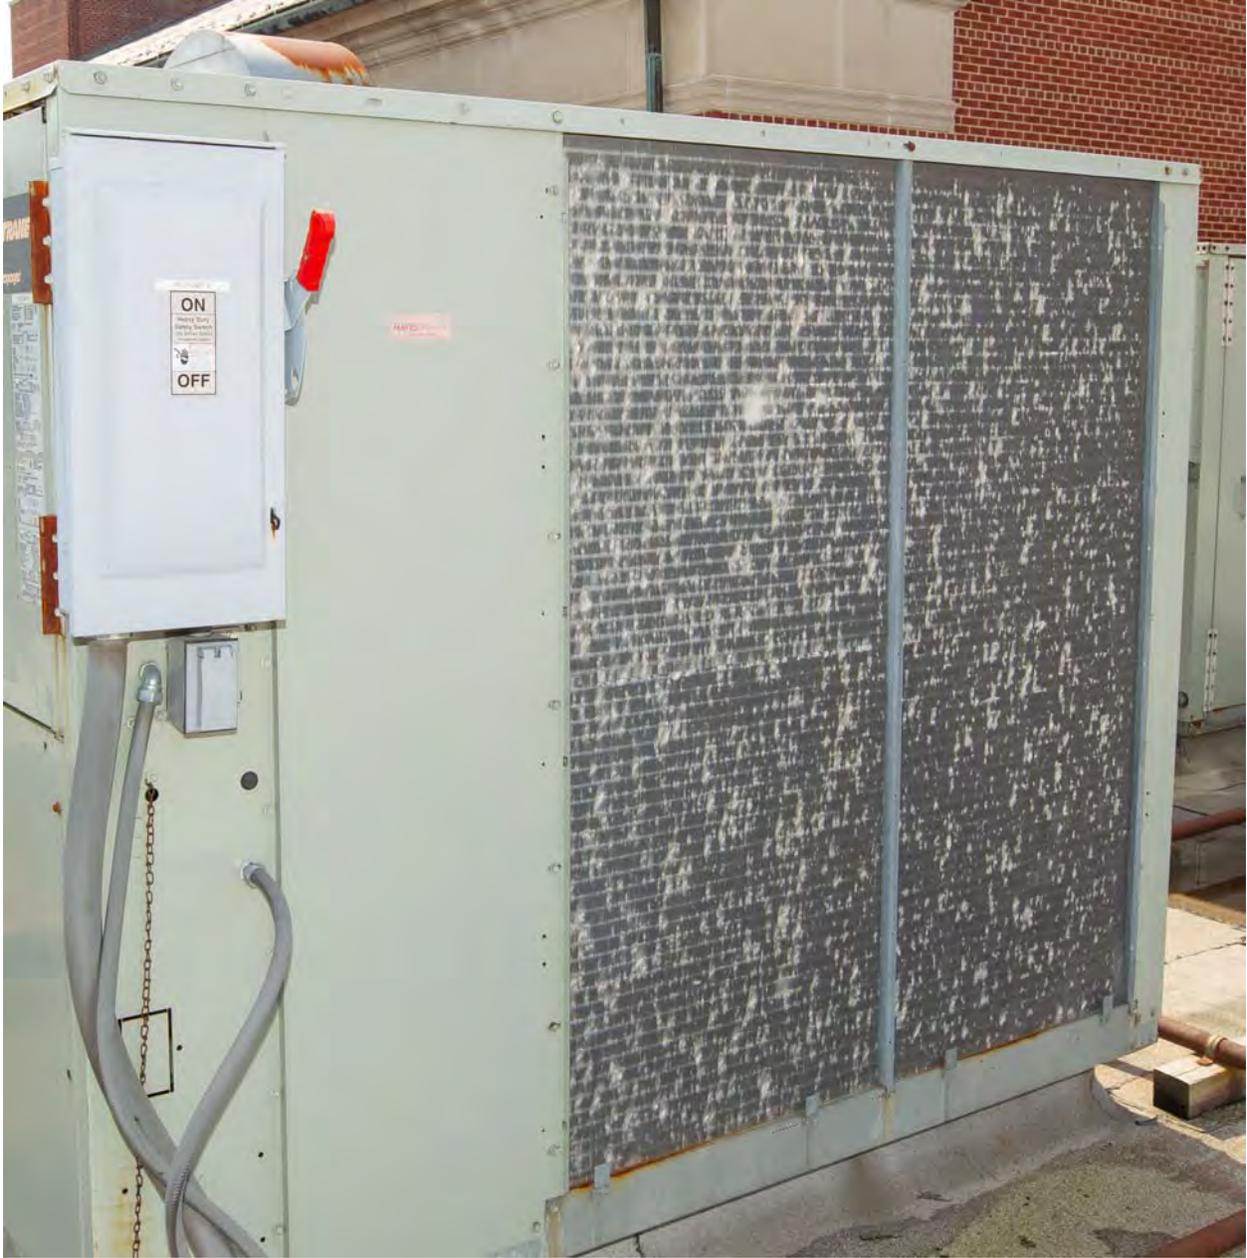
SAINT PETRONILLE PARISH - PHOTO #2-05

ROOF-TOP HVAC UNIT "RT-4" DAMAGED CONDENSER COIL

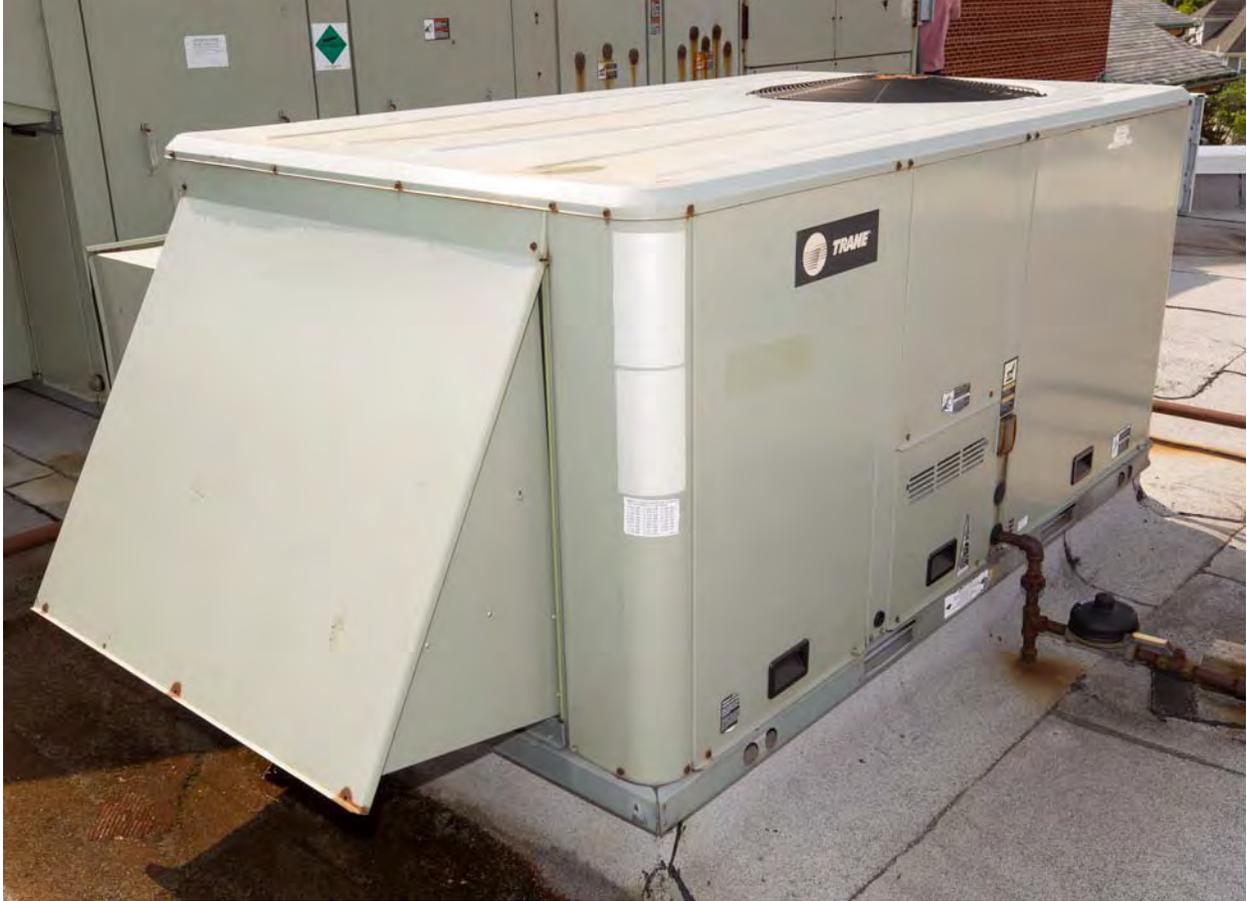
SAINT PETRONILLE PARISH - PHOTO #2-07

2.05.3 - Roof-Top Unit "RT-5", installed in 2002, based on the observed condition and the condition of the Condenser Coils that have been severely damaged by hail (see **Photo #2-07**) - in our judgement - has a projected remaining useful life of 7 years (based on an original life expectancy of [say] 25 years).

ROOF-TOP HVAC UNIT "RT-6"

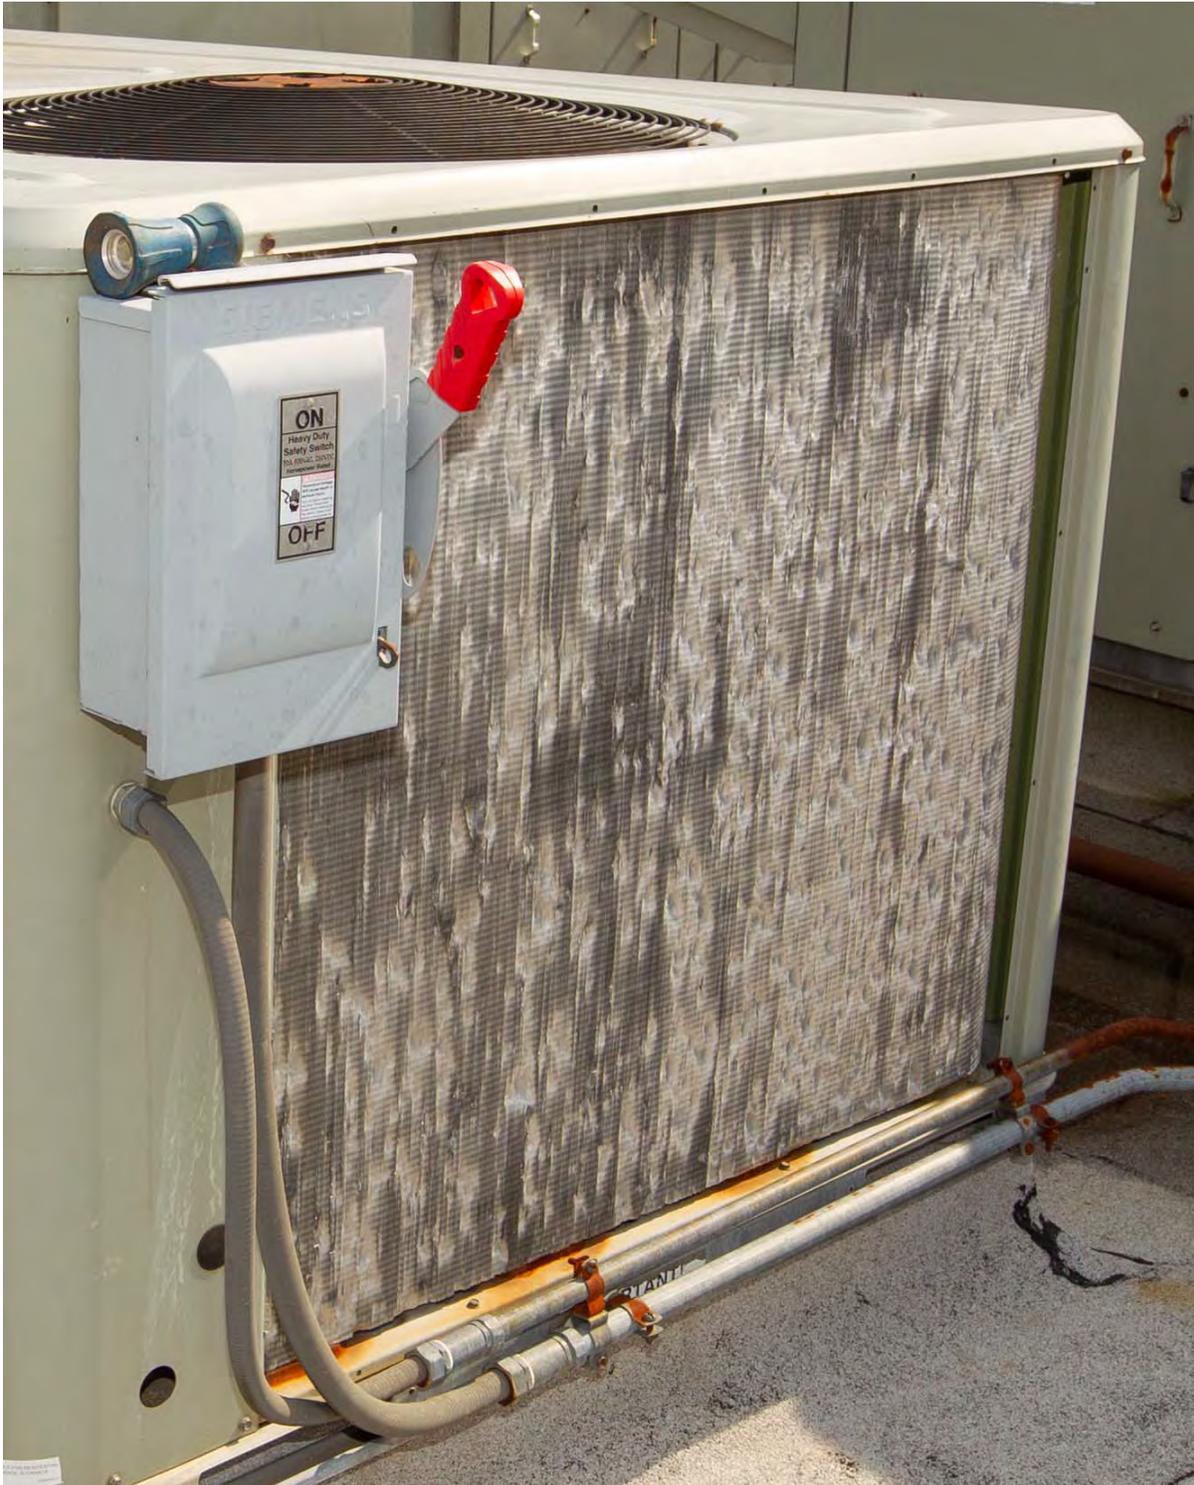
SAINT PETRONILLE PARISH - PHOTO #2-08

2.06.3 - Roof-Top Unit "RT-6", installed in 2002, based on the observed condition and the condition of the Condenser Coils that have been severely damaged by hail (see Photo #2-08)- in our judgement - has a projected remaining useful life of 7 years (based on an original life expectancy of [say] 25 years).

ROOF-TOP HVAC UNIT "RT-6" DAMAGED CONDENSER COIL

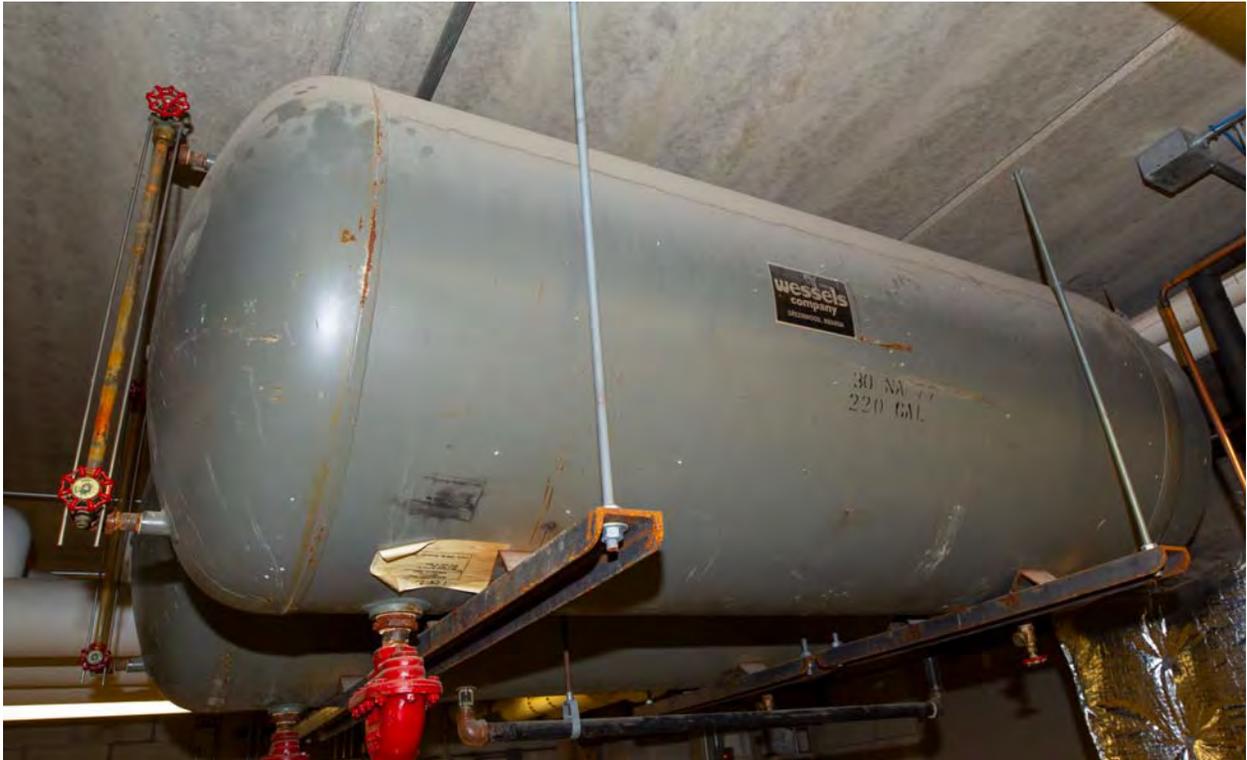
SAINT PETRONILLE PARISH - PHOTO #5-04

5.09 - Expansion Tanks tagged "SE-1" & "SE-2" (see **Photo #5-04**), each 220 gallons, have extended predictable remaining lives.

5.10 - Expansion Tanks (lets call it) "SE" (see **Photo #5-04**), 44 gallons, has an extended predictable remaining life.

EXPANSION TANKS
