RESERVE STUDY
for
SAINT PETRONILLE PARISH
at
420 GLENWOOD LANE
GLENN ELLYN, ILLINOIS 60137

KGH NO. 19-11-454

November 11, 2019

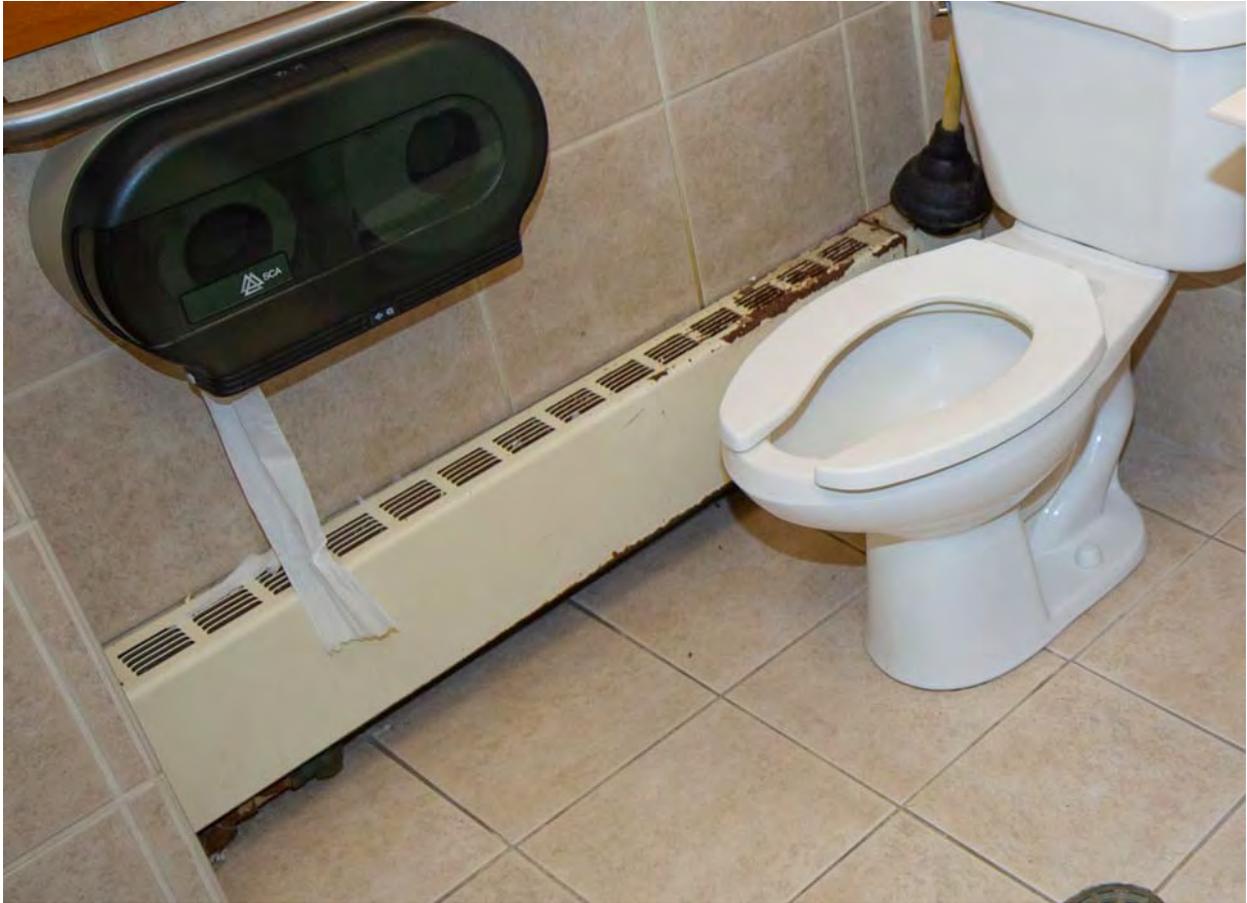
SAINT PETRONILLE PARISH - PHOTO #7-01

7.01.3 - A few example of damaged enclosures/covers are in the Church Toilet Rooms (see **Photos #7-01 & #7-02**).

BASEBOARD RADIATION

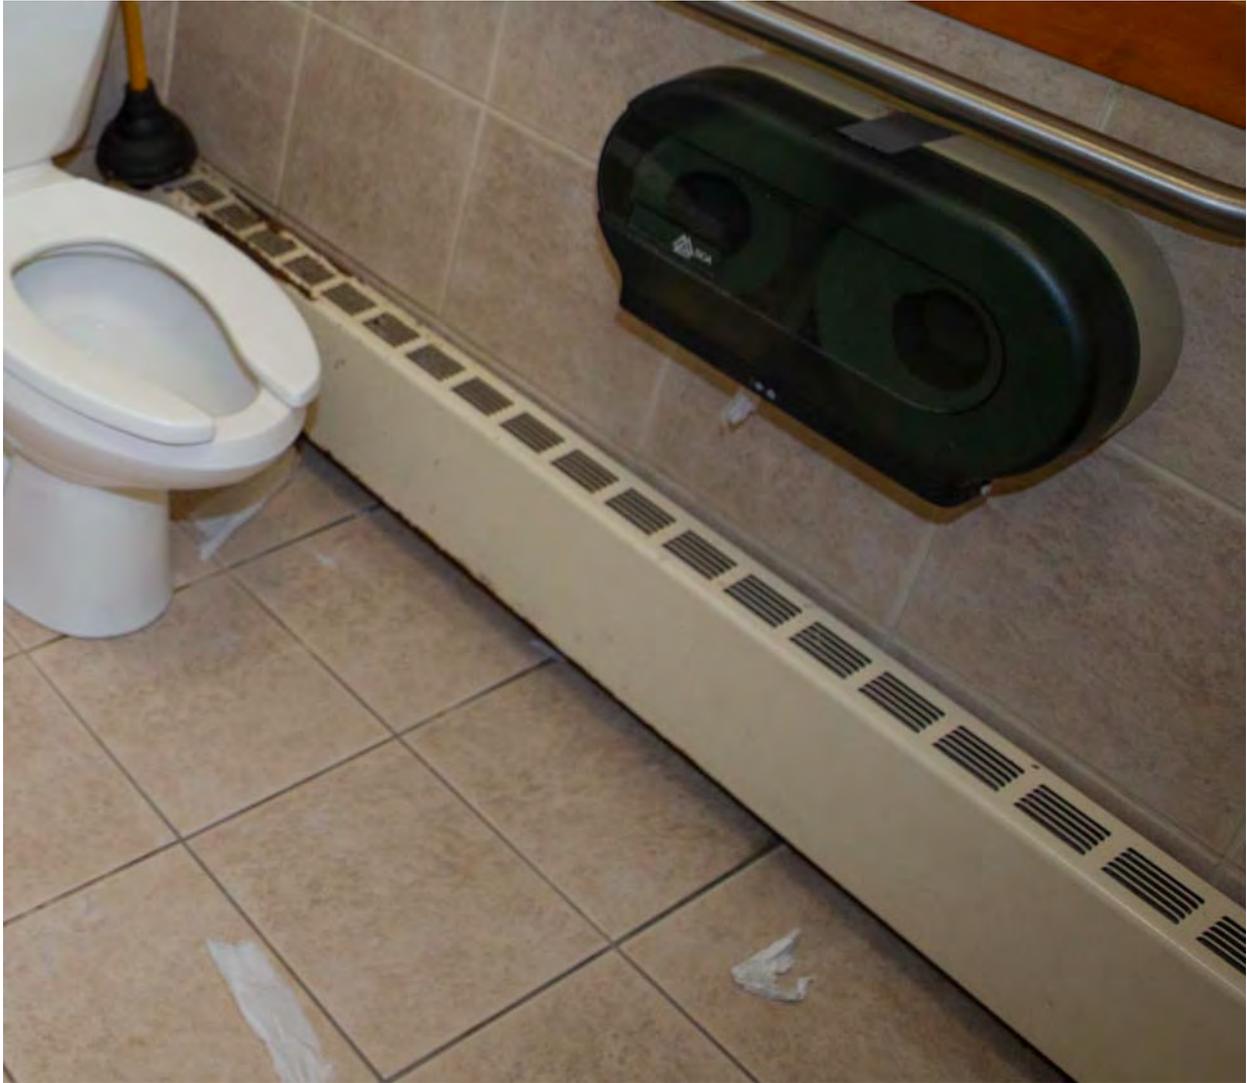
SAINT PETRONILLE PARISH - PHOTO #7-02

BASEBOARD RADIATION

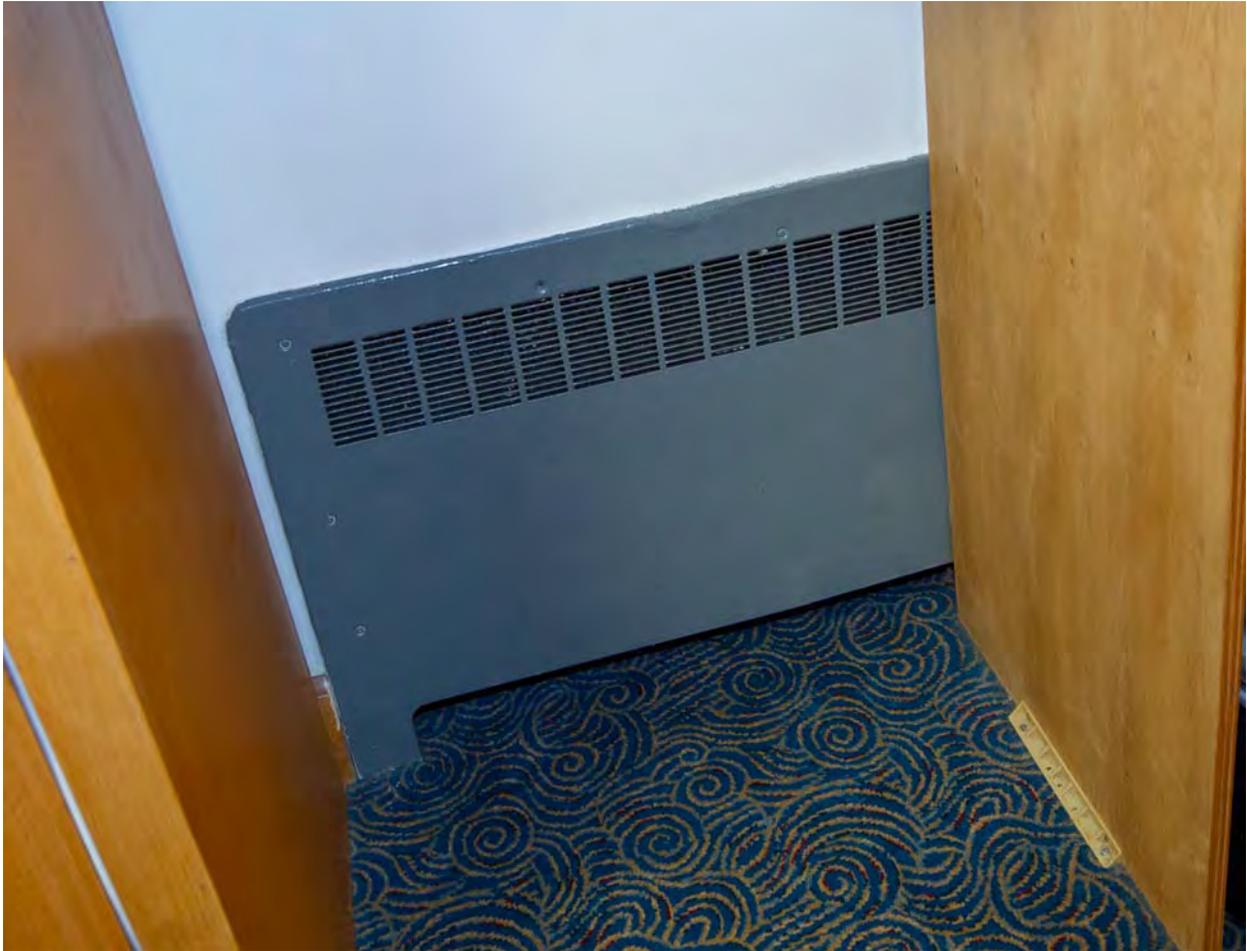
SAINT PETRONILLE PARISH - PHOTO #8-01

CABINET HEATER (BOTTOM OPEN ON CARPETED FLOOR)

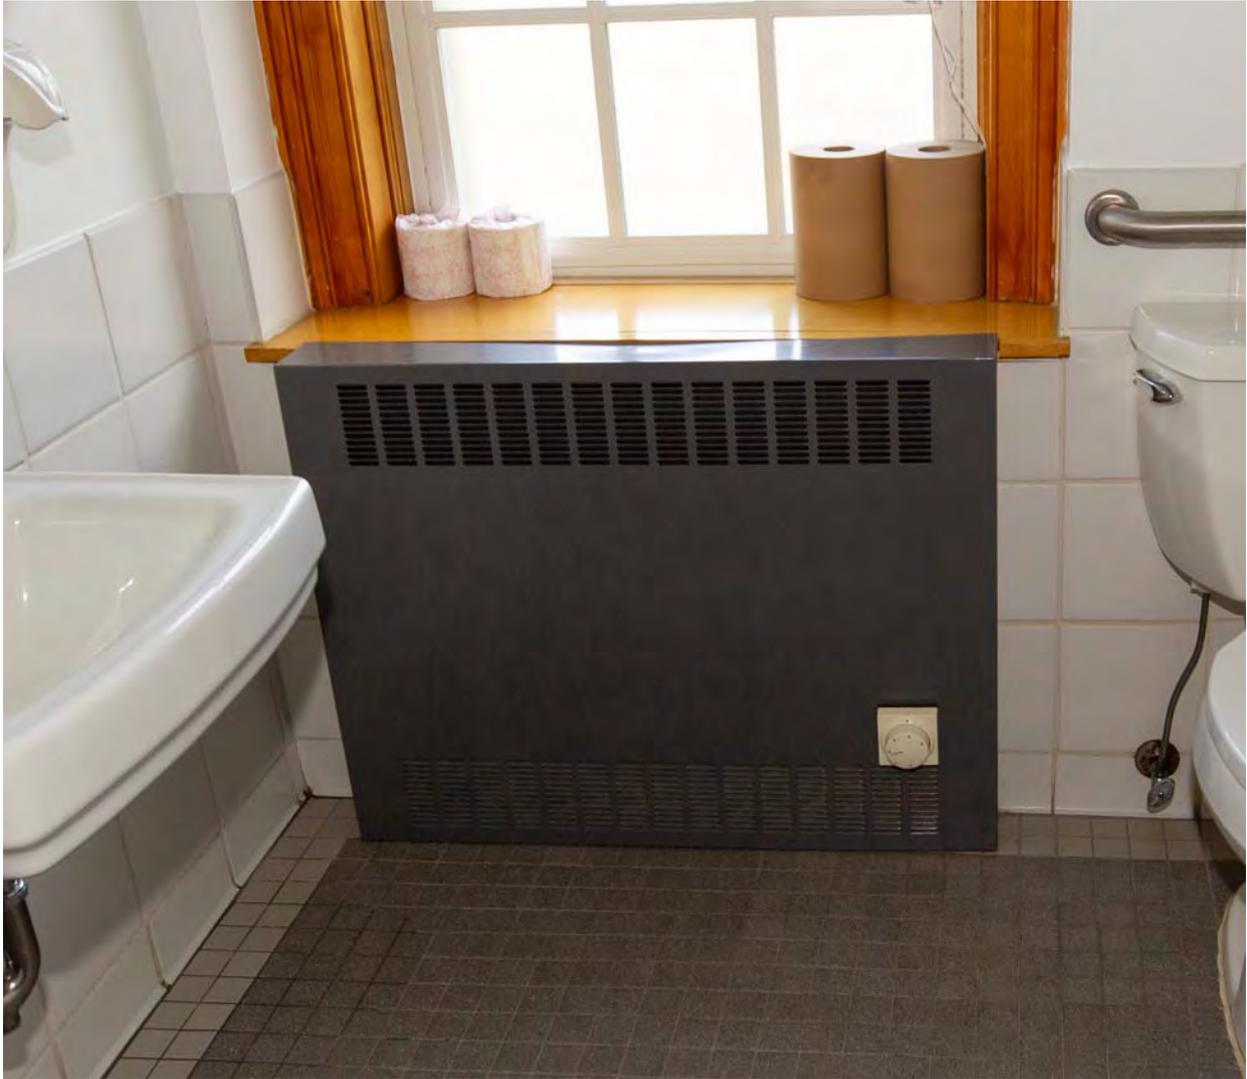
SAINT PETRONILLE PARISH - PHOTO #8-02

CABINET HEATER (INTEGRAL GRILLE DOWN TO FLOOR)

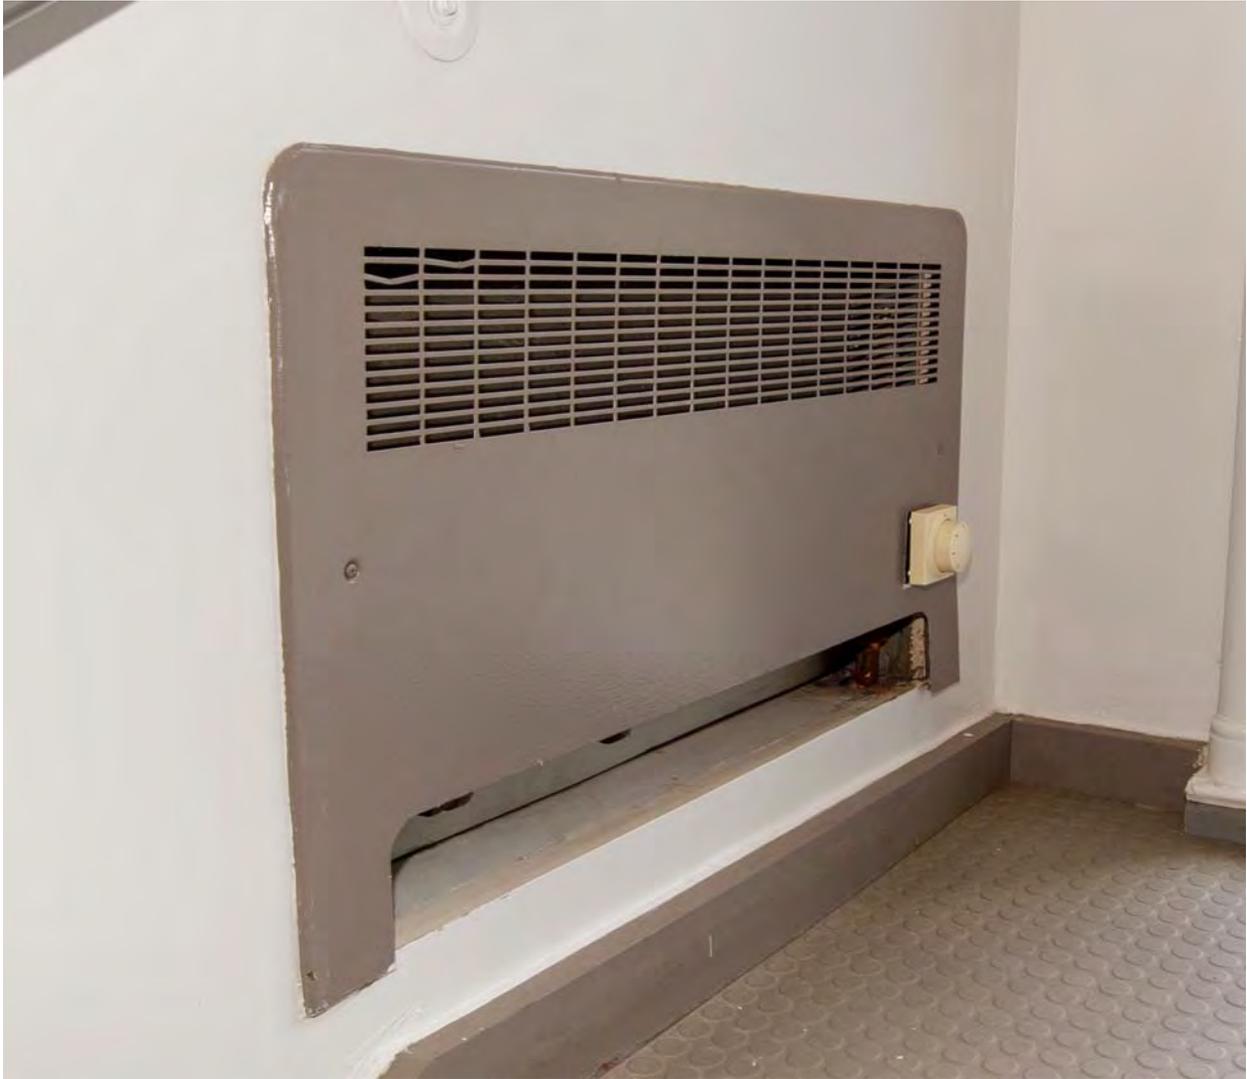
SAINT PETRONILLE PARISH - PHOTO #8-03

CABINET HEATER (BOTTOM OPEN & ELEVATED)

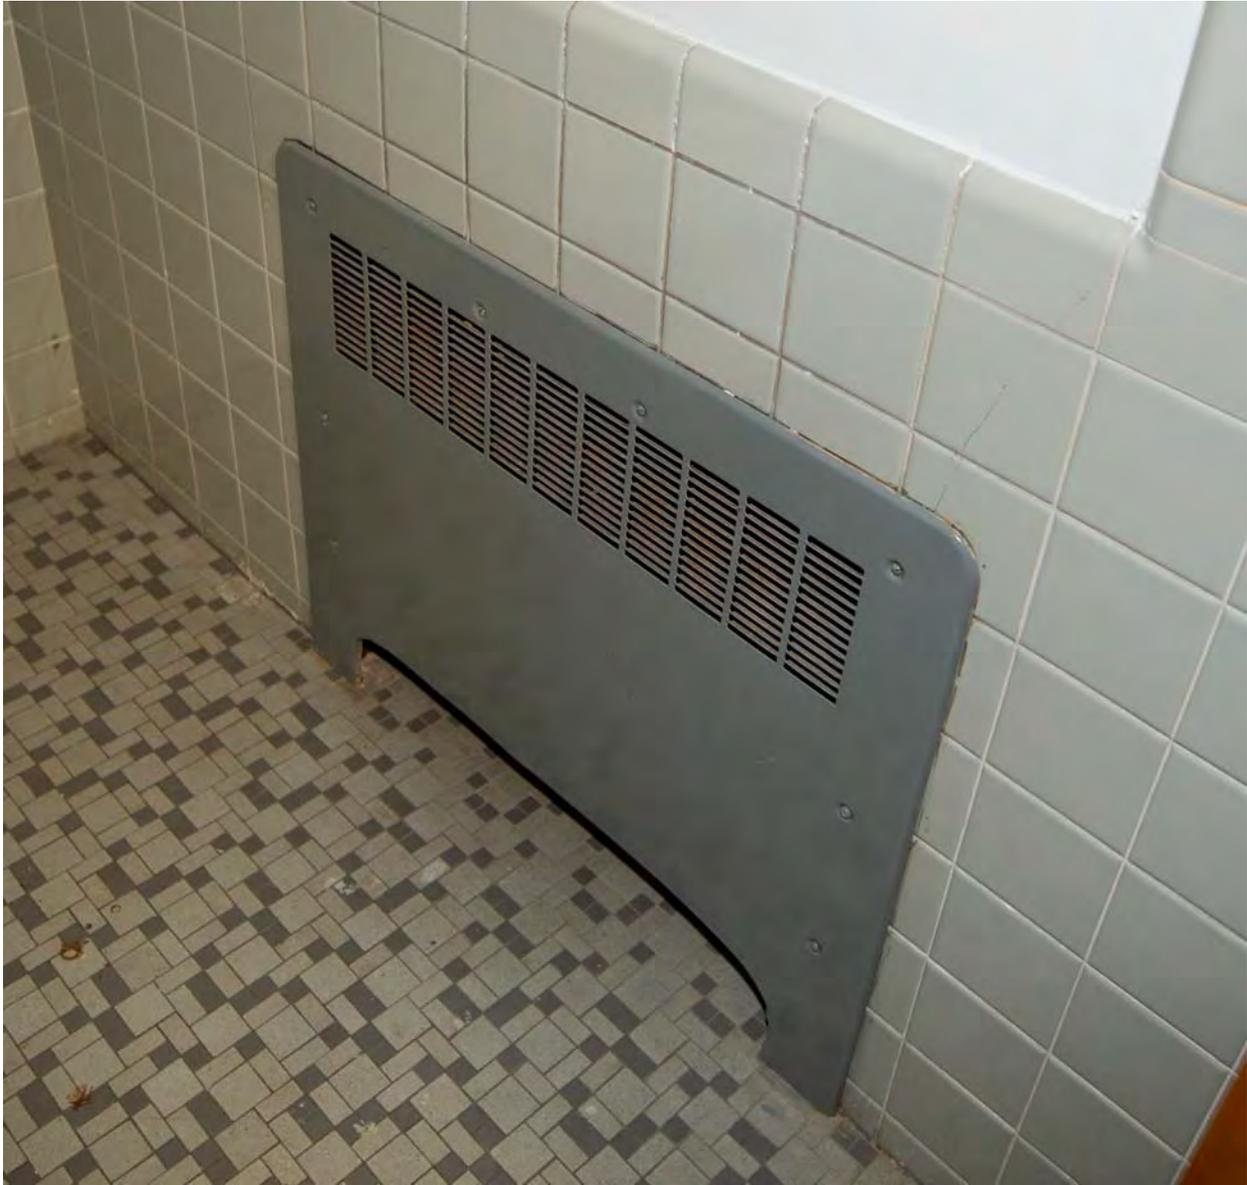
SAINT PETRONILLE PARISH - PHOTO #8-04

CABINET HEATER (BOTTOM OPEN ON TILE FLOOR)

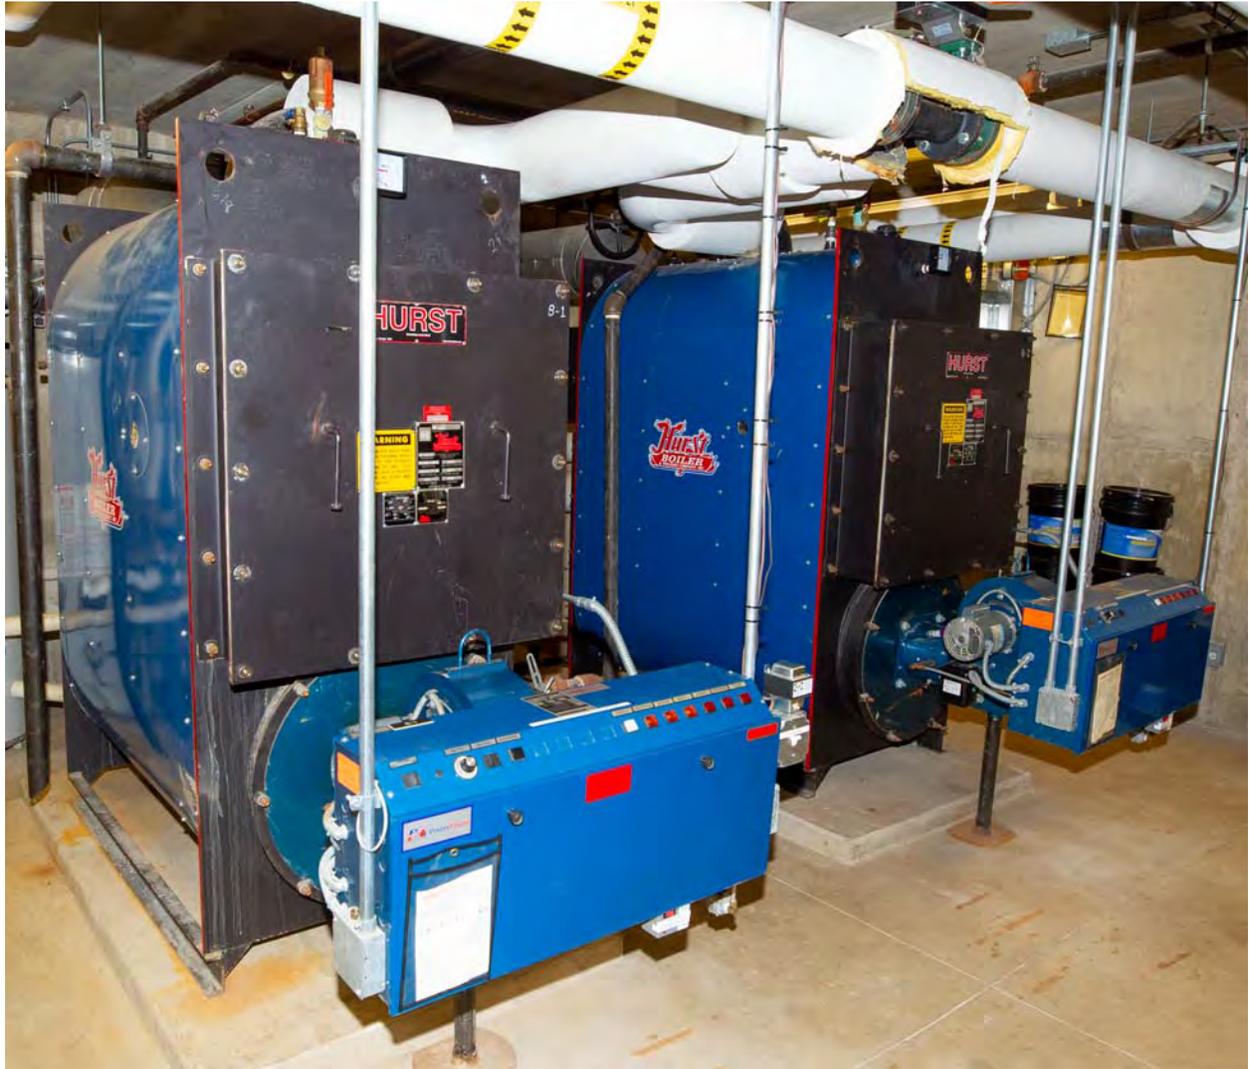
SAINT PETRONILLE PARISH - PHOTO #9-01

9.01.1 - These Gas-Fired Boilers are located in Mechanical Room 033 (see **Photo #9-01**).

SPACE HEATING BOILERS "B-1" & "B-2"

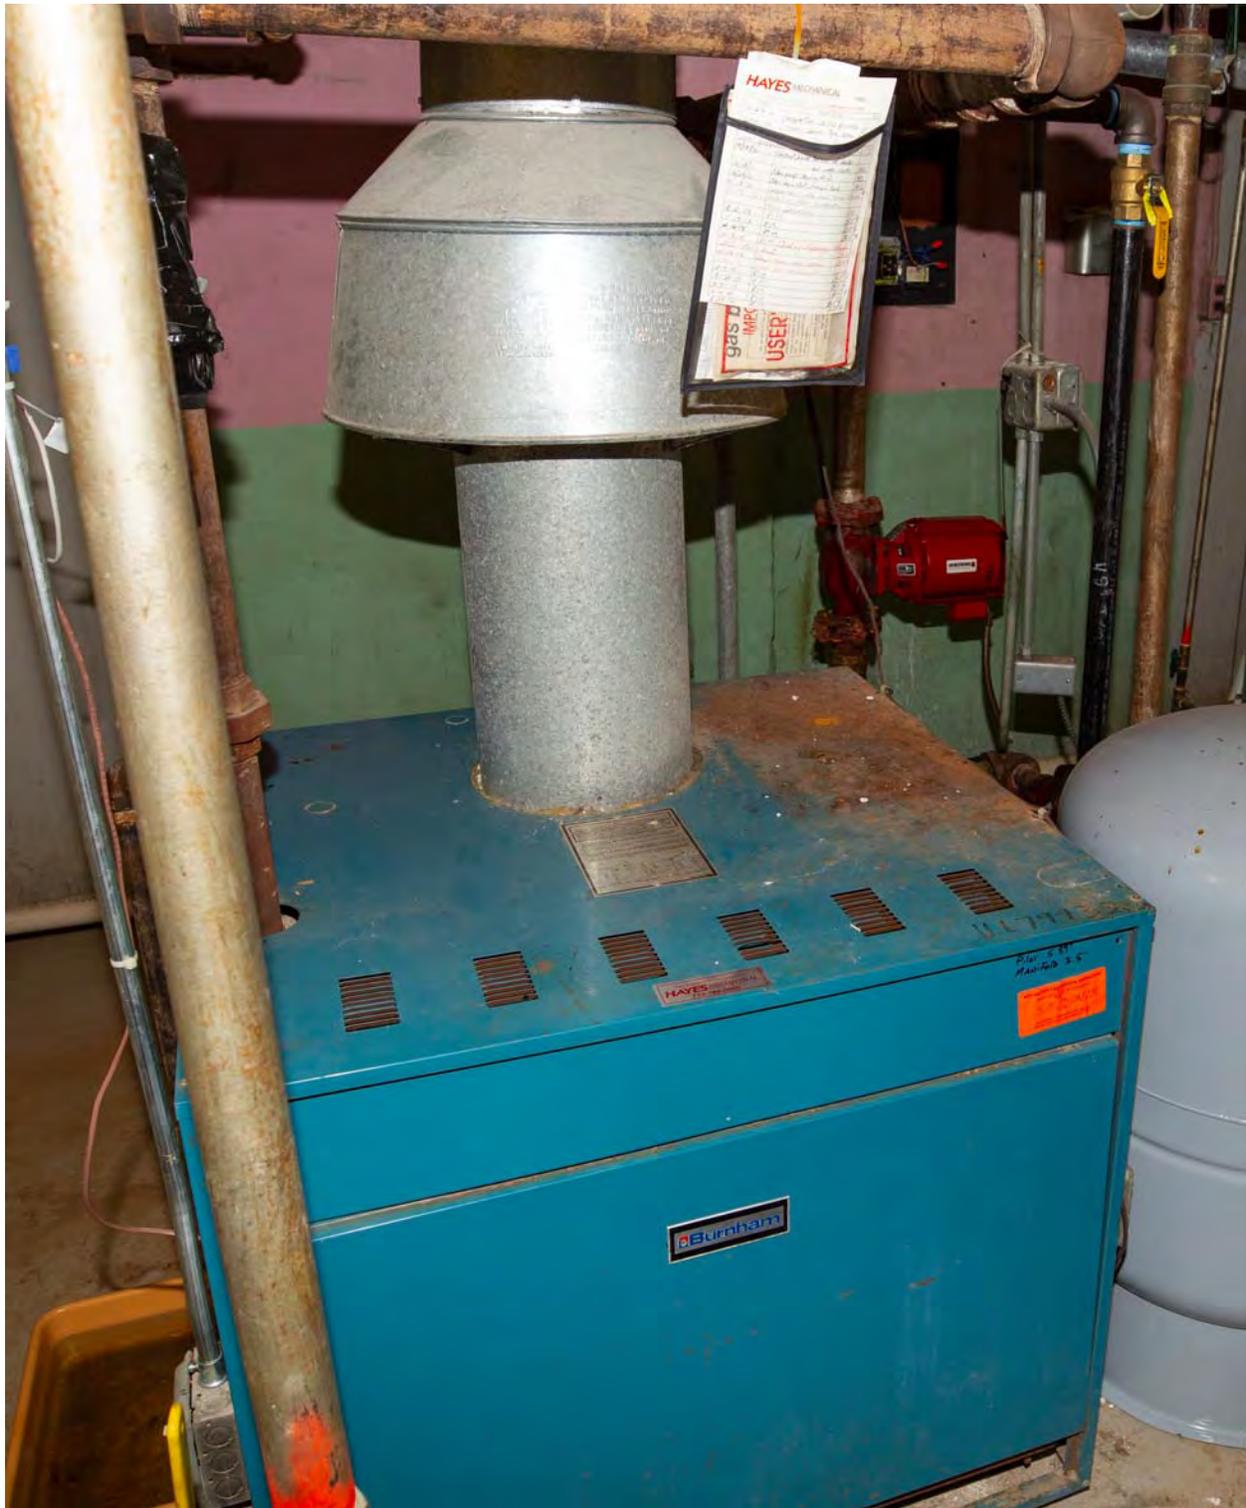
SAINT PETRONILLE PARISH - PHOTO #9-02

9.02 - Heating Hot Water Boiler (lets call it) "**B-3**", is located in Basement of the School (see **Photo #9-02**).

SCHOOL HOUSE SPACE HEATING BOILER

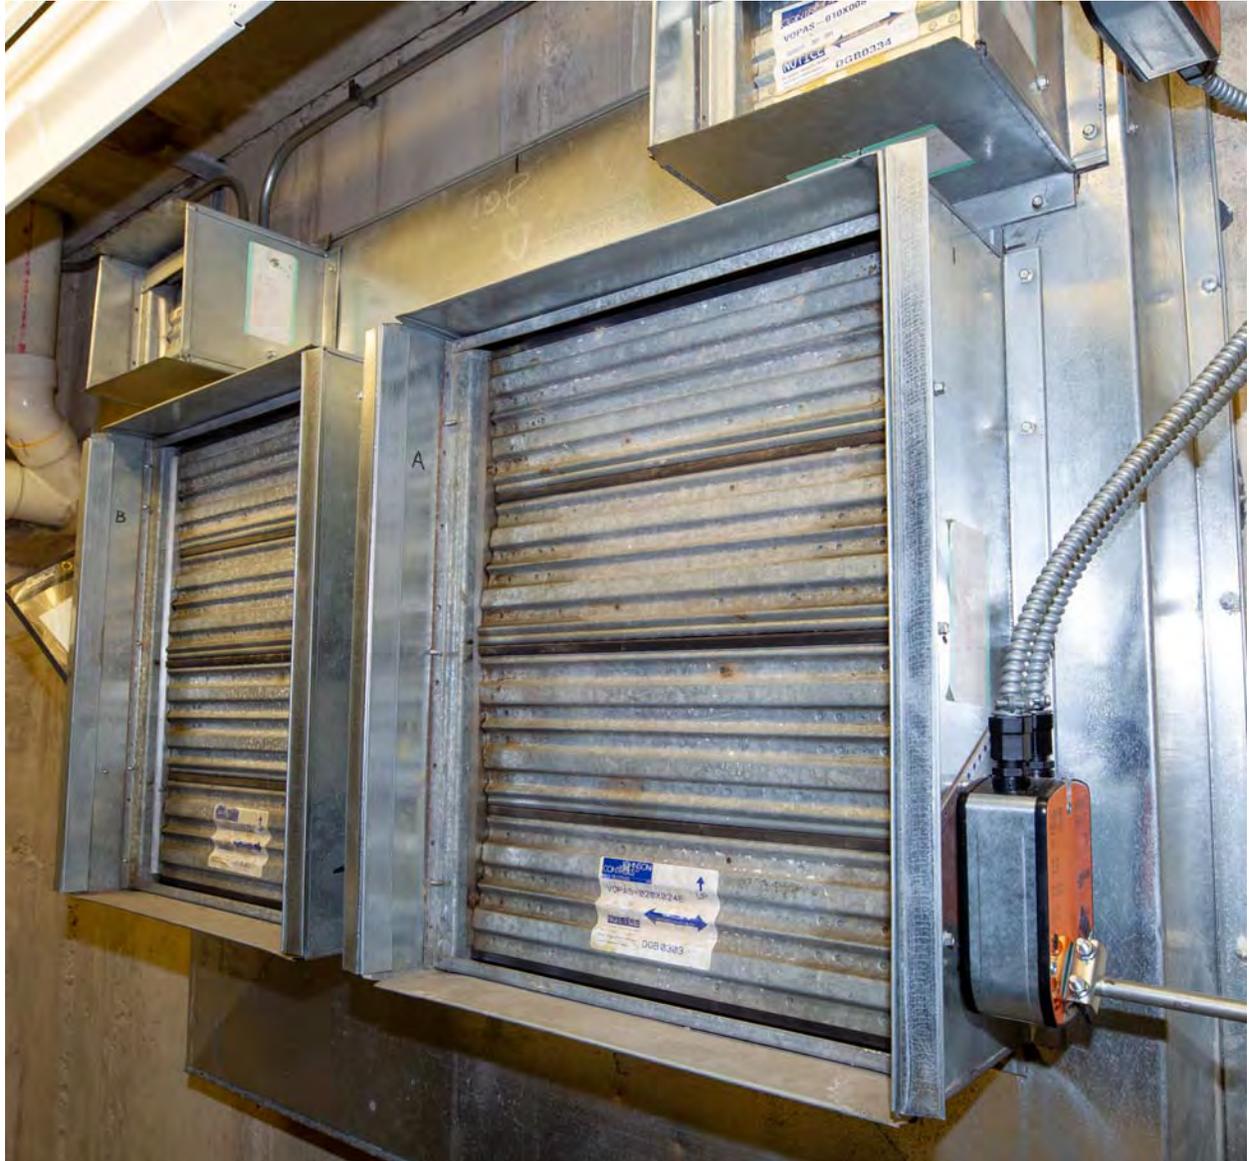
SAINT PETRONILLE PARISH - PHOTO #9-03

9.03 - Combustion Air Intake Dampers "**CAI-1**" & "**CAI-2**", located in Mechanical Room 033 (see **Photo #9-03**) are gravity relief intakes used to supply "fresh" outdoor make-up air to Heating Hot Water Boilers "B-1" & "B-2" for the natural gas products of combustion that are vented out the stack.

COMBUSTION AIR INTAKES "CAI-1" & "CAI-2"

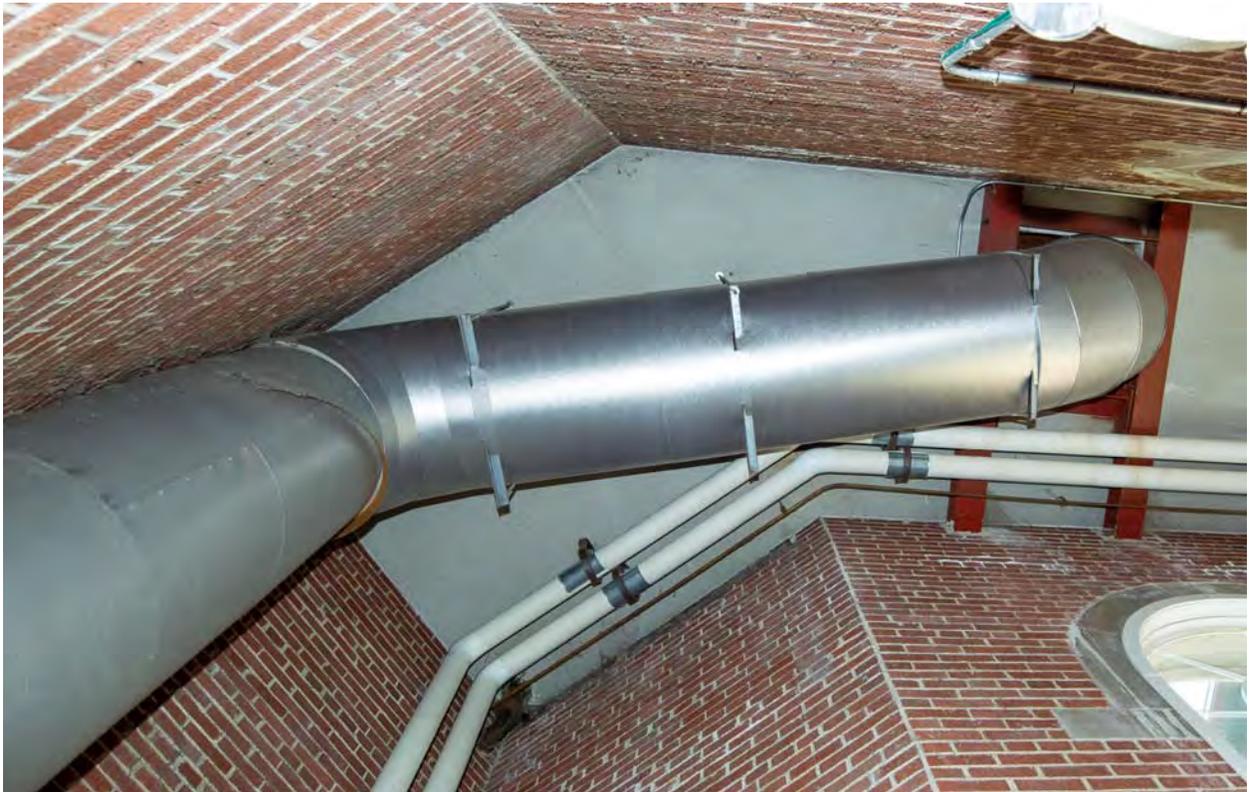
SAINT PETRONILLE PARISH - PHOTO #9-04

9.04 - The related Indoor Stack (see **Photo #9-04**) appears to be intact, however, the Outdoor Stack (see **Photo #9-05**) is probably in need of replacement, both from an aesthetics viewpoint and operation standpoint.

BOILER STACK (INDOORS)

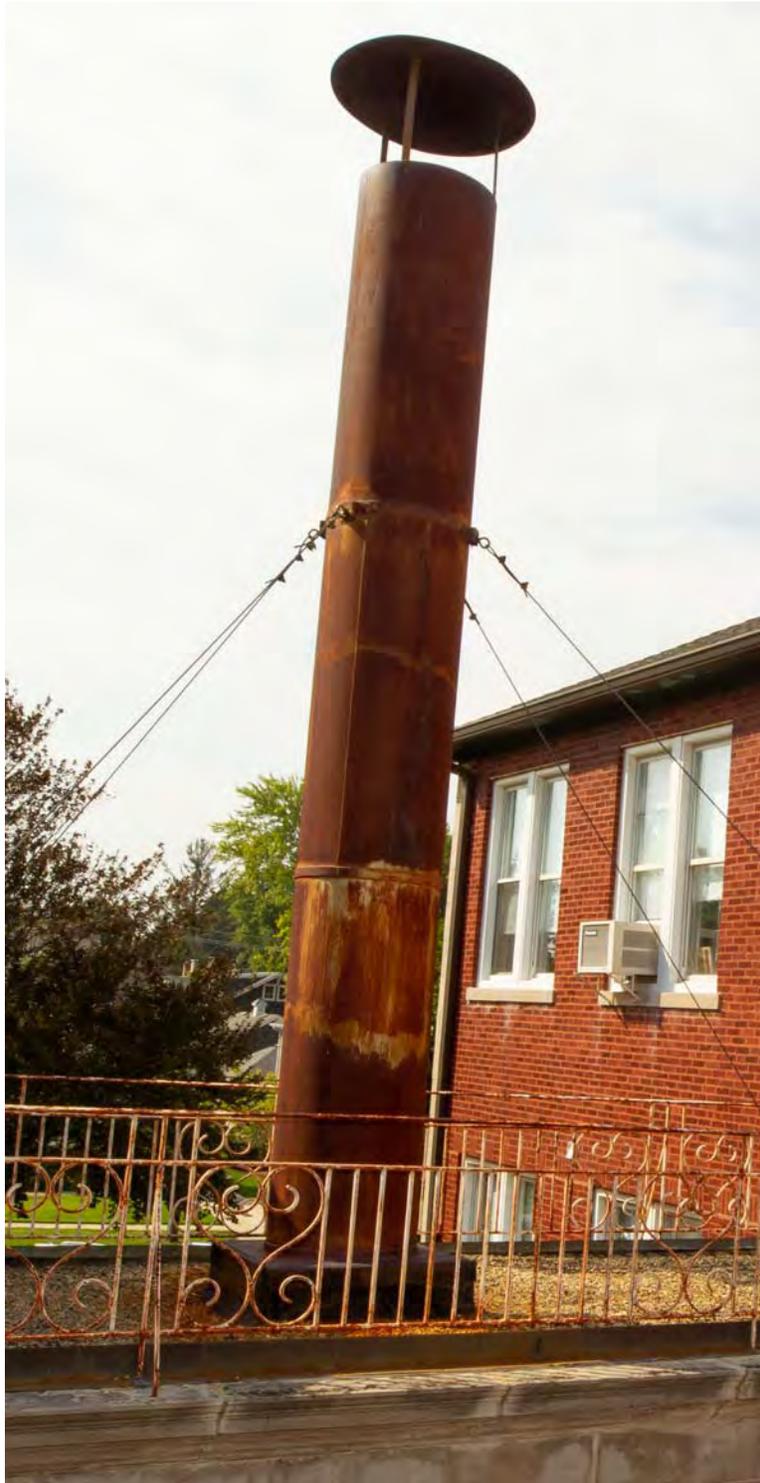
SAINT PETRONILLE PARISH - PHOTO #9-05

BOILER STACK (OUTDOORS)

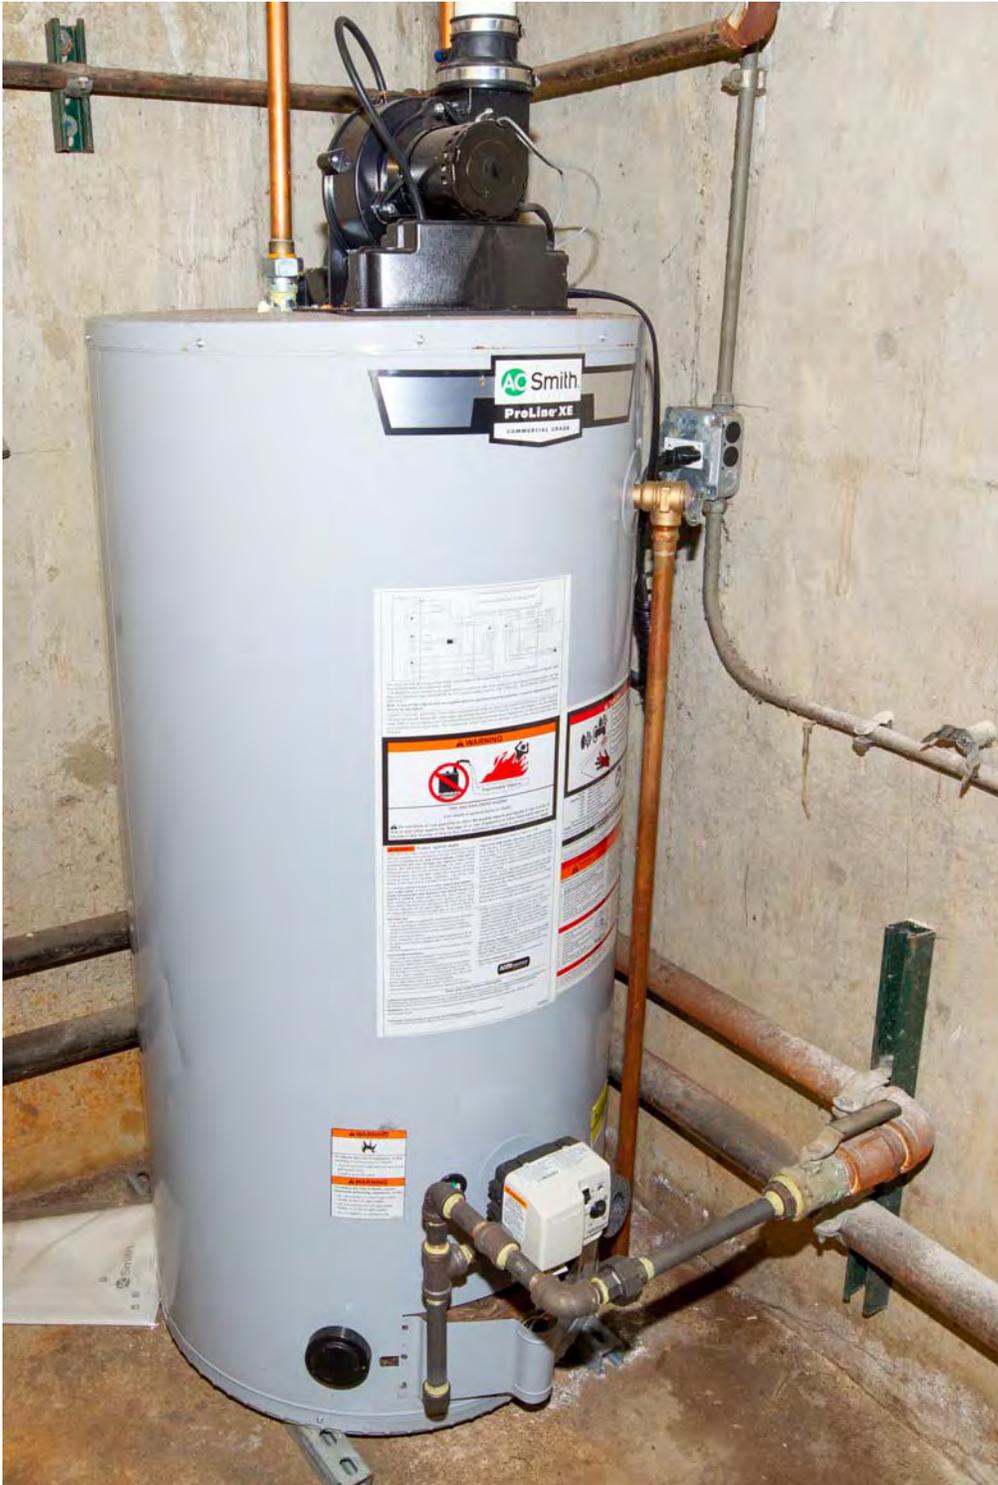
SAINT PETRONILLE PARISH - PHOTO #10-03

10.03.1 - This Natural Gas-Fired Domestic Water Heater (**see Photo #10-03**) installed in 2018, based on the observed condition - in our judgement - has a projected remaining useful life of 23 years (based on an original life expectancy of [say] 25 years).

DOMESTIC WATER HEATER

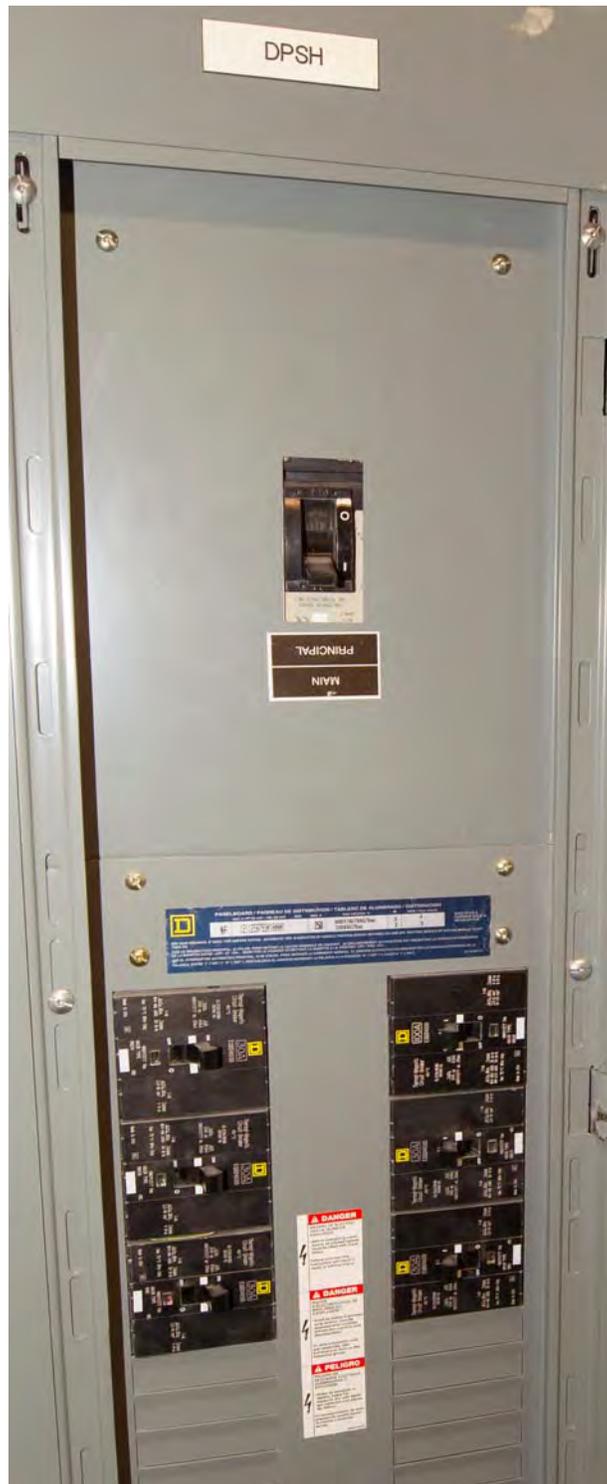
SAINT PETRONILLE PARISH - PHOTO #12-03

12.03 - Distribution Panel "DPSH" (see Photo #12-03) -**12.03.1** - Untagged Breakers.**12.04** - Service Distribution Panel "SDP-BA" 277/480V-3PH, 600A in Electrical Room 019 -.**12.04.1** - Panel "PP-01", Elevator "EV-1" & Transformer "T-B1".**12.05** - Service Distribution Panel "SDP-B1" 120/208V-3PH, 600A (see Photo #12-04) -**12.05.1** - Panels "LP-B1", "LP-B2", "LP-1A", "LP-1B", "LP-1C" & "RP-1B", Boilers "B-1" & "B-2", Sump Pumps "SP-1" & Ejector Pit Pumps "SE-1".**12.06** - Service Distribution Panel "SDP-3A" 120/208V-3PH, 600A (see Photo #12-06) -**12.06.1** - Condensing Unit "CU-3".**12.07** - Power Panel "Pp-1b" -**12.07.1** - Receptacles, Lighting, Outside Irrigation System Timer & Trane VAV Power.**12.08** - Power Panel "PP-B1" - 277/480V-3PH, 225A in Mechanical Room 033 (see Photo #12-07) -**12.08.1** - Air-Handling Units "AH-1" & "AH-2", Condensing Units "CU-1" & "CU-2", Pumps "P-4" & "P-5".**12.09** - Power Panel "PP-3A" 277/480V-3PH, 600A in Storage 304 -**12.09.1** - Roof Top Units "RT-1", "RT-2", "RT-3", "RT-4", "RT-5" & "RT-6", Transformer "T-3A", Air-Handling Unit Supply Fan "AH-3S" & Air-Handling Unit Return Fan "AH-3R".**12.10** - Emergency Panel "EM" (Battery & Exit Lights) 120/208V-1PH, 100A, 20CCT (see Photo #12-08) -**12.10.1** - 1st Floor Offices, 1st Floor School, Main Floor School, Upper Level School & Ministry Building.**12.11** - Kitchen Panel "KP-2A" 120/208V-3PH, 225A in Storage 237 (see Photo #12-09) -**12.11.1** - Kitchen Lights, Storage Rm Lights, Coffee Urn, Kitchen Island Power, Convection Oven, Refrigerator, Fire Suppression System, Braising Pan, Deep Fryers, Fire Alarm Relay, Office Receptacles, Make-up Air, Hood Lights, Dishwasher Exhaust, Hood Fan, Kitchen Receptacles, Ice Maker, Kitchen GFI, Microwave, Disposal & Dishwasher.**12.12** - Panel "DP-1" 120/208V-3PH, 175A in Storage 304 -

PANEL "DPSH"

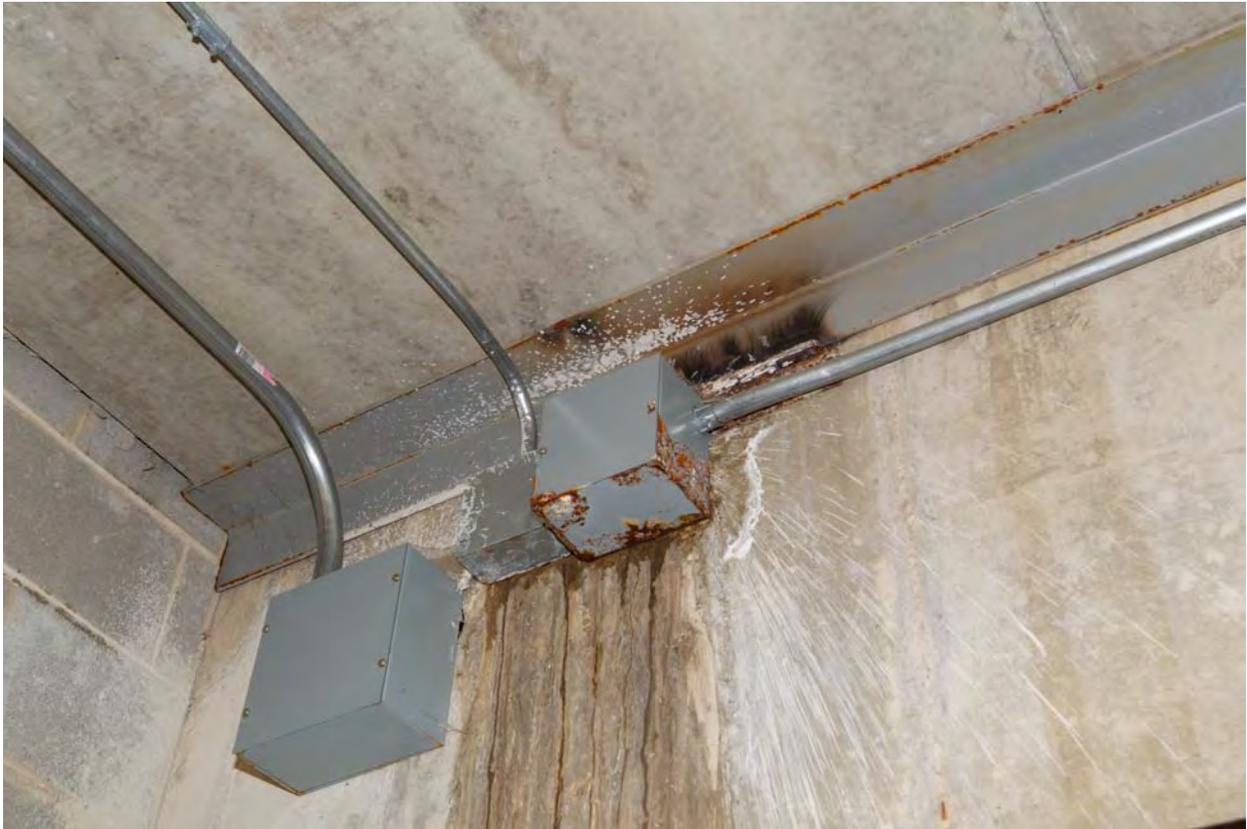
SAINT PETRONILLE PARISH - PHOTO #12-24

12.30 - Compromised Junction Box (see Photo #12-24) -

COMPROMISED JUNCTION BOX

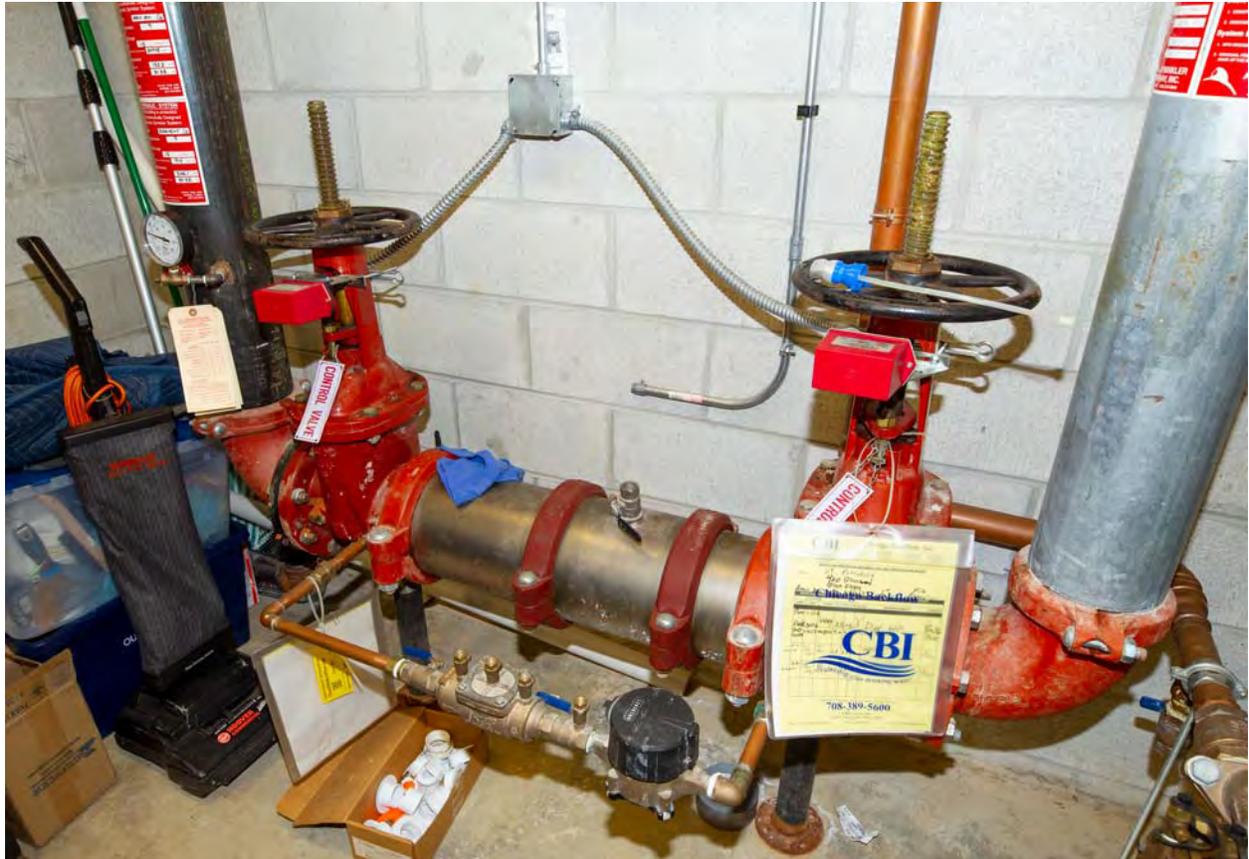
SAINT PETRONILLE PARISH - PHOTO #14-01

14.01 - A Double-Detector Valve Assembly (**see Photo #14-01**) is used to prevent backflow from being pumped or siphoned into the potable water supply.

DOUBLE-DETECTOR VALVE ASSEMBLY

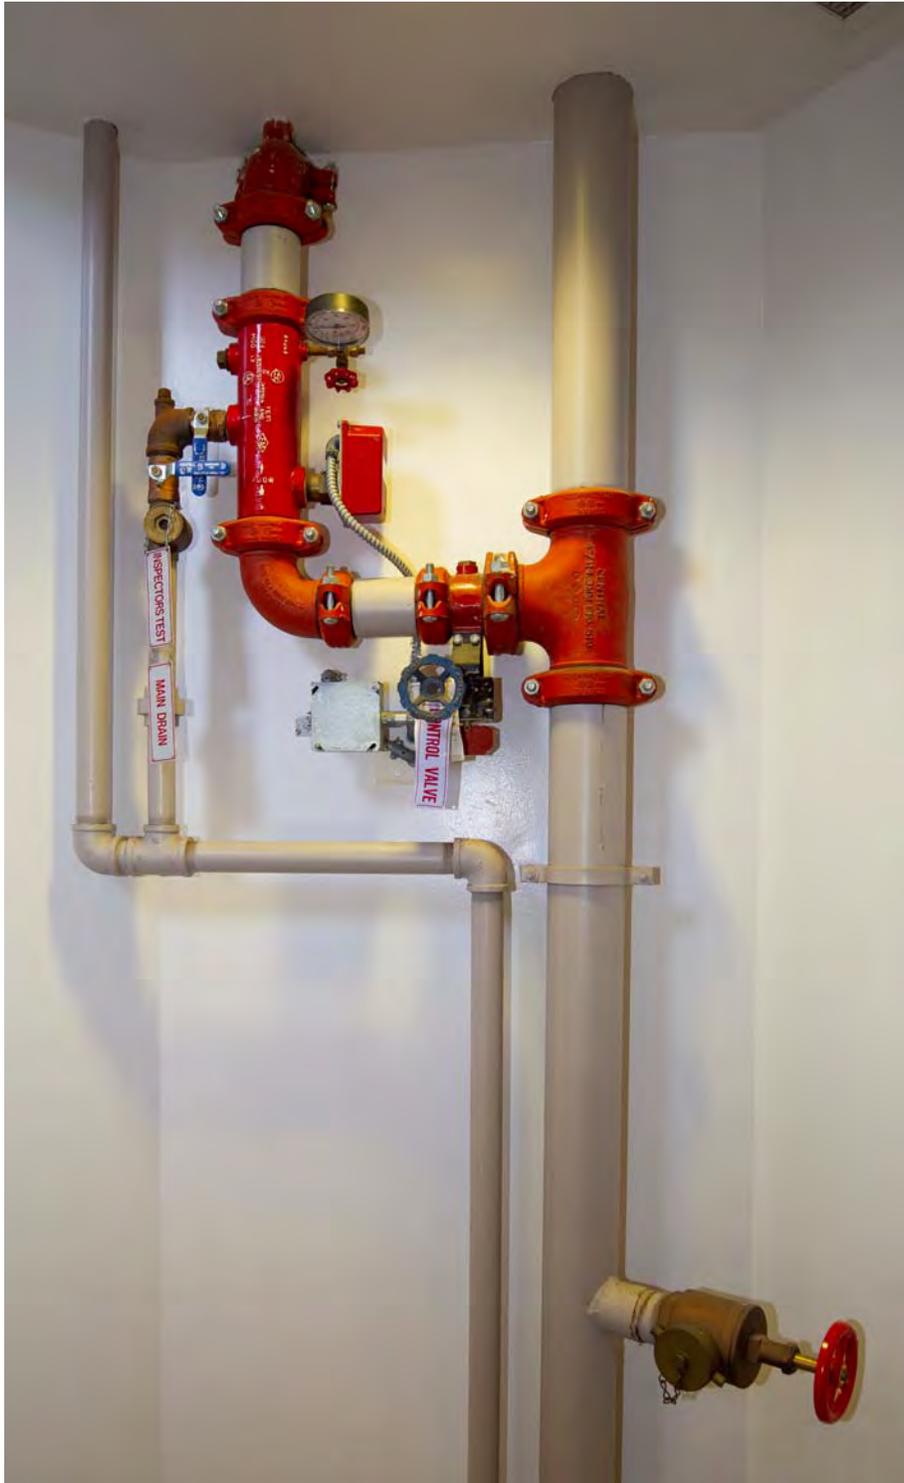
SAINT PETRONILLE PARISH - PHOTO #14-02

14.02 - The Fire Suppression System Backflow Preventer (**see Photo #14-02**) keeps the facility's fire suppression water system from flowing back into the Glen Ellyn municipal water line.

FIRE SUPPRESSION SYSTEM BACKFLOW PREVENTER

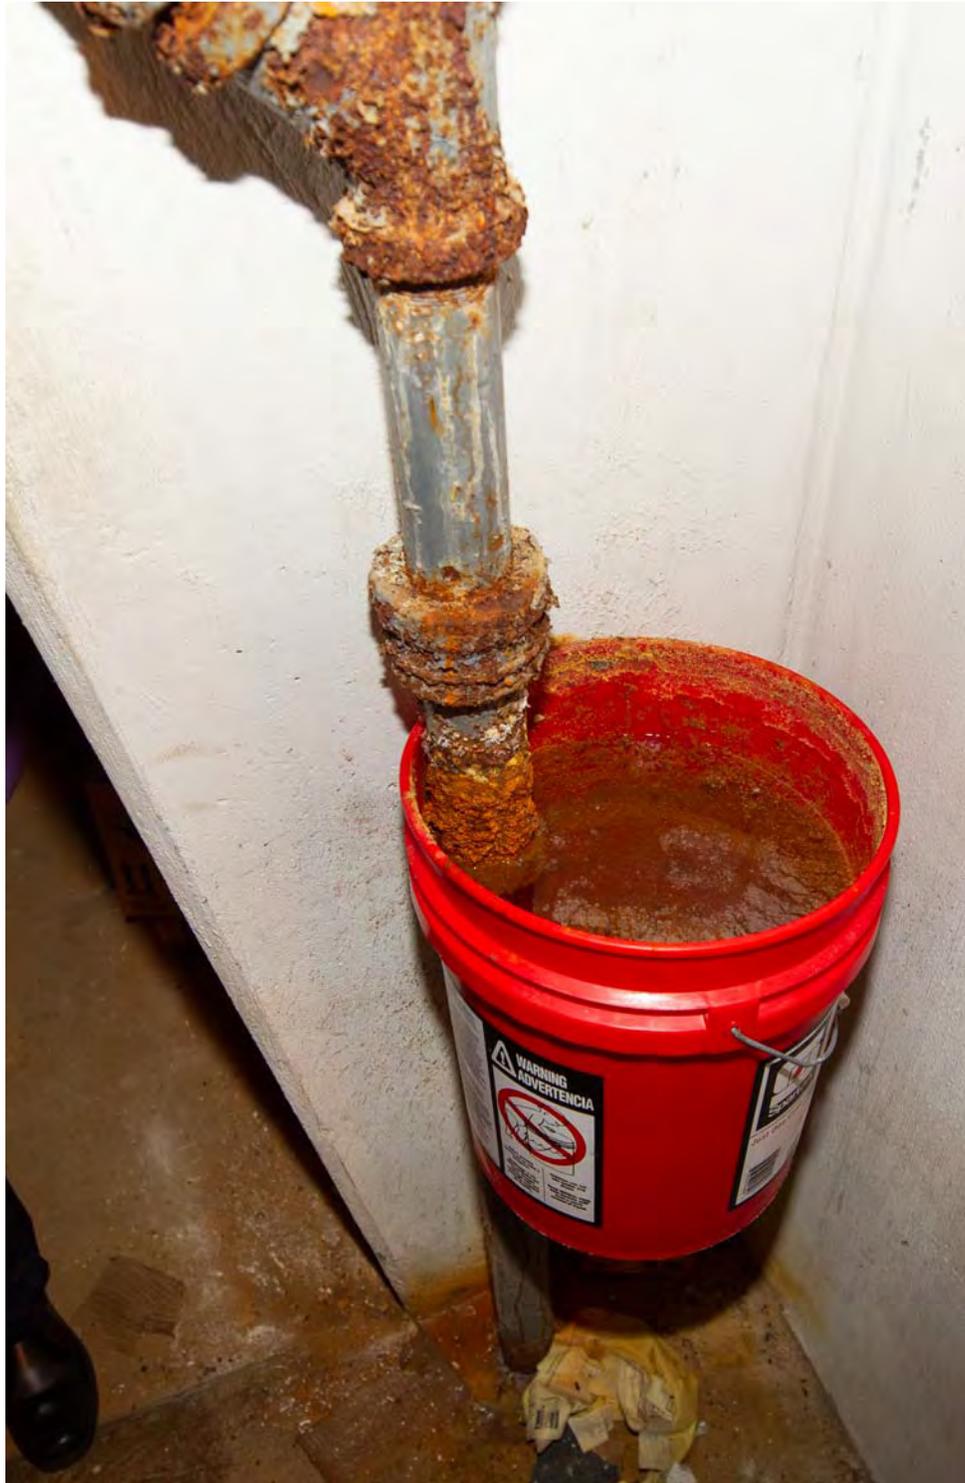
SAINT PETRONILLE PARISH - PHOTO #16-01

16.01 - One example of Bad Piping in Pool Area (see Photo #16-01).

AN EXAMPLE OF BAD PIPING (IN POOL AREA)
