RESERVE STUDY
for
SAINT PETRONILLE PARISH
at
420 GLENWOOD LANE
GLENN ELLYN, ILLINOIS 60137

KGH NO. 19-11-454

November 11, 2019

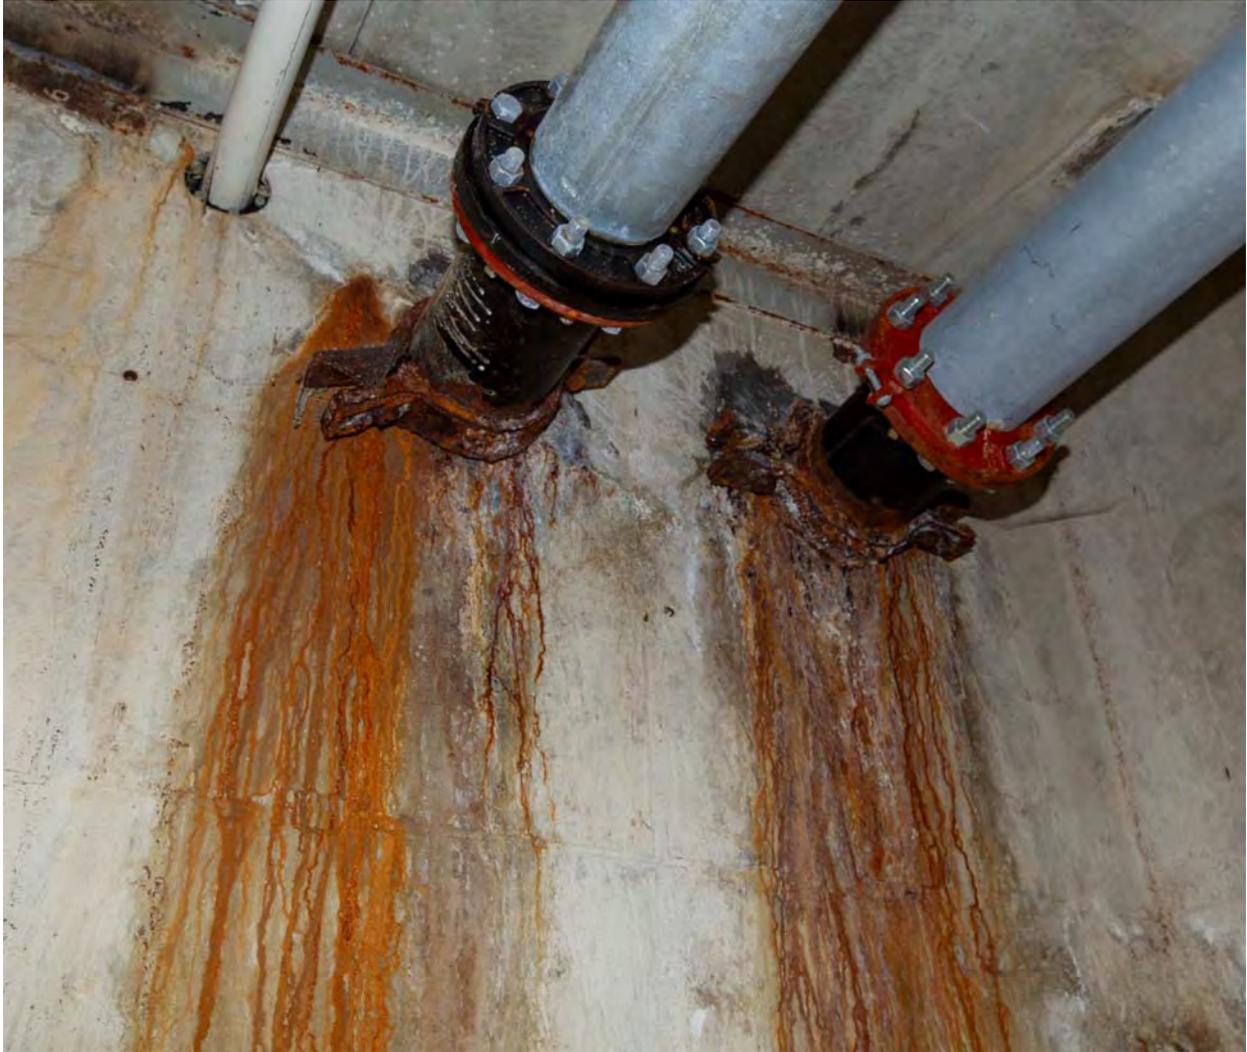
SAINT PETRONILLE PARISH - PHOTO #16-02

16.02 - Another example of a Bad Piping Situation in Pool Area (see Photo #16-02).

ANOTHER EXAMPLE OF A BAD PIPING SITUATION (IN POOL AREA)

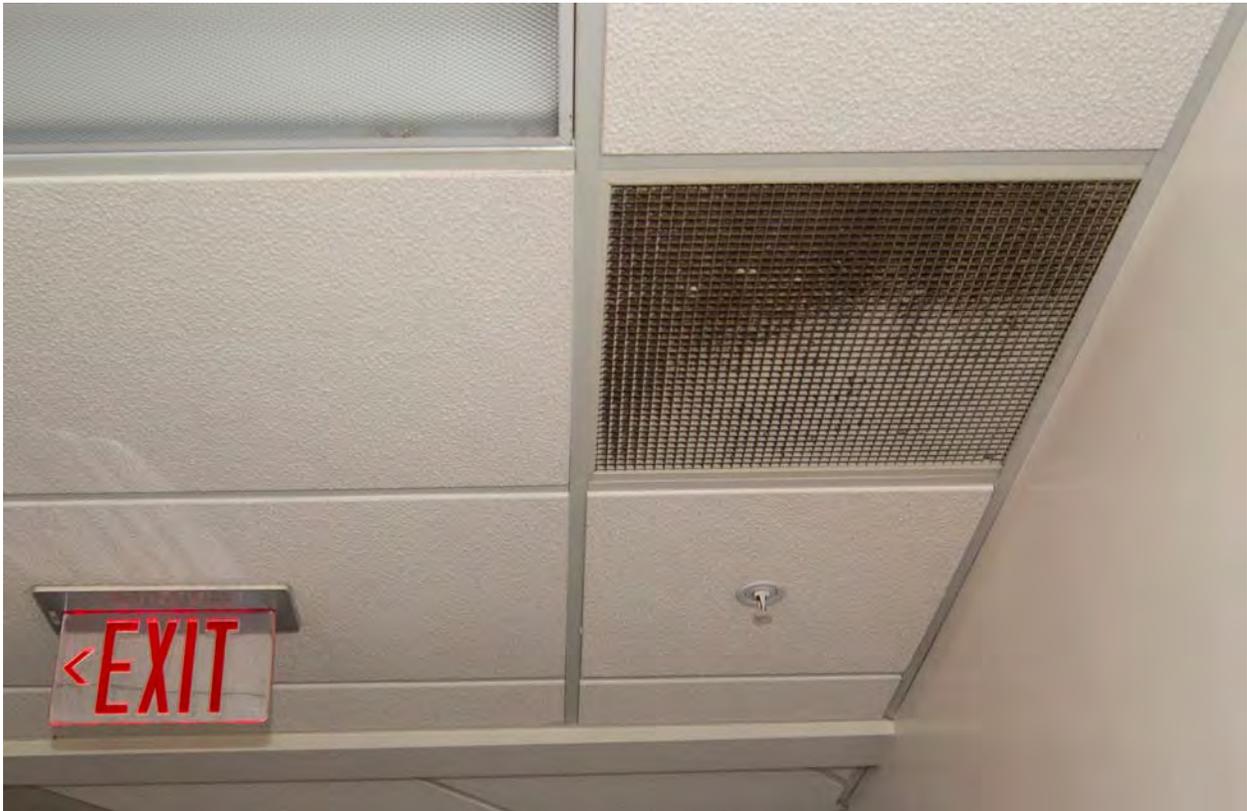
AN EXAMPLE OF A SOILED CEILING PANEL

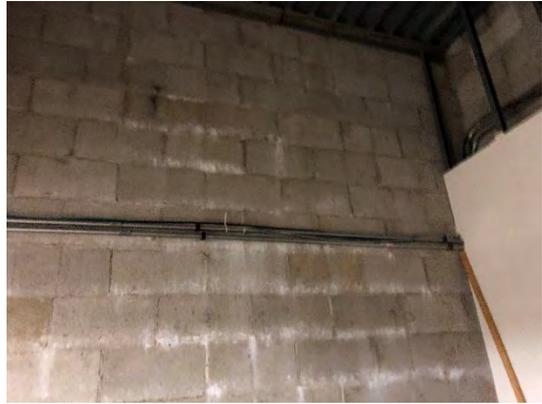
Church Attic Storage – CMU Staining

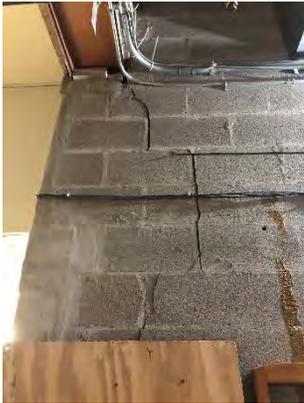
Church Attic Storage – CMU Cracking

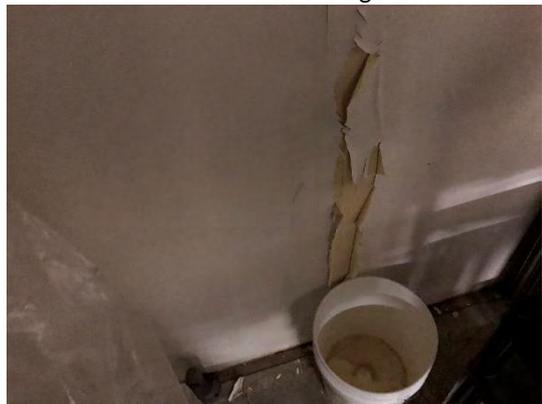
Church Attic Storage – Drywall Damage

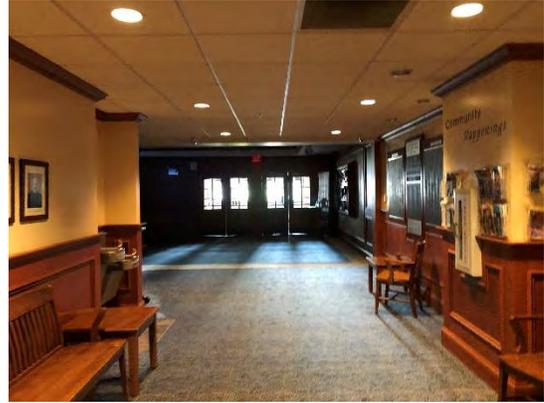
Gathering Room – Ceiling Tile Staining

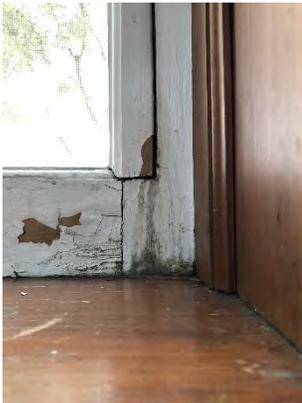
Sanctuary – Window Peeling Paint

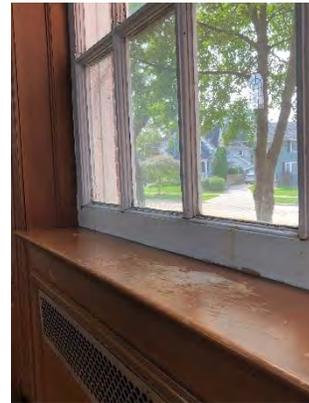
Sanctuary – Window Peeling Paint

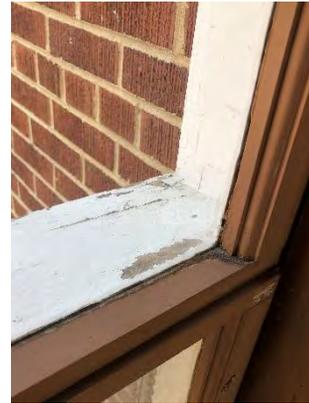
Sanctuary – Window Peeling Paint

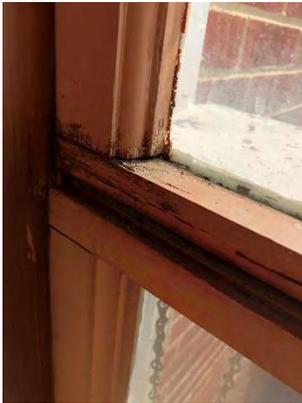
Sanctuary – Window Peeling Paint

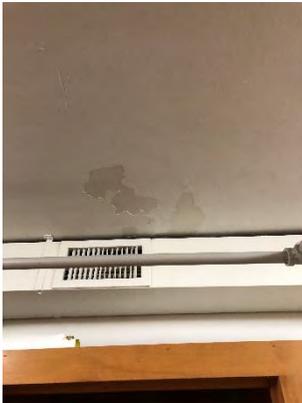
Sacristy Priest Quarters – Peeling Paint

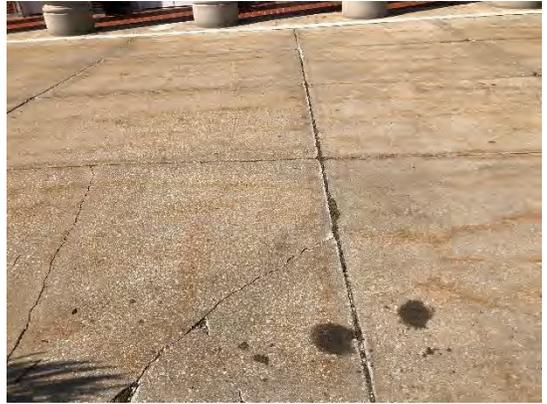
Church Entrance – Sidewalk Cracking

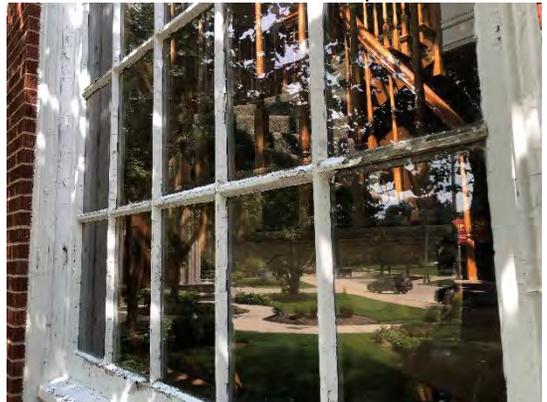
Church – South Window Peeling Paint

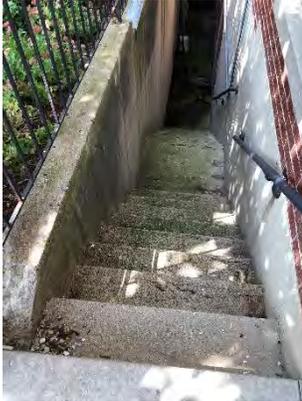
Church – South Stair Deterioration

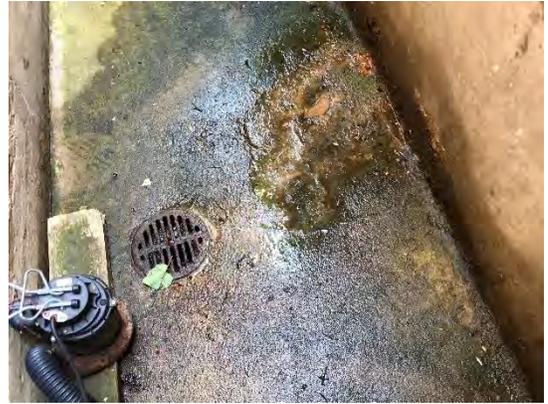
Church – South Drain Ponding

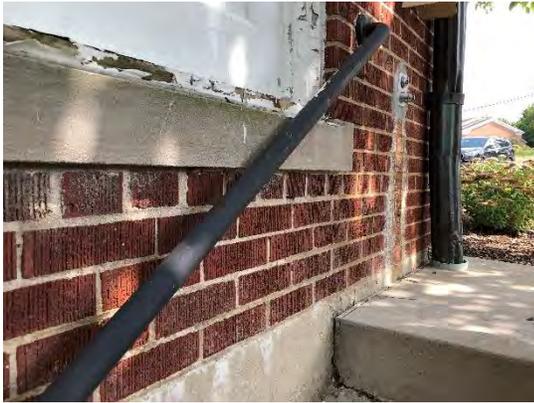
Church – South Stair Deterioration

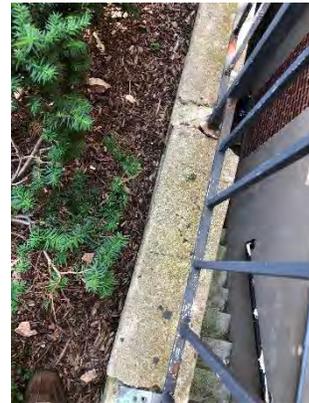
Church – South Stair Concrete Cracking

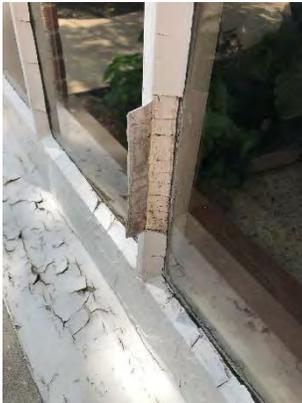
Church – South Window Peeling Paint

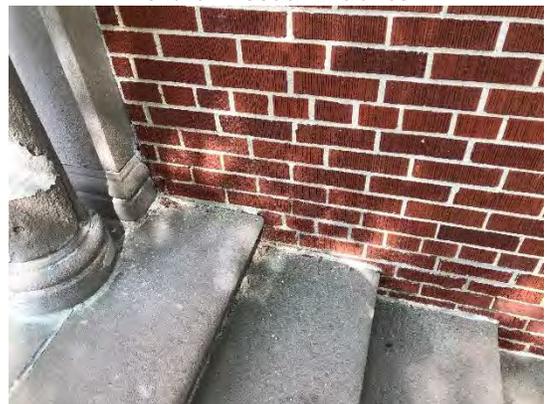
Church – South Entrance Failed Sealant

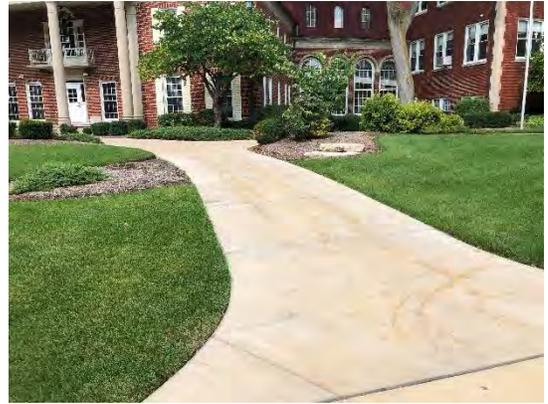
Ministry Center – East Sidewalk

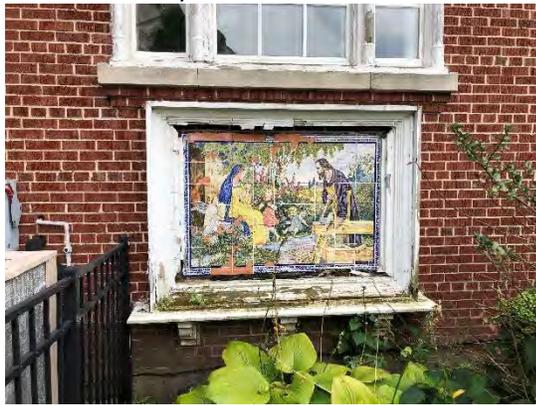
Ministry Center – North Mosaic Peeling Paint

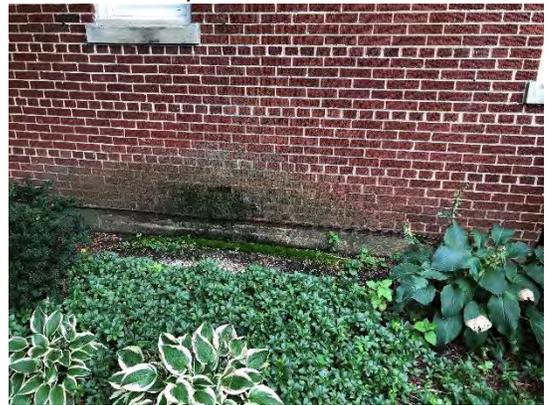
Ministry Center – North Masonry Dirty

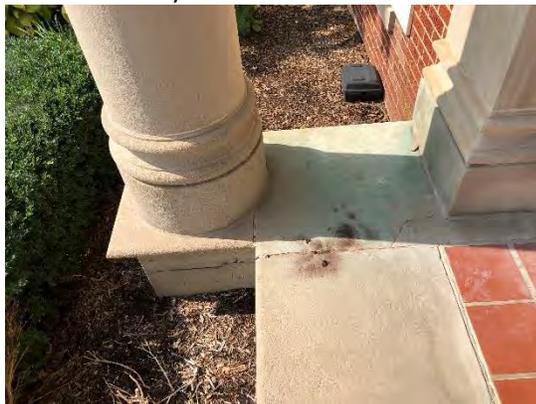
Ministry Center – South Entrance Cracked Concrete

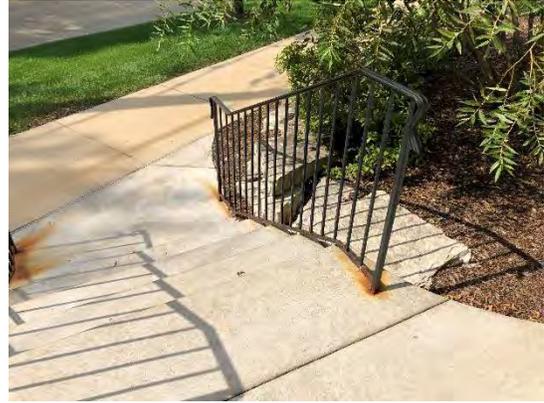
Ministry Center – West Railings Corrosion

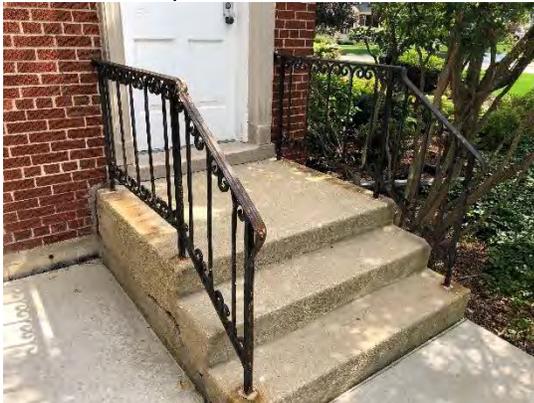
Ministry Center – West Stair Corrosion

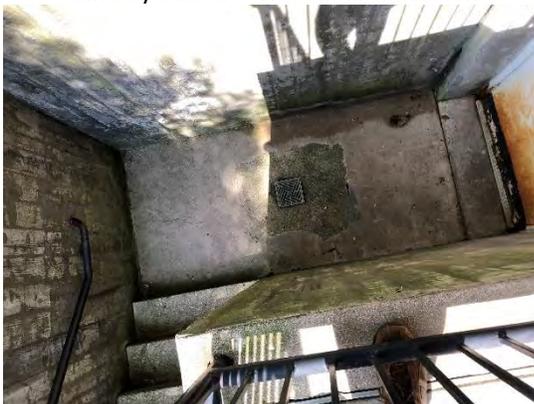
Ministry Center – West Pit Ponding

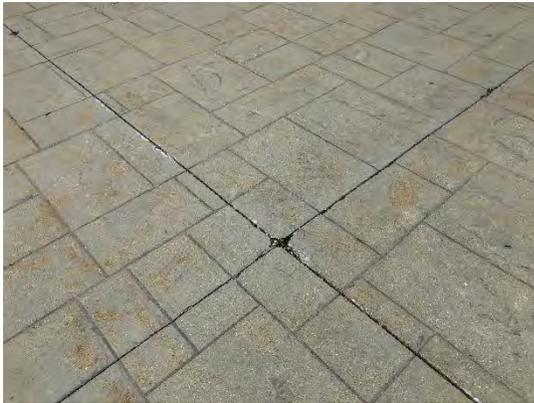
School – South Terrace Staining

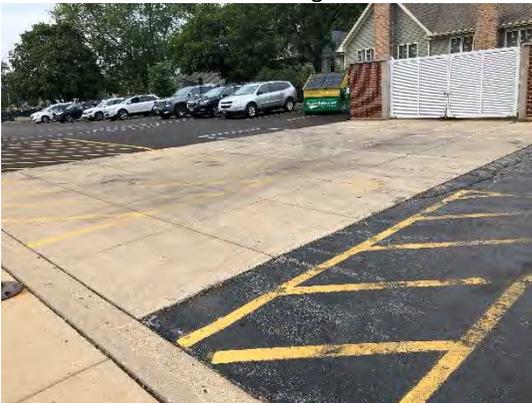
North Parking Lot Pavement Cracking

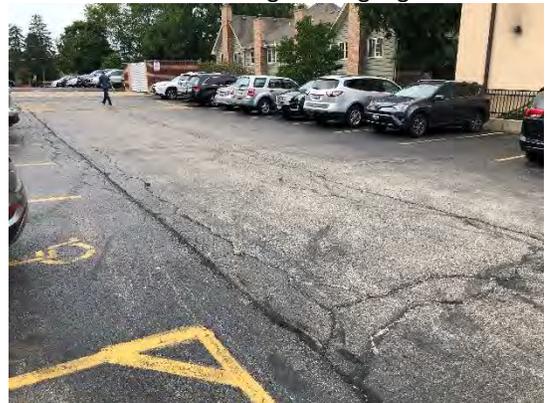
North Parking Lot Pavement Cracking

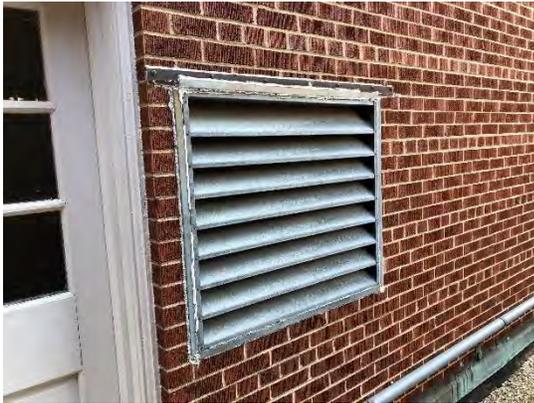
Roof – Louver Deterioration

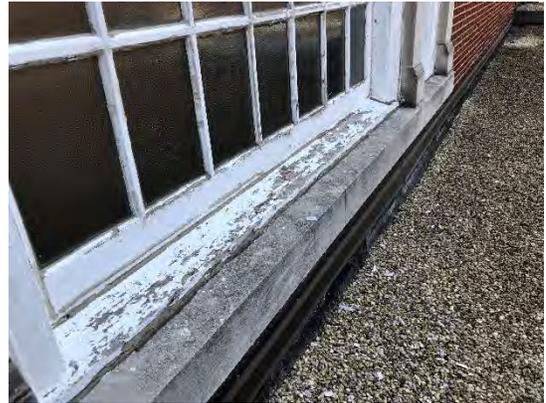
Roof – Window Peeling Paint

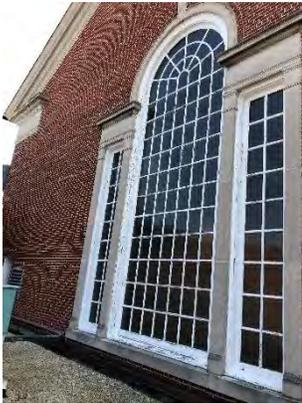
Roof – Window Peeling Paint

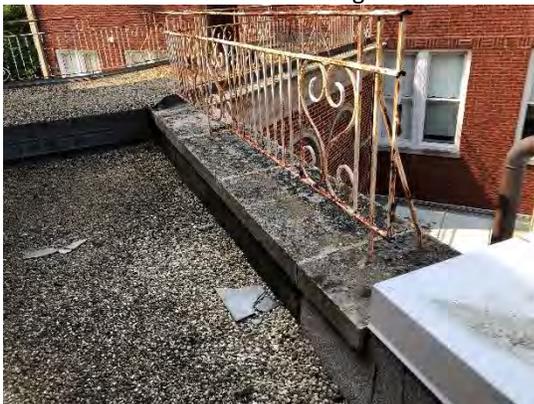
Roof – Railing Corrosion

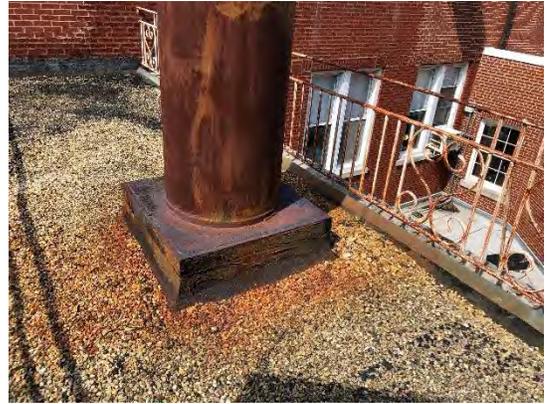
Roof – Chimney Corrosion

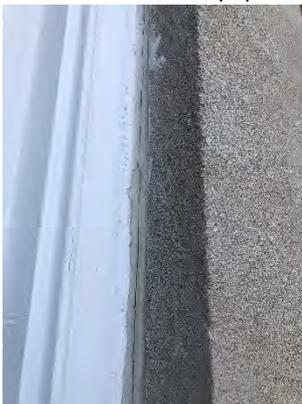
Roof – Caulking Deterioration

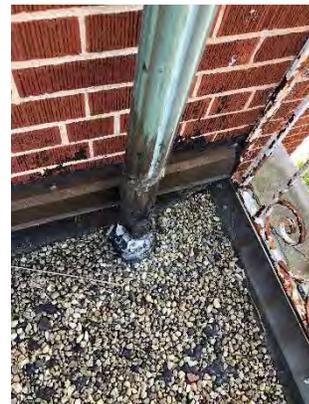
Roof – Downspout Corrosion

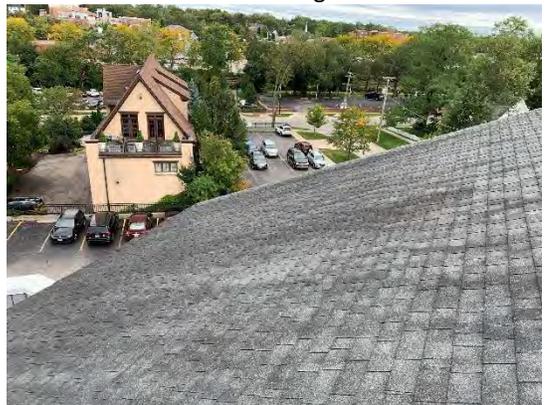
Roof – Valley

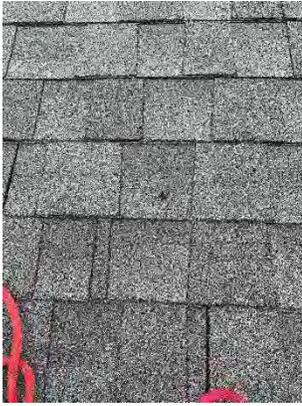
Roof – Field Staining

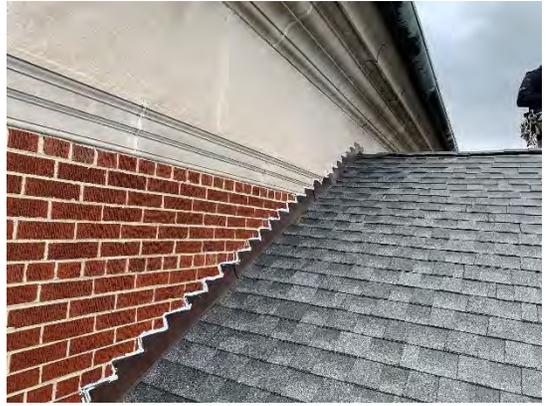
Roof – Displaced Shingles

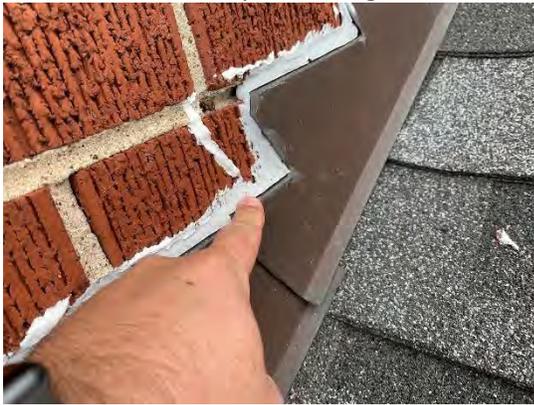
Roof – Step Flashing

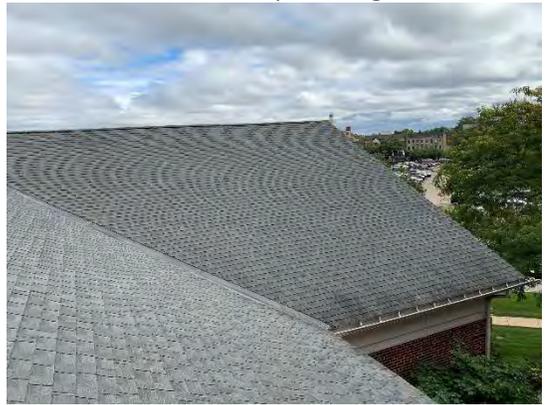
Roof – Flashing Failed Sealant

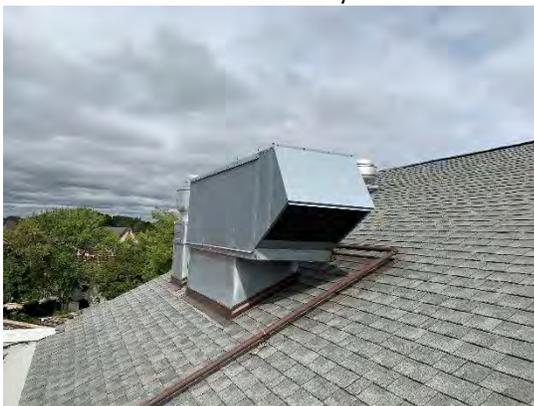
Roof – Vent Corrosion

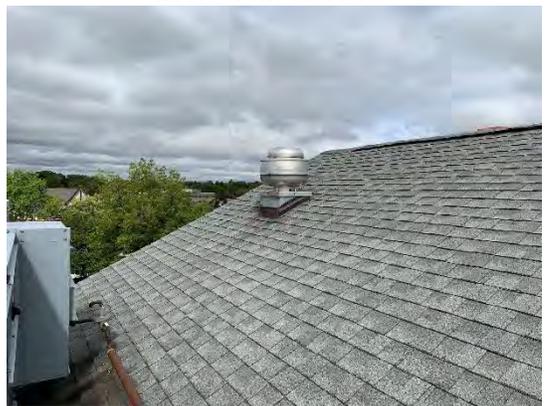
Roof – Vent

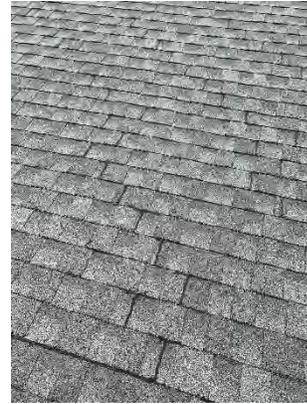
Roof – Valley Failed Joint

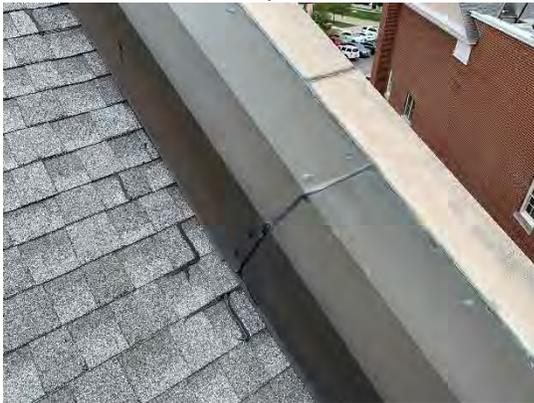
Roof – Shingle Displacement

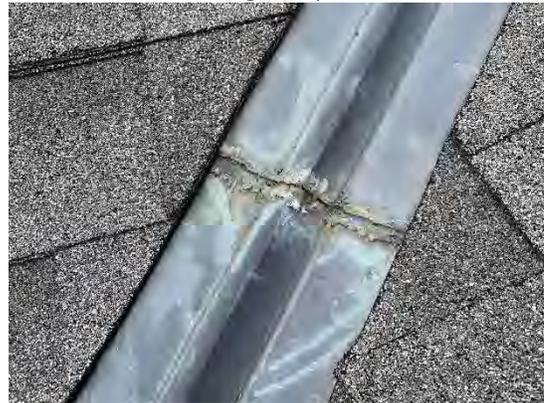
Roof – Coping Joint

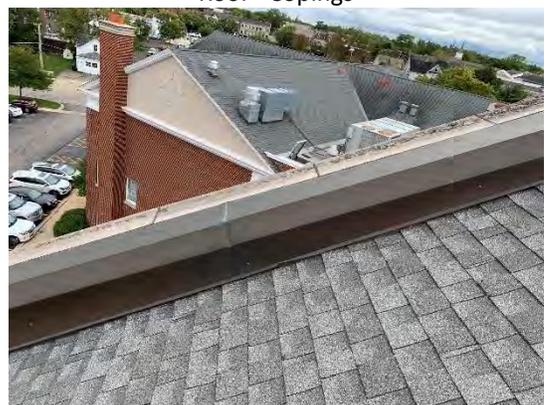
Roof – Dormer

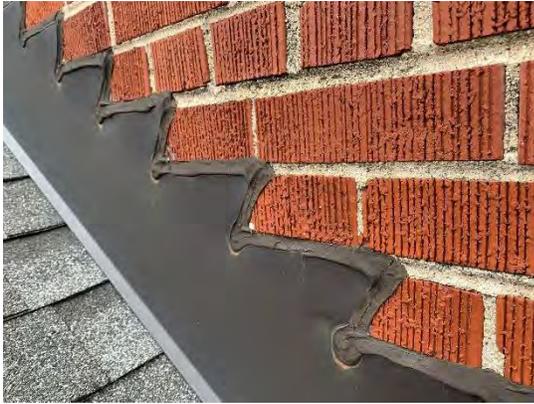
Roof – Parapet

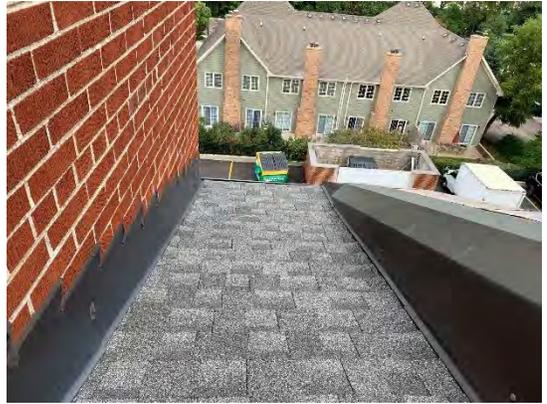
Roof – Flashing Failed Sealant

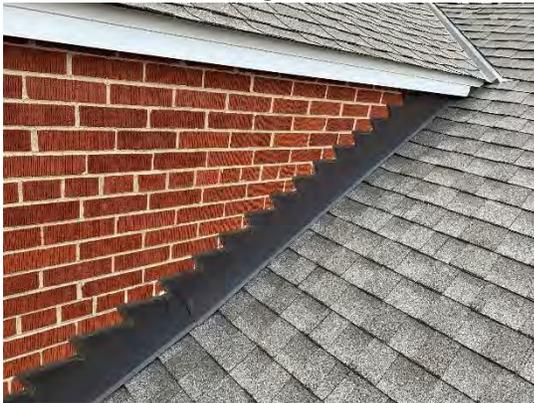
Roof – Flashing and Dormer

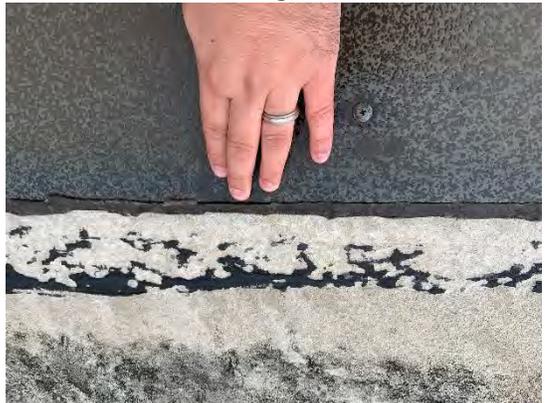
Roof – Step Flashing

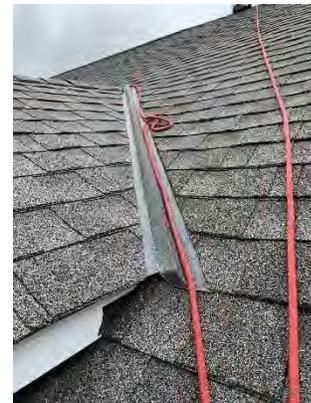
Roof – Security Camera

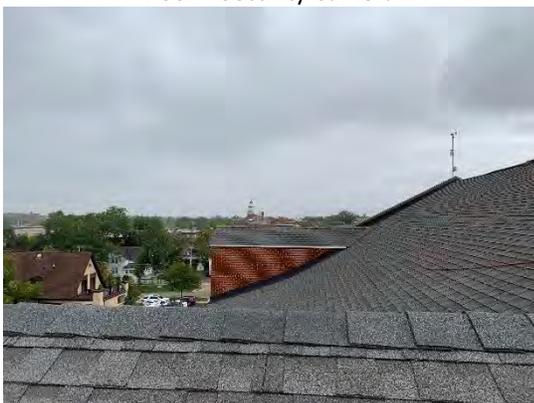
Roof - Valley

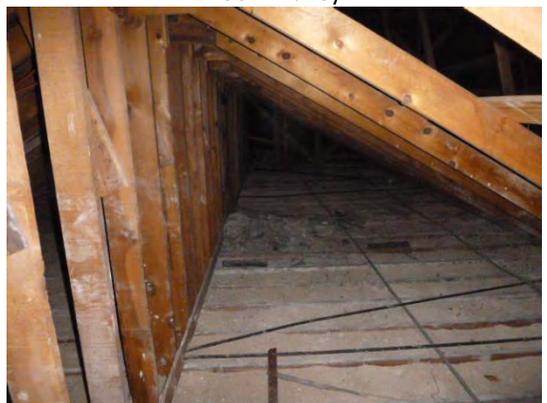
Roof – Ridge

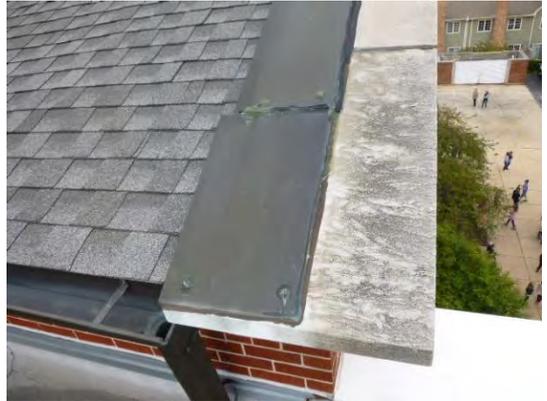
Roof – Copper Gutter

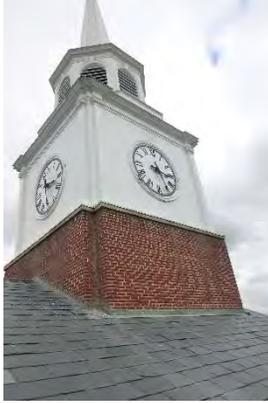
Roof – Staining

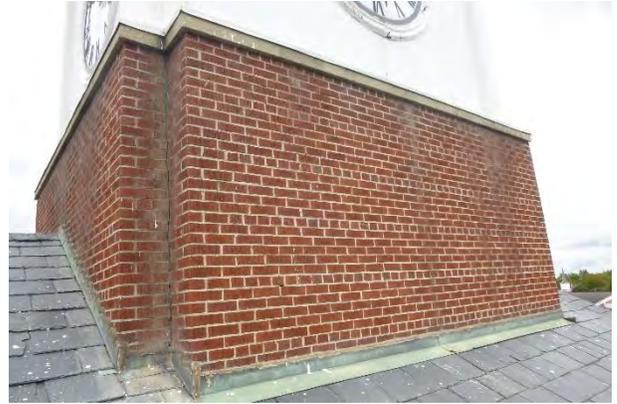
Roof - Clocktower

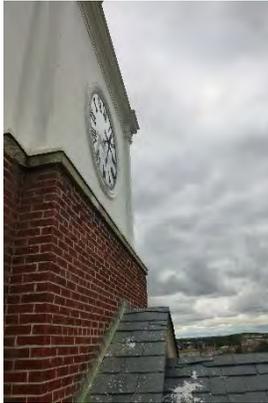
Roof – Flashing

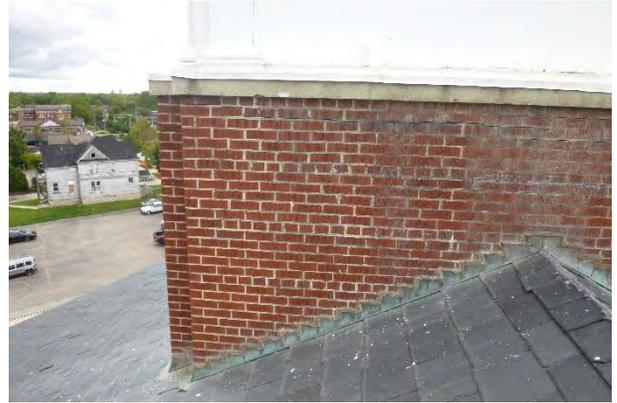
Roof – Clocktower

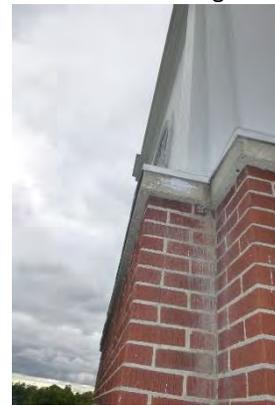
Roof – Clocktower
